State of California
California Natural Resources Agency
DEPARTMENT OF WATER RESOURCES
Division of Engineering

CALIFORNIA AQUEDUCT SUBSIDENCE STUDY
San Luis Field Division
San Joaquin Field Division

June 2017

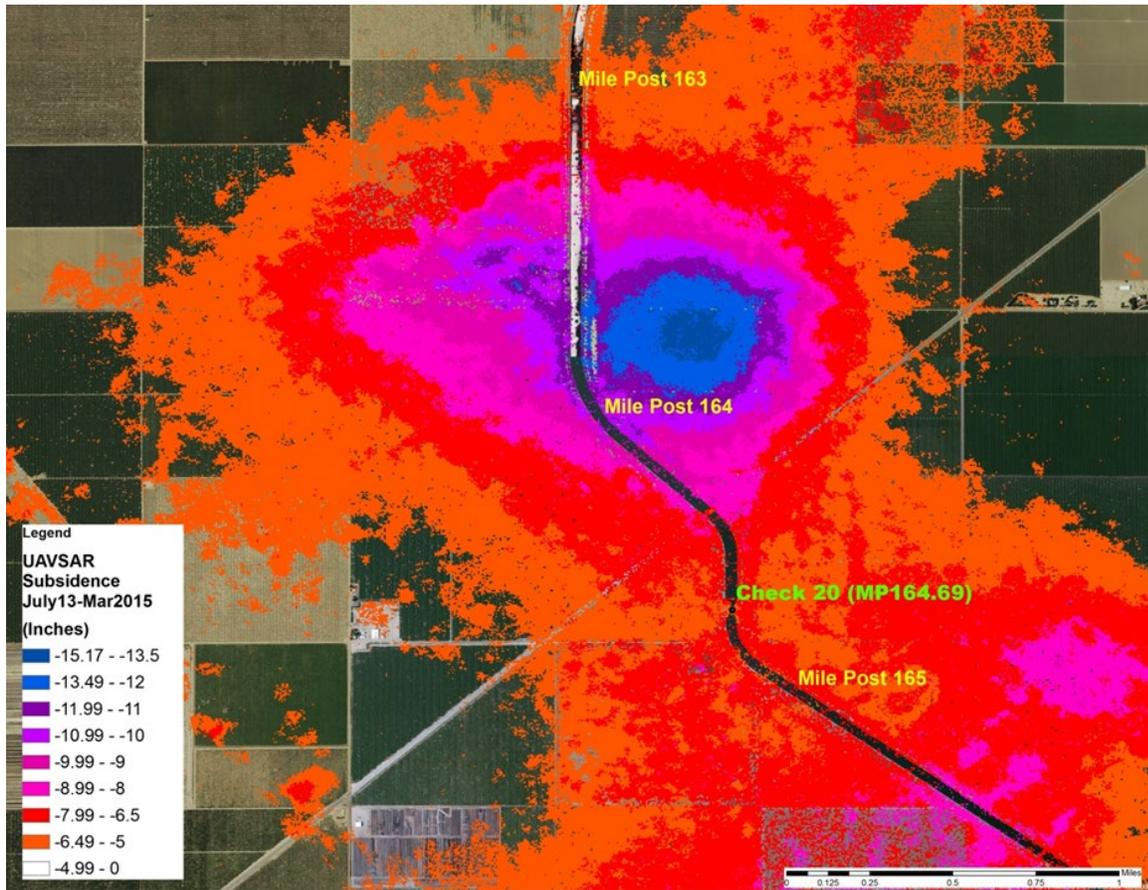
After the creation of the first few sets of UAVSAR interferograms in the SLFD, an area was noticed near Avenal Cutoff Road, Milepost 163.69, which had significantly more subsidence than the surrounding area. It was a distinct “hotspot” bowl of subsidence centered approximately 1,500 feet east of the Aqueduct.

Figure 6-9 Avenal Cutoff Subsidence Hotspot – Plan

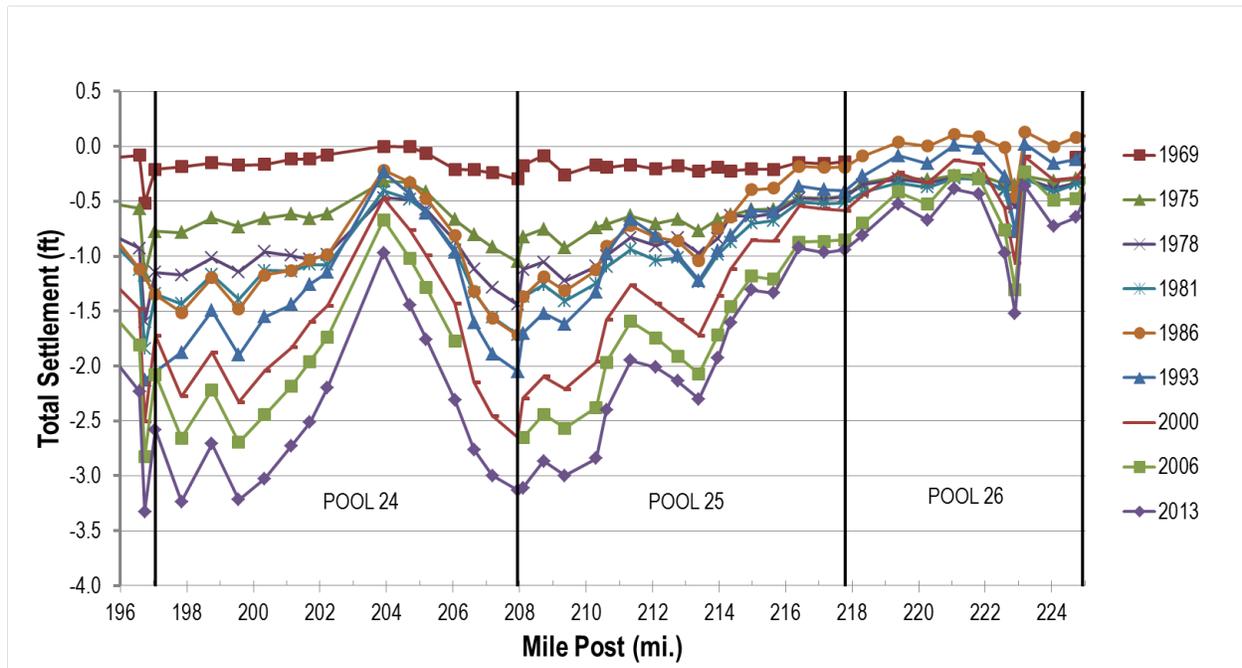
Figure 7-2 shows the magnitude of subsidence in Pools 24 through 26 in the SJFD, by year. Figure 7-2 shows that in 2013, the subsidence at Check 24 (between Pools 24 and 25) was approximately 3.1 feet, while Check 25 subsided 0.94 foot. As of 2013, the upstream side of Pool 25 subsided 2.2 feet more than the downstream end, where the controlling level sensors are located.

Figure 7-2 Subsidence Profile (Pools 24 to 26)

The magnitude of the subsidence shown in Figure 7-2 in Pool 25 compares well with the difference between the top of concrete lining (as built), and the top of concrete lining (2013) as shown in Figure 7-1. The subsidence (or difference) is greater on the upstream end of Pool 25, and decreases as it goes downstream to the end of the pool.

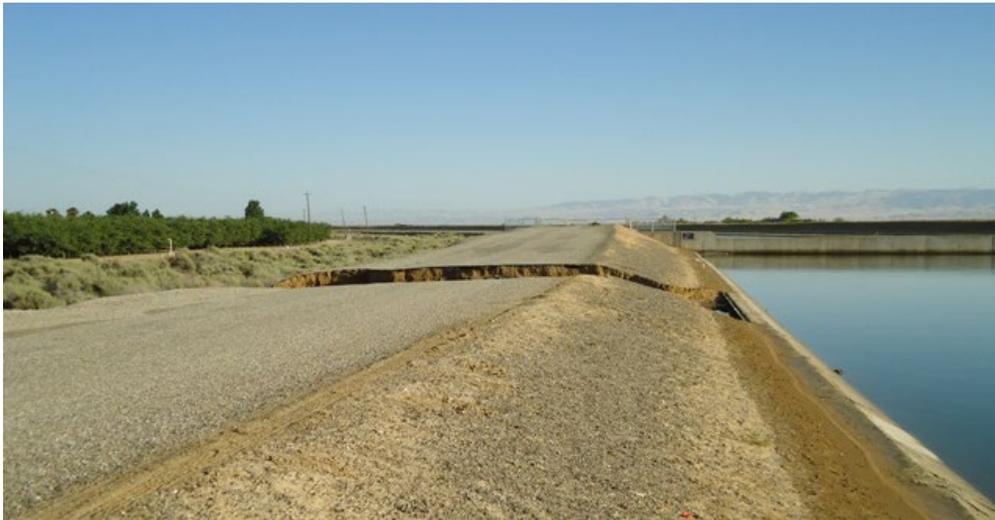
Figure 7-3 Milepost 208.08 Embankment Failure, June 2011

The DWR Division of Operations and Maintenance (O&M) conducted a root cause investigation of the Pool 25 washout event. Root causes for the failure were attributed to decrease freeboard in some pools, equipment (or sensor) difficulties, rodent holes, regulatory constraints, trainings, communication, and management systems. While not all of the factors of this failure are attributable to subsidence, two of them are. The subsidence in Pool 25, which is higher on the upstream end and lower on the downstream end, made the downstream level sensor to be a poor indicator of the conditions in the pool. The normal operational maximum WSE in Pool 25 is 2.1 feet above the design water surface elevation (the blue line in Figure 7-1). But, the top of the concrete liner on the upstream end is only 8 inches to 10 inches above the design WSE.

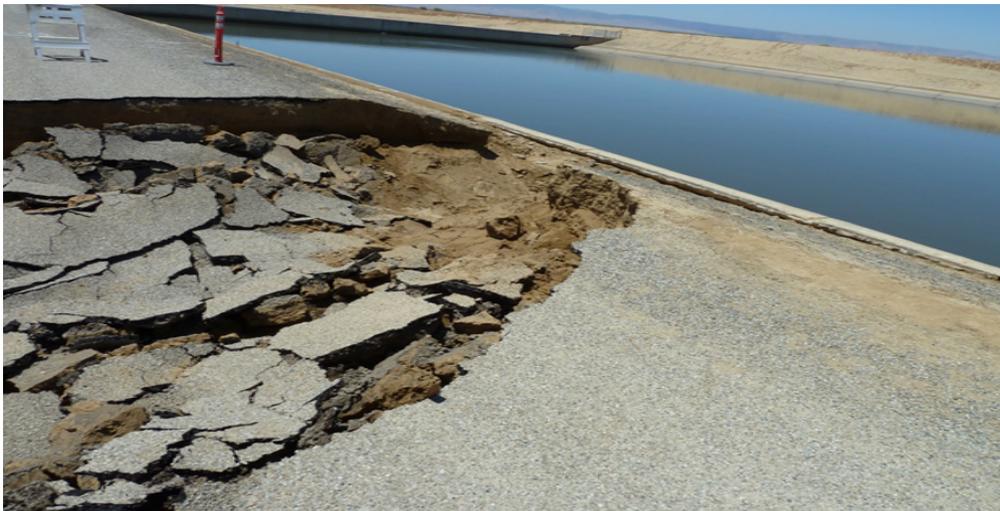
Figure 7-4 Milepost 208.08 Embankment Failure

Figure 7-4 is a photograph of the access road failure at Milepost 208.08. Shortly after the breach was reported, the water surface was dropped in Pool 25 and the flow ceased. Figure 7-4 also shows very little lined freeboard and little to no gap between the water surface and the overchute that is just downstream at Milepost 208.11.

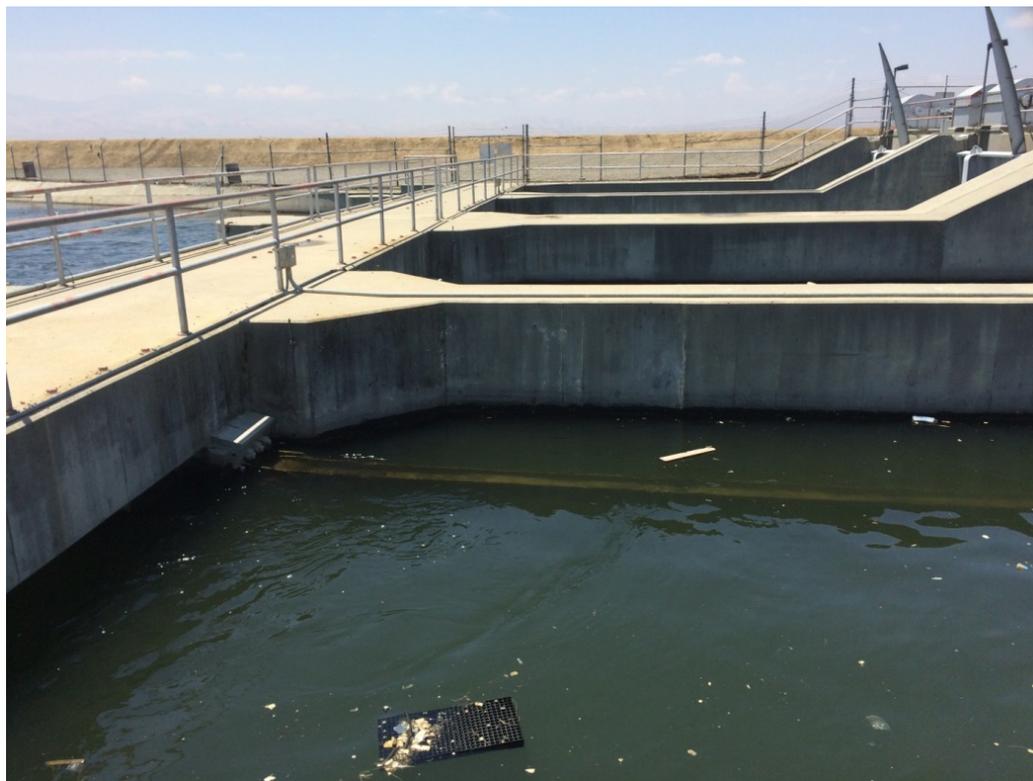
Figure 7-5 Check 20, Trunnions in the Water

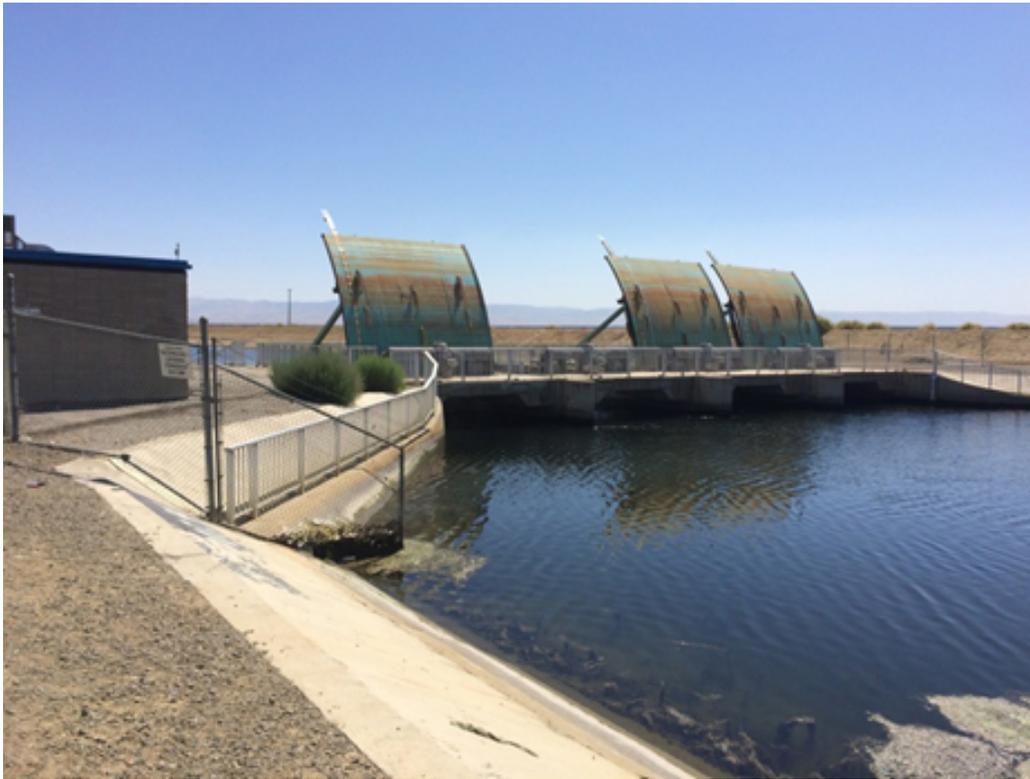
Figure 7-6 Check 24, Gates Operated out of the Water
