Lake Oroville Spillways Emergency Recovery

Board of Consultants Memorandum No. 10 – July 25, 2017

SUBJECT: Memorandum No. 10

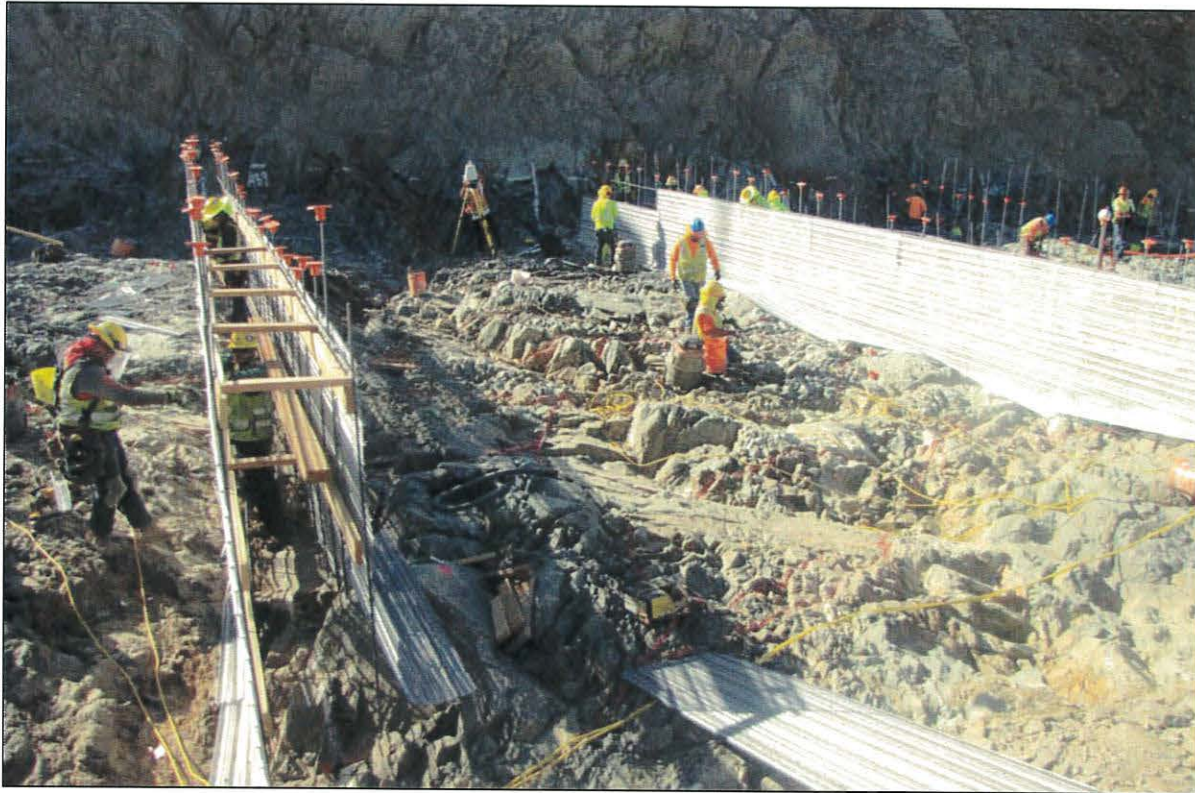
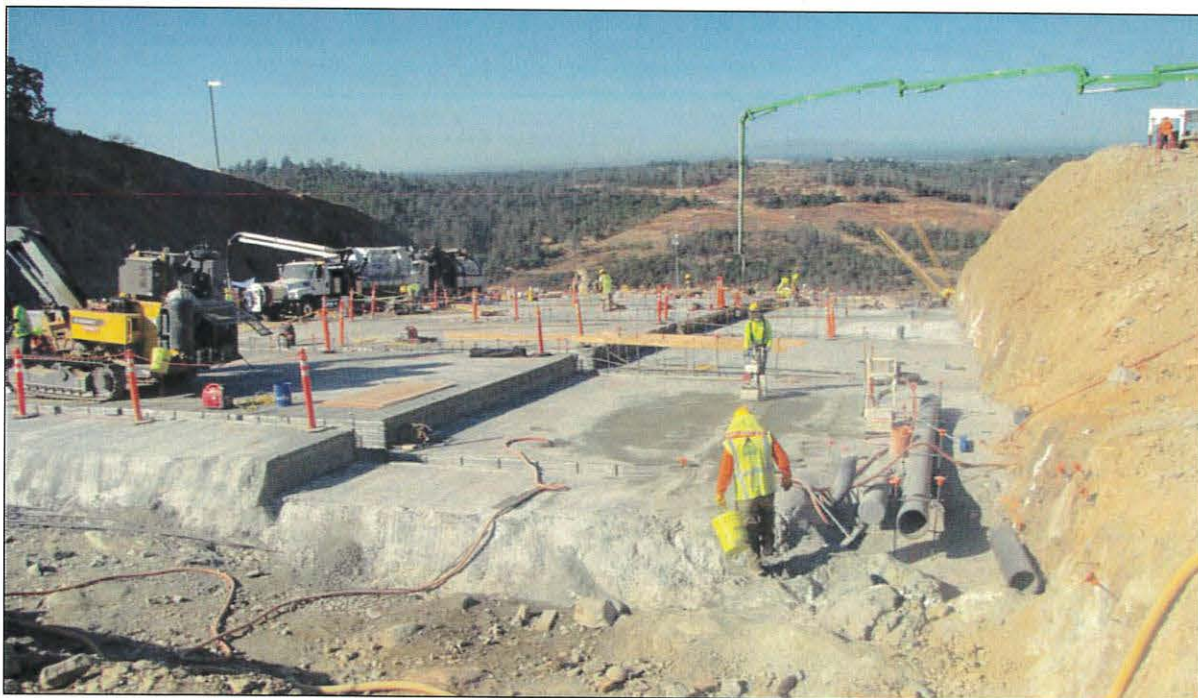
- 1. *Cleaning of the FCO Spillway Foundation.*** The BOC is impressed with the progress and quality of the foundation cleaning. The cleaning of areas of the chute foundation for placement of RCC and leveling concrete that were observed by the BOC exceed expectations and represent significant progress. The BOC visited an area of the spillway chute rock foundation that was being cleaned from approximate Stations 23+00 to 27+00 (see photographs in Figure 1). This rock surface is rough and all soil material has been removed by cleaning. This differs from the original chute foundation design that allowed some soil to remain under the original leveling concrete. The thickness of leveling concrete appeared to typically range from 3 to 6 feet in thickness, but in local areas where fractured or more weathered material was removed, the leveling concrete thickness may exceed 10 feet. At this location the BOC also observed the Stay-Forms that are being used to create the drains that extend through the leveling concrete to the rock foundation surface (see Figure 1).

Figure 1. Photographs of typical FCO foundation preparation showing foundation cleanup and Stay-Form (upper photos), and placement of leveling concrete (lower photo).
