Lake Oroville Spillways Emergency Recovery

Board of Consultants Memorandum No. 11 – August 25, 2017

Board of Consultants Memorandum

SUBJECT: Memorandum No. 11

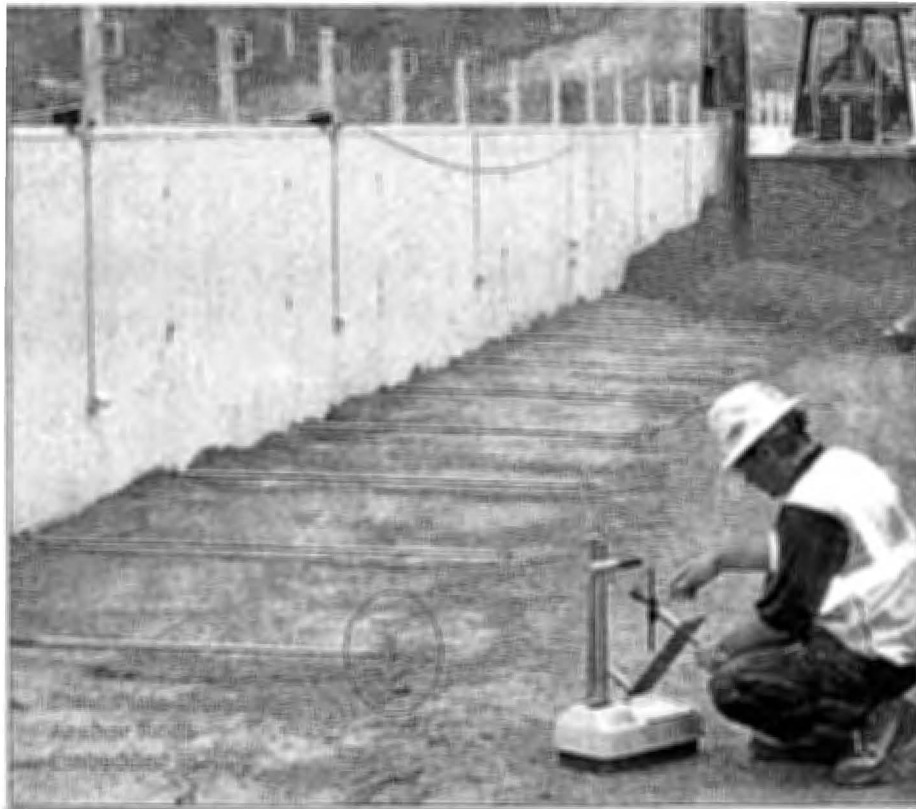
Figure 1. Example of anchor rods embedded in RCC equipped with steel plates.

3. The vertical inside faces of the provisional RCC spillway training walls are being formed using a Hilfiker welded wire wall forming system, and will later be surfaced with a 6-inch-thick application of 7,000 psi shotcrete reinforced with steel fibers. Some concerns were expressed with the embedment of the No. 4 transverse anchor bars that will be used to anchor the shotcrete steel reinforcement to the vertical face of the RCC gravity wall. Some of the No. 4 anchor bars embedded in the RCC could easily be twisted after the RCC had set. The BOC recommends that steel plates like those shown in Figure 1 be added to the ends of the transvers anchors, or that the ends of the anchors be bent 90 degrees to increase their pull-out resistance.

- M11-3 The BOC recommends that steel plates be added to the ends of the transverse anchors embedded in the vertical face of the RCC training walls of the FCO spillway, or that the ends of the anchors be bent 90 degrees to increase their pull-out resistance.

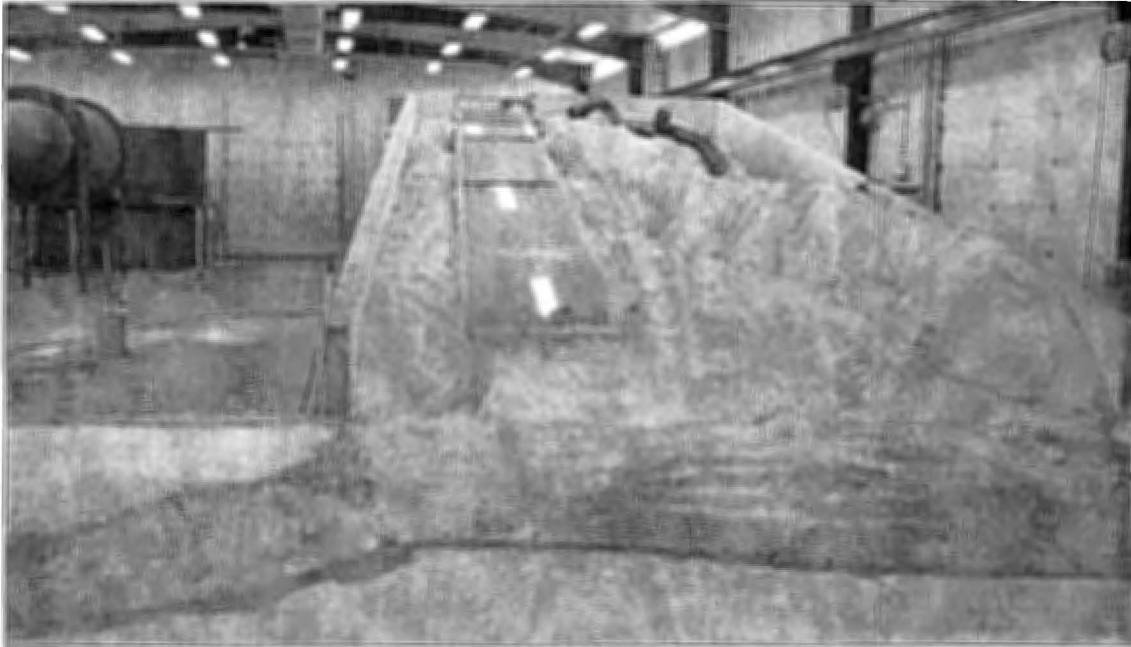
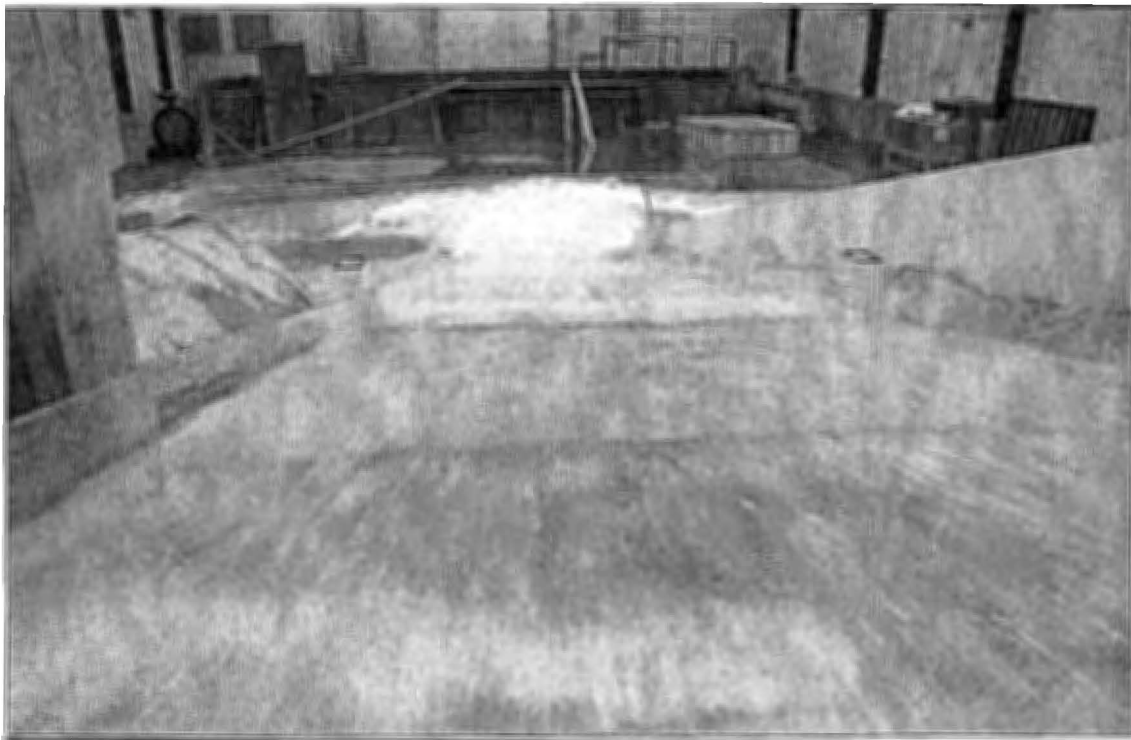
Figure 2. Photographs of Physical Model of FCO Spillway at Utah State University's Water Research Laboratory

2. On July 31, 2017, Paul Schweiger, on behalf of the BOC, visited the Utah State University's Water Research Laboratory to observe the operation of the physical model of the FCO Spillway. The model study is being conducted under the direction of Dr. Michael Johnson. During the visit, Dr. Johnson and his assistants operated the model for full-scale flows representing 10,000, 20,000, 50,000, 100,000, 150,000 and 270,000 cfs. The version of the model observed included an aerated 30-inch vertical step at Sta. [REDACTED], and two air slots further downstream of the chute [REDACTED]. Observations from the physical model corroborate the numerical computations and design recommendations of the Design Team. The following main observations were made:

a. The two aerators downstream of Sta. [REDACTED] appear to be excessively large and create considerable flow disturbance within the FCO Spillway chute, especially at lower flows. The benefit provided by these additional aerators is questionable.

b. When the 30-inch step at Sta. [REDACTED] is aerated [REDACTED] it appears to perform very well as an aerator for the full range of flows up to the maximum design flow. At the maximum design flow, the amount of air supplied to the step could be increased to improve the aeration for this extreme flow condition, however it still appears to work satisfactorily as an aerator. Increasing the size of the air vents as currently proposed by the Design Team is recommended.
