## Lake Oroville Spillways Emergency Recovery

# Board of Consultants Memorandum No. 12 – September 22, 2017

## Board of Consultants Memorandum

SUBJECT: Memorandum No. 12

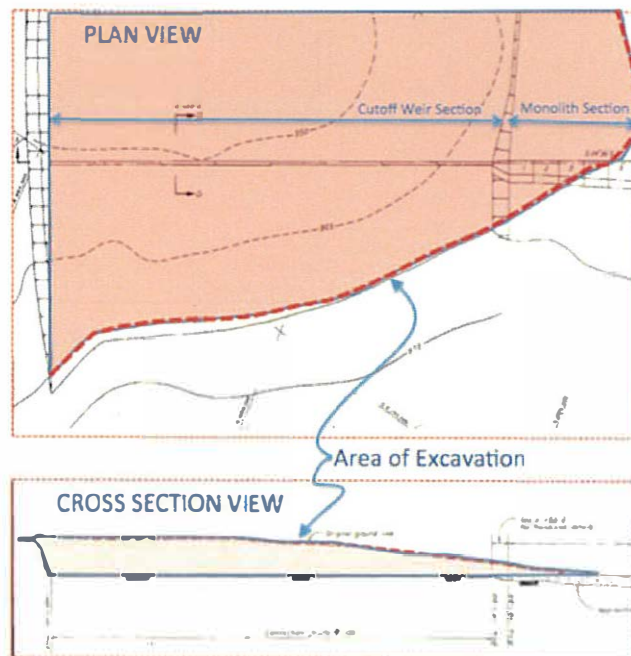
**5. Emergency Spillway Weir Foundation:** During the September 21 field visit, the BOC viewed the foundation excavation for the Emergency Spillway Weir. The original design specified that the subsurface portion be embedded 14 feet into the ground and founded on slightly weathered or fresh rock. The contractor's initial excavation method used a trenching machine that was unable to penetrate the bedrock. Subsequently, an excavator with a hoe ram attachment was used to perform the foundation excavation. This resulted in a wider than planned foundation (approximately 6 to 7 feet wide instead of 2 feet), but this method was also unable to penetrate to the full 14-foot depth (measured from the top of the weir) with the current depth approximately 6 feet below the natural ground surface. The rock exposed in the foundation bottom is predominately slightly weathered to fresh rock. It should be noted that the current "ground surface" is itself an excavated surface that was created during the original 1960's construction by excavating from 5 to 40 vertical feet of amphibolite rock, and re-contouring a hill to create the approach for this part of the emergency spillway (see Figure 1). The BOC believes that the bedrock currently exposed in this foundation is of sufficient strength and quality to serve as an adequate foundation for the weir, and that requiring the contractor to continue deepening this excavation would not be meaningful.

Figure 1. Plan and Section showing the original 1960's Emergency Spillway Excavation

- M12-5      The BOC believes the bedrock currently exposed in the foundation of the Emergency Spillway weir is of sufficient strength and quality to serve as an adequate foundation for the cutoff weir.

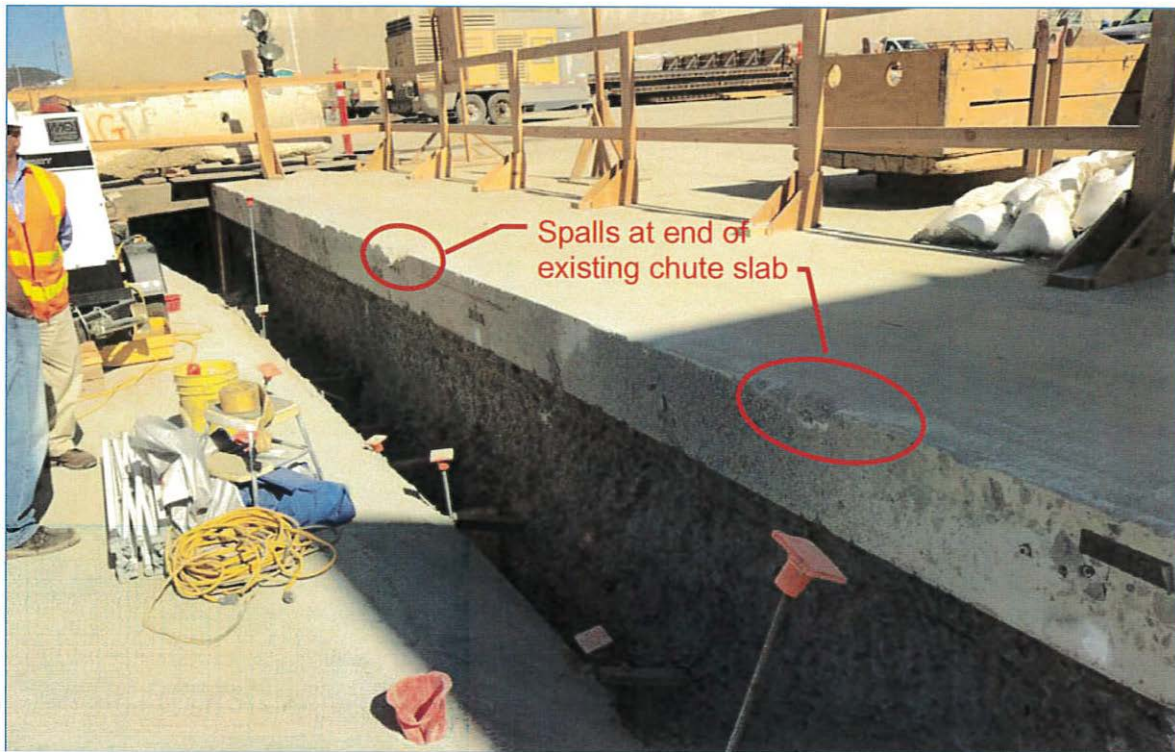
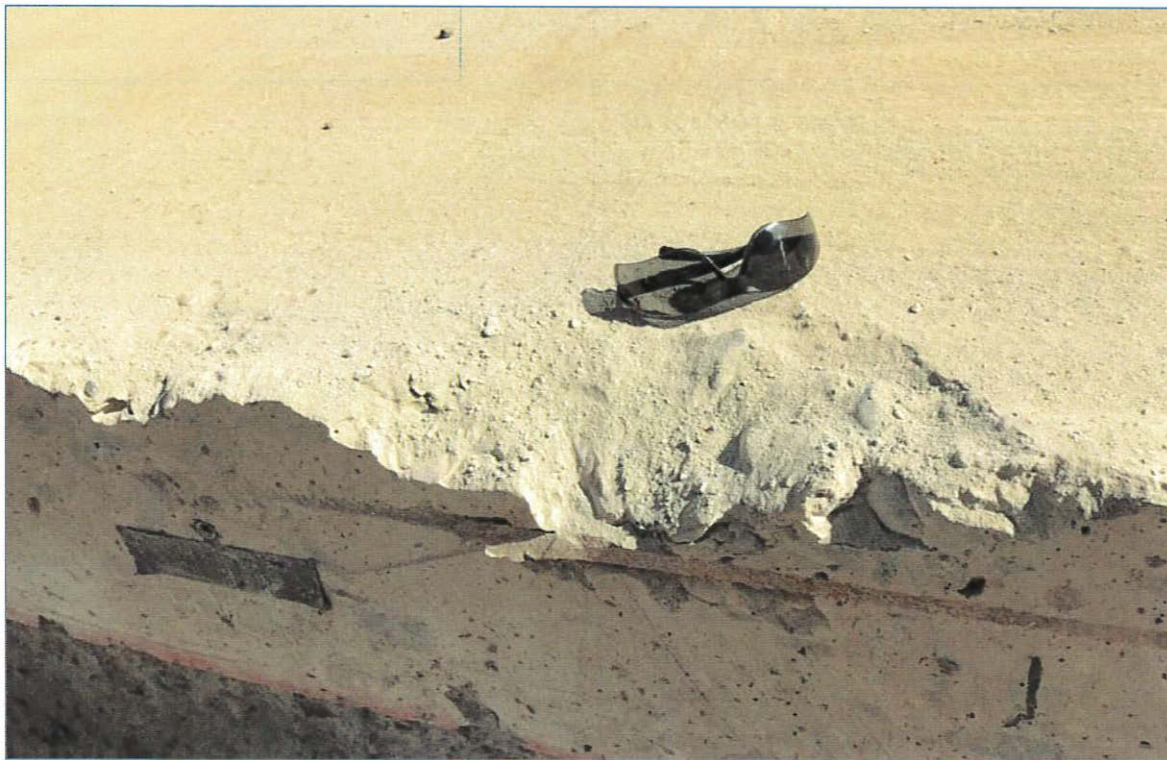
2. The BOC noted during their tour of the FCO Spillway chute that the downstream end of the existing chute slab at Station 20+30 where the connection to the new constructed slabs will be made, has a number of areas of spalled or broken concrete on the top edge. These must be repaired by the best method of concrete patching. Photos showing the spalls along the downstream end of the existing chute slab are provided in Figure 2.

Figure 2. Photos of the downstream end of the existing chute slab showing spalls.

- M12-12 The BOC recommends that the spalled areas along the downstream end of the existing FCO chute slab at Station 20+30 (where the connection to the new constructed panels will be made) be repaired by the best method of concrete patching.
