OROVILLE EMERGENCY RECOVERY – SPILLWAYS

Board of Consultants Memorandum

DATE: October 11-12, 2018

SUBJECT: Memorandum No. 21

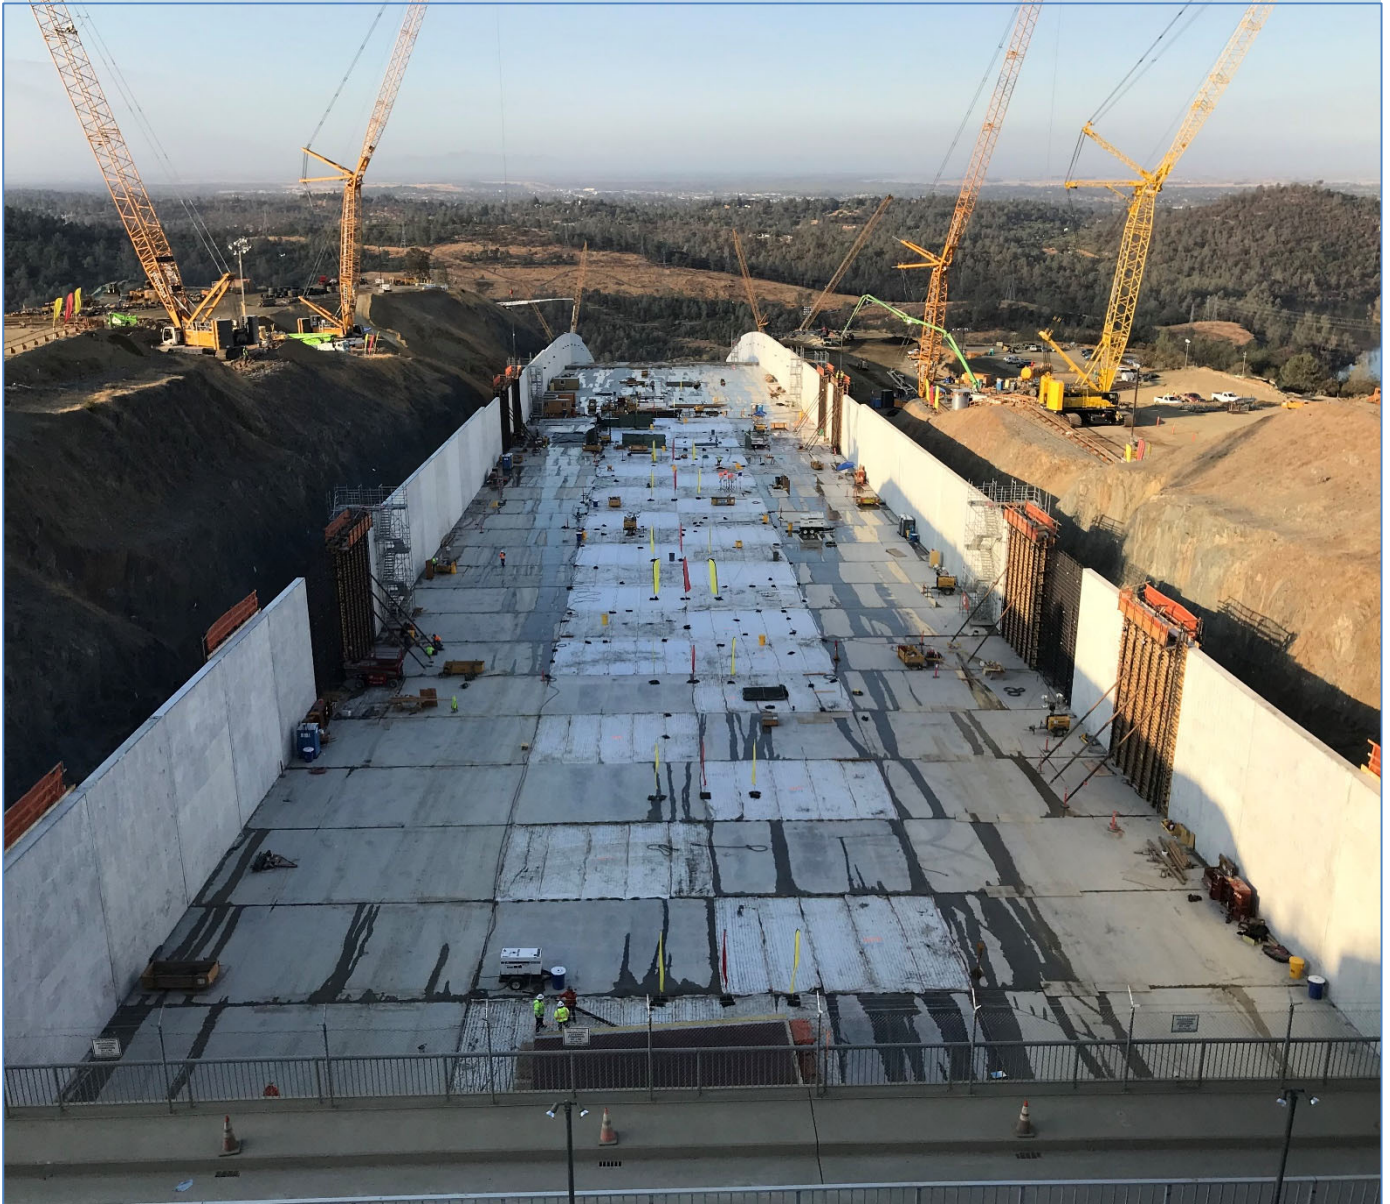
Figure 1. Construction of chute slabs and walls in the upper section of FCO chute.

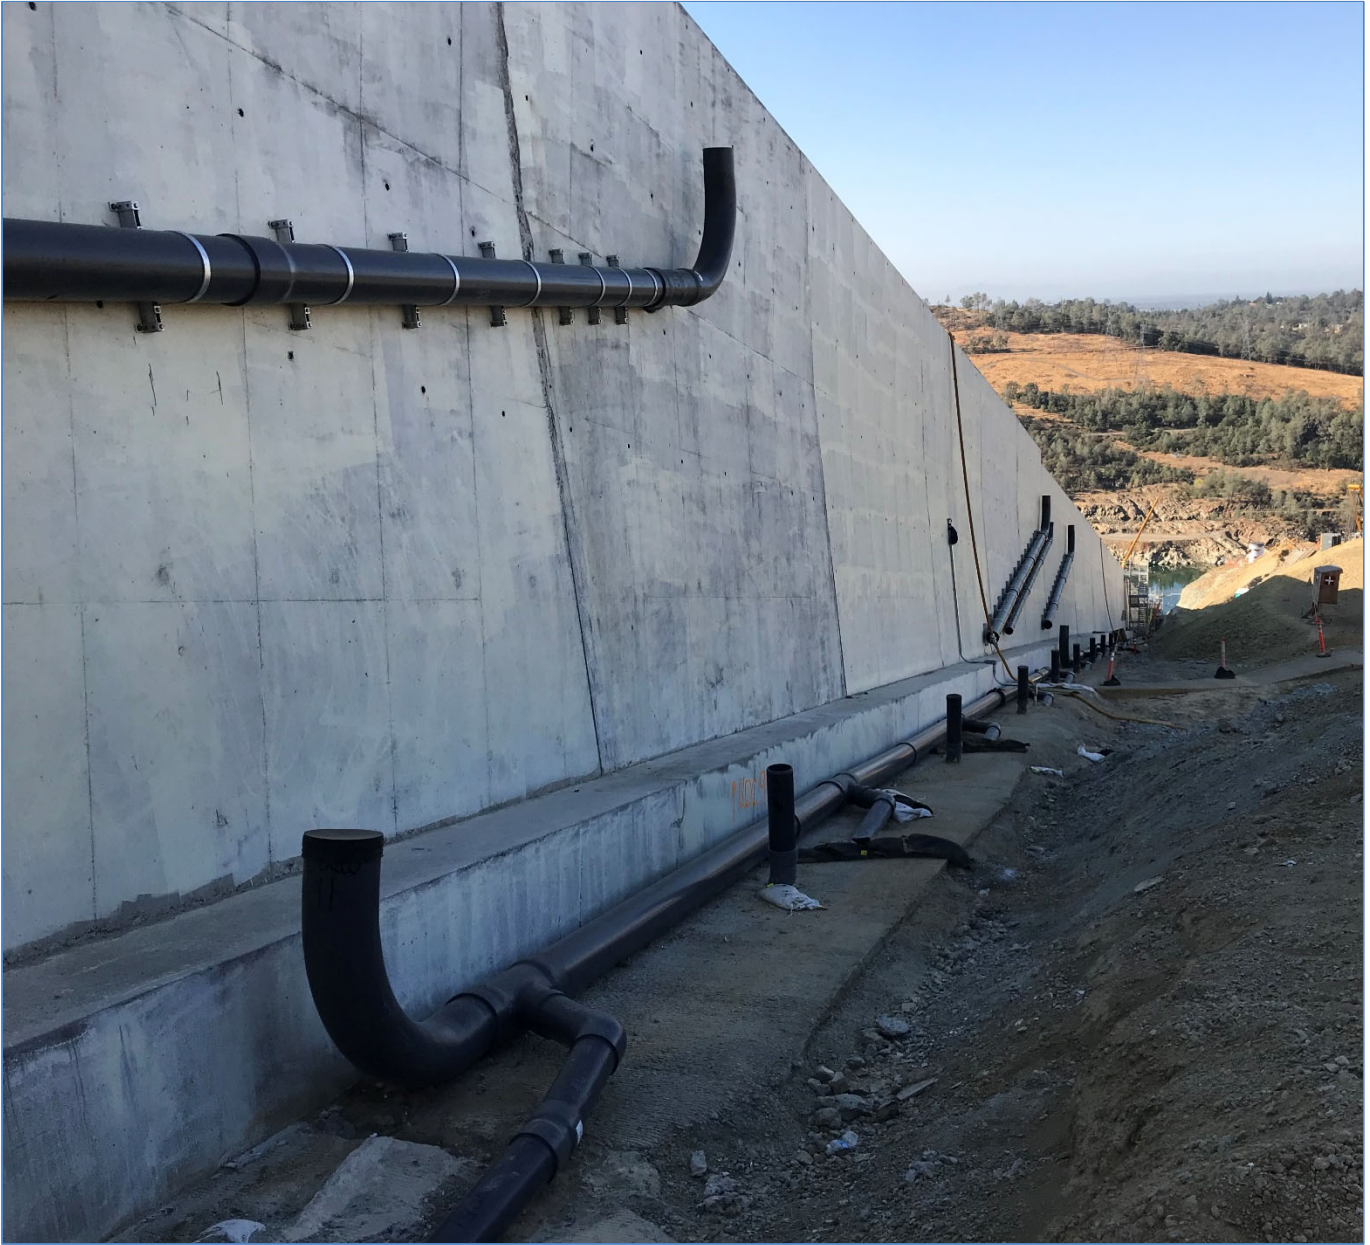
Figure 2. Construction of wall drains in the middle section of FCO chute (middle right side).

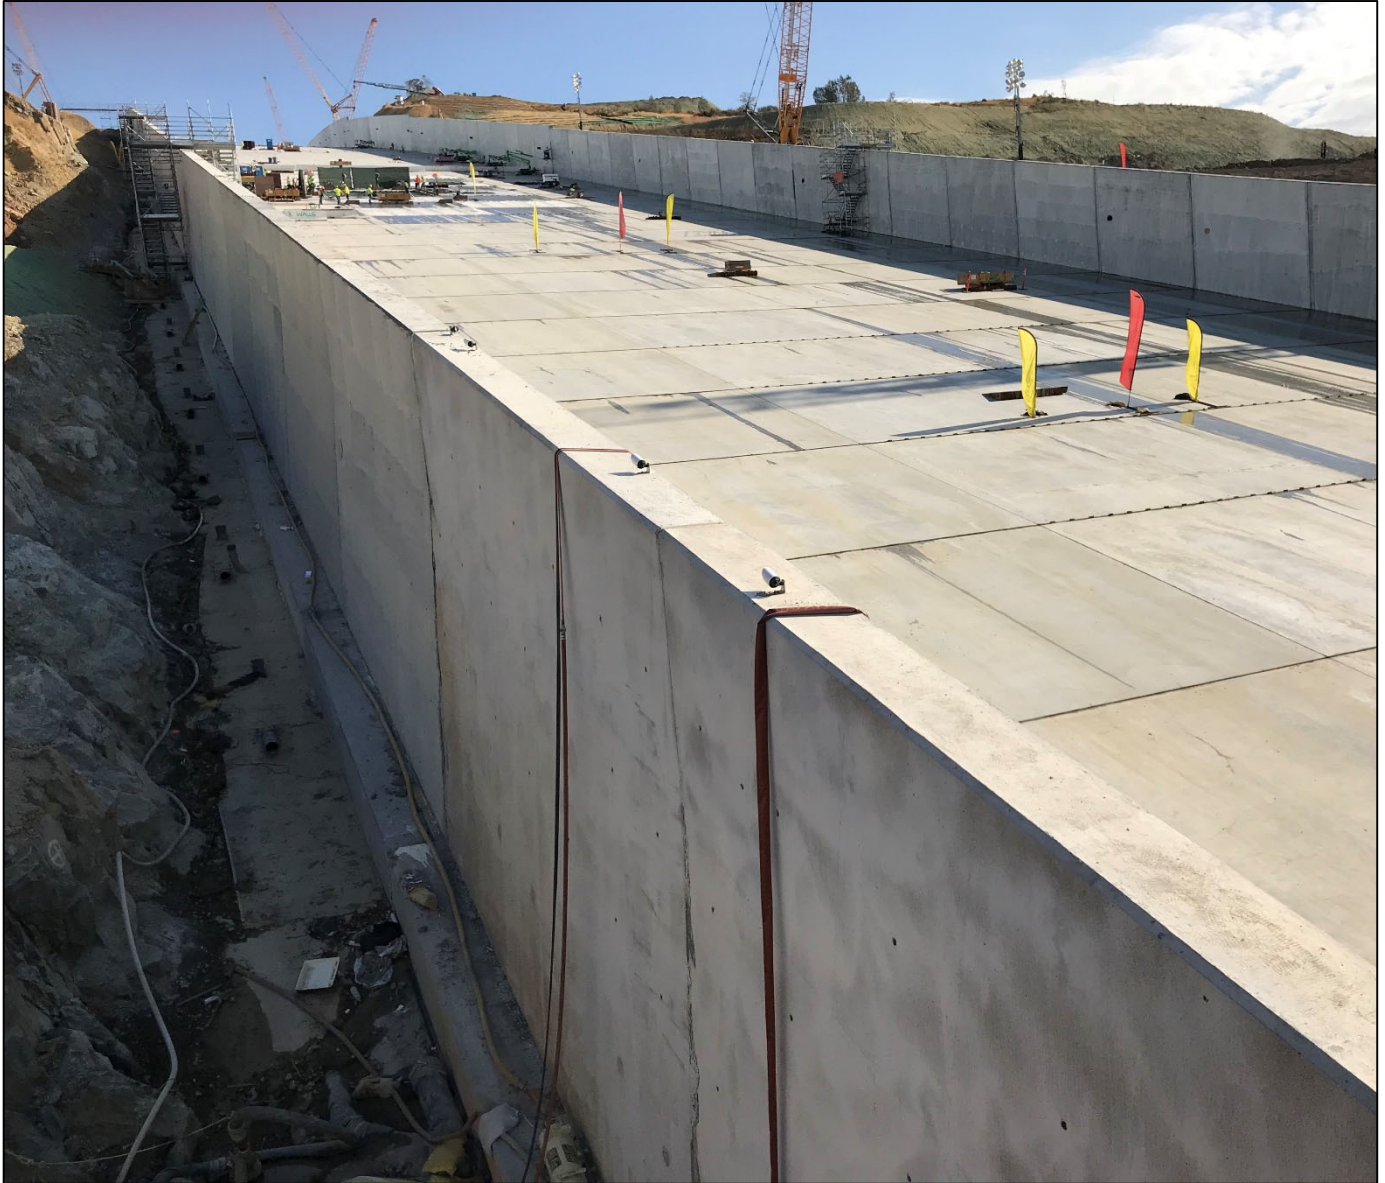
Figure 3. Construction of chute slabs, walls and drains in the middle sections of FCO chute (lower right side).

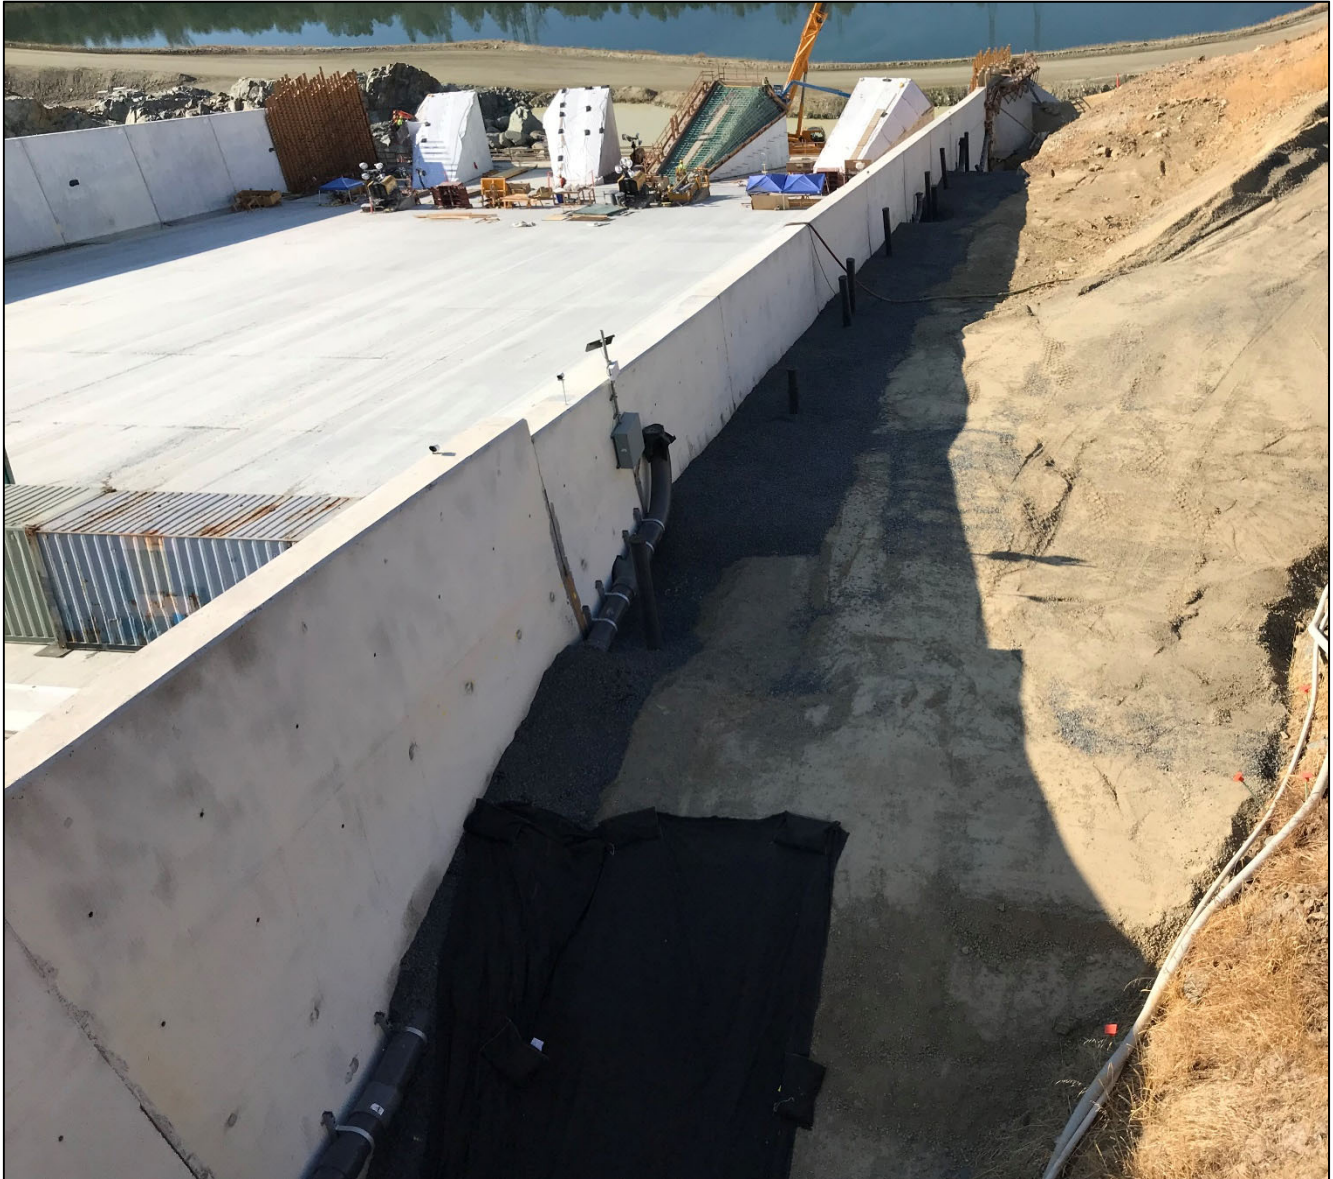
Figure 4. Reconstruction of the terminal structure and backfill along the end section of FCO chute (end of right side).

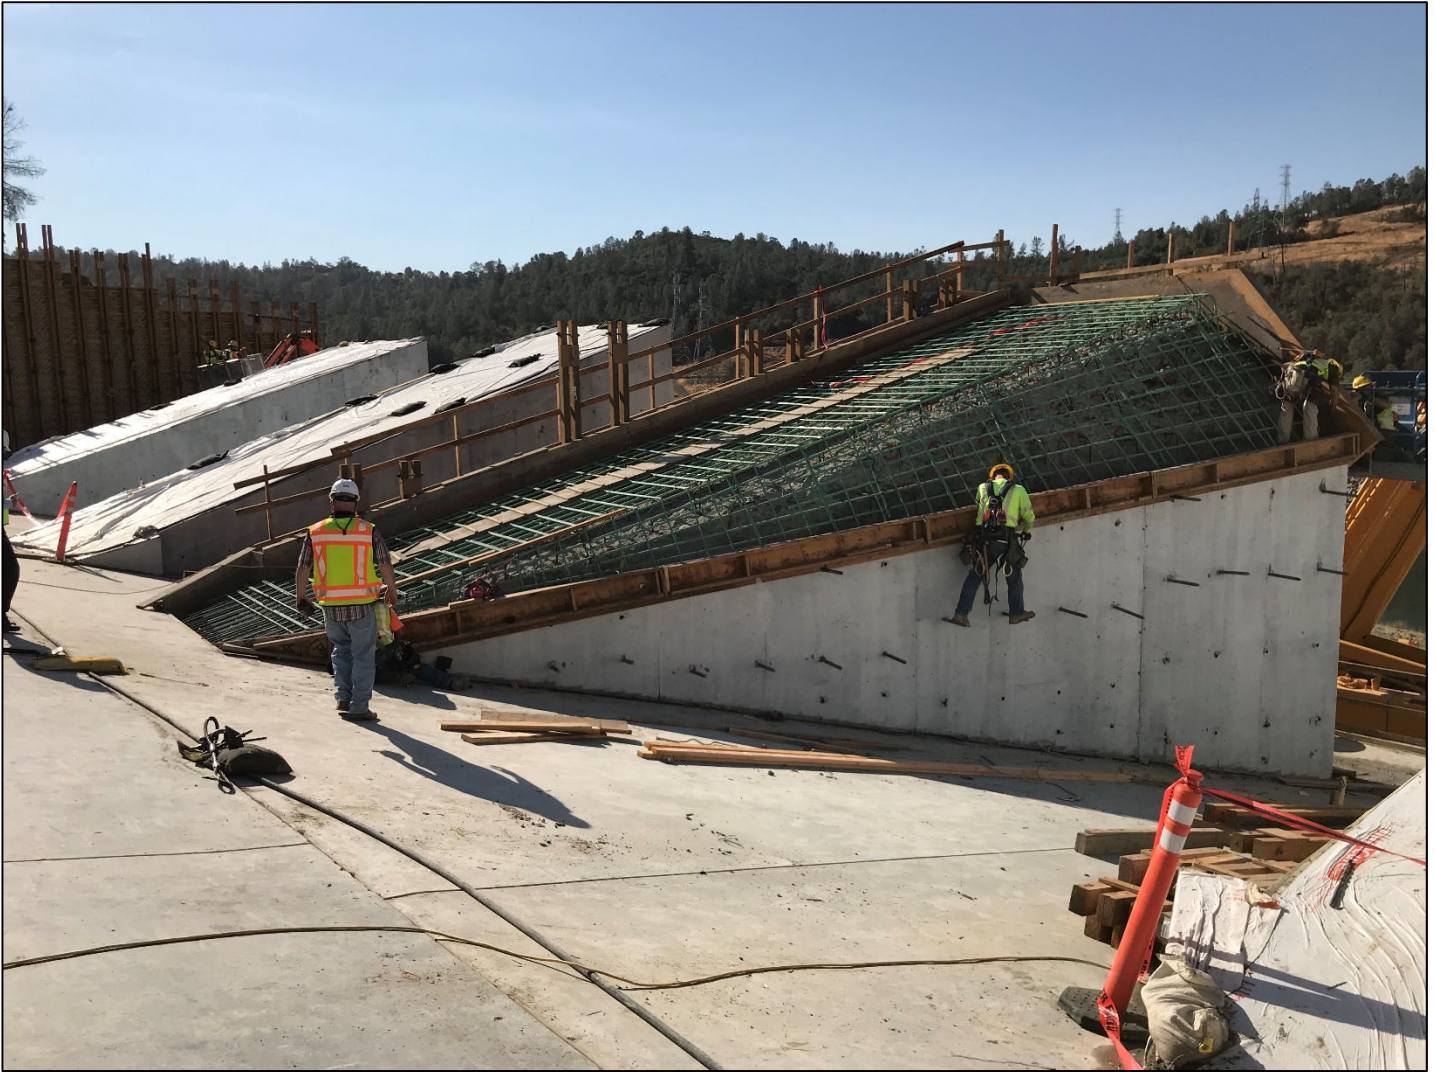
Figure 5. Reconstruction of the dentates at downstream end of FCO chute.

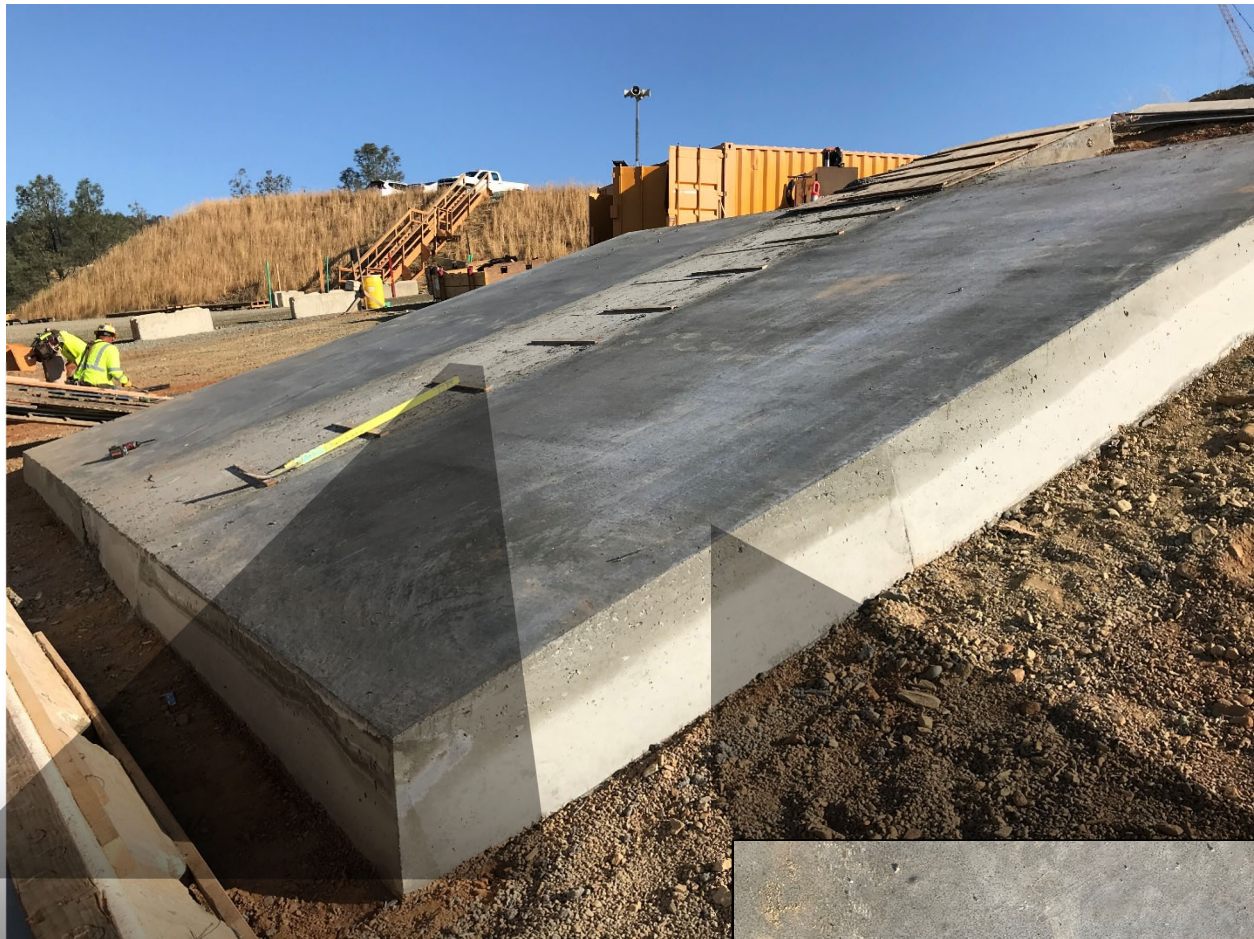
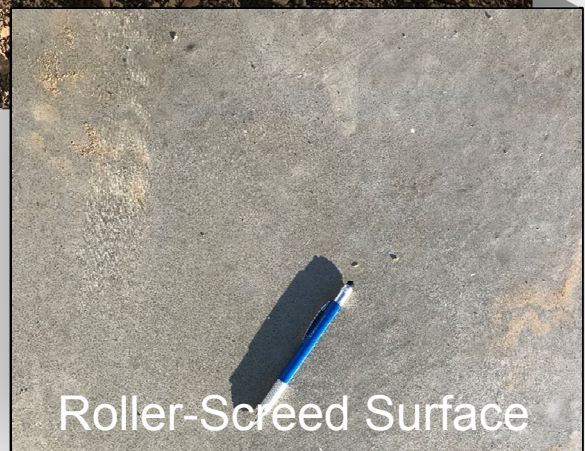
Figure 6. Test section for the 2H:1V conventional concrete transition section at the top of the RCC stepped buttress for the Emergency Spillway Ogee section.

Based on the inspection of the test section for the 2H:1V conventional concrete transition section at the top of the RCC stepped buttress for the Emergency Spillway Ogee section (see Figure 6), the BOC concurs with the Design Team's decision to use slip-forming or screeding instead of conventional forming to provide the best finished surface.

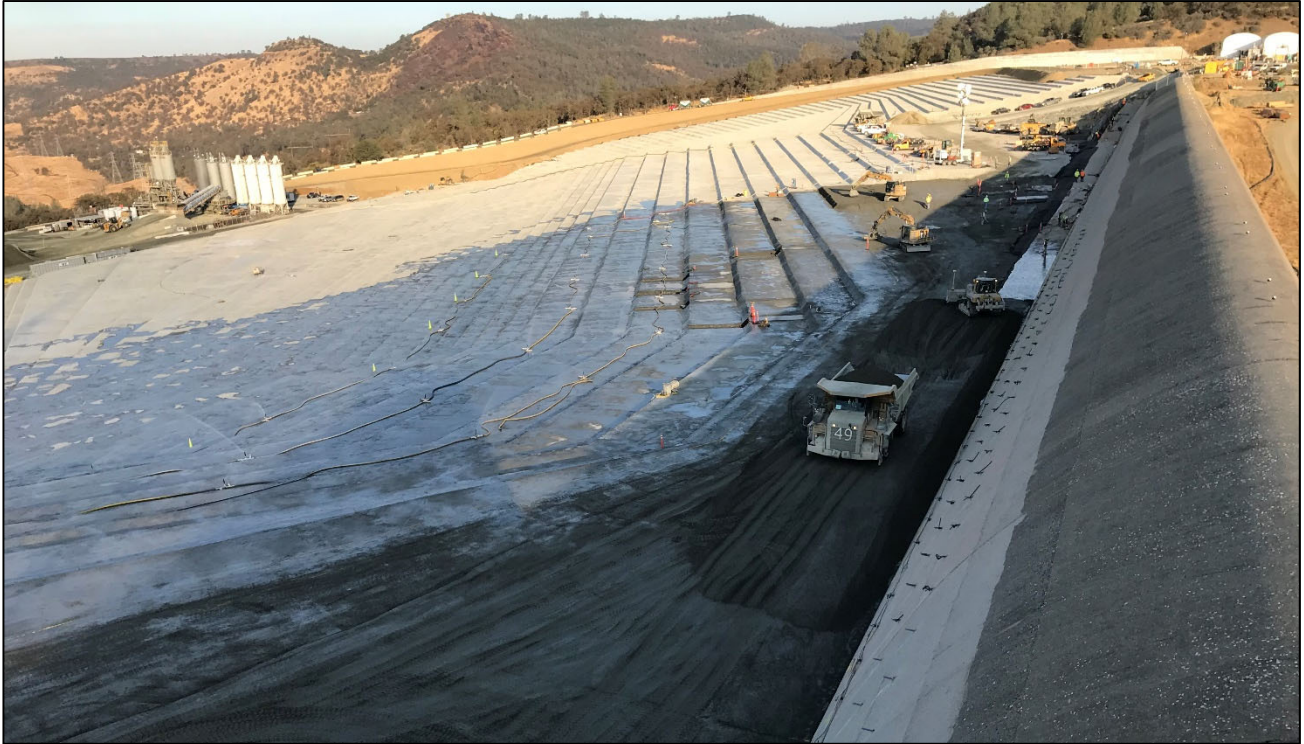
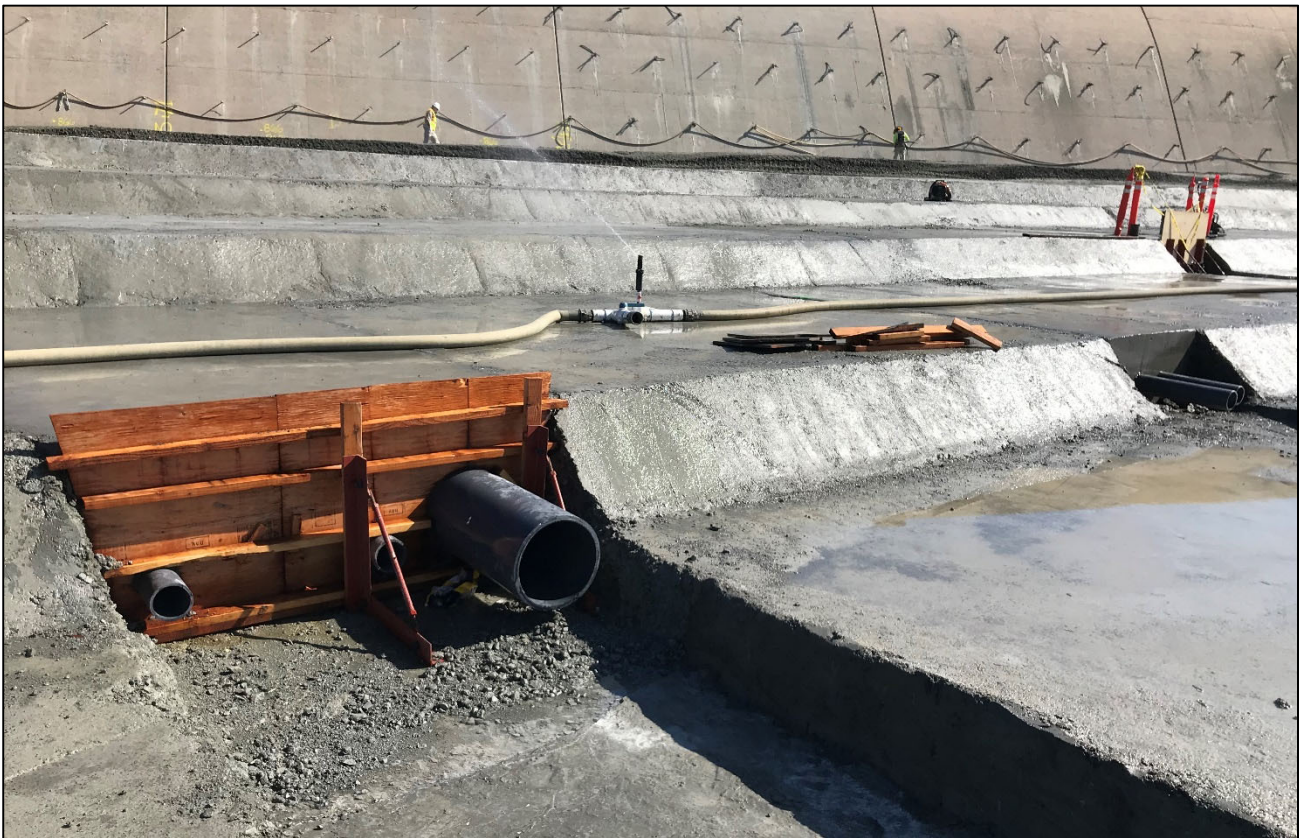
Figure 7. RCC apron, drains, and butress of the ogee monoliths for the Emergency Spillway.

RCC Buttress and Erosion Resistant Concrete (ERC) cap in the Emergency Spillway by November 1 may be optimistic. This work includes placement of the RCC buttress and the ERC cap detail at the top of the RCC buttress. Notwithstanding, the BOC congratulates the Design Team, contractor and regulators for this momentous accomplishment.
