Burned Area Emergency Response

Mendocino Complex

Burned Area Emergency
Response (BAER) Plan
for the Bureau of Land Management

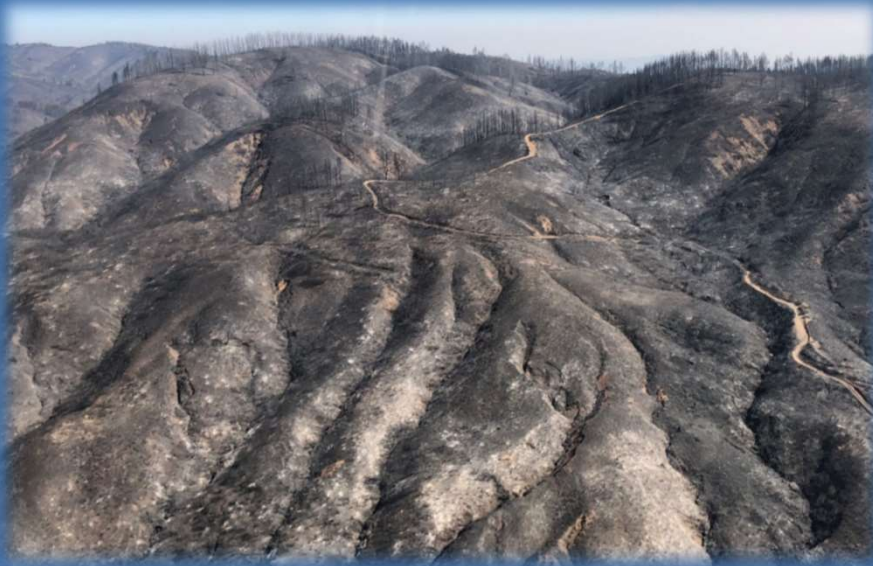
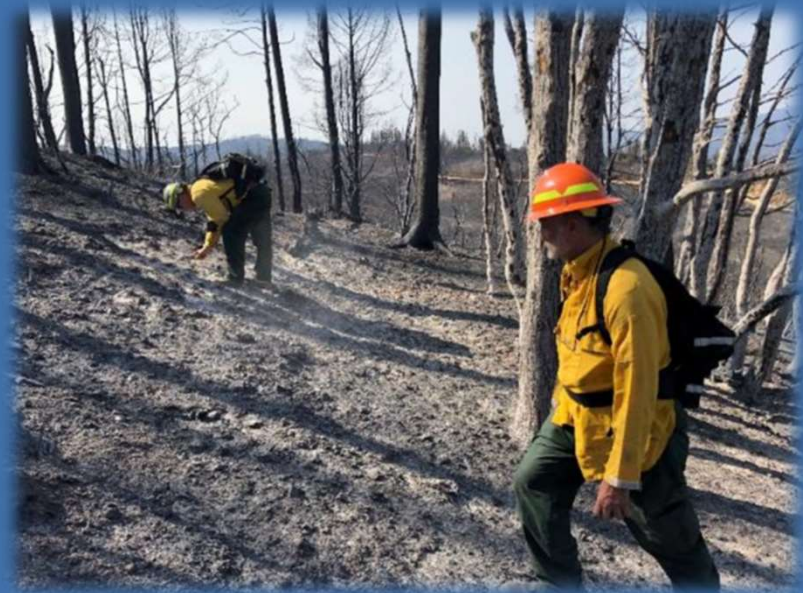
Watershed Observations

- Changes in ground cover
- Potential for erosion and sediment delivery due to Soil Burn Severity (SBS)

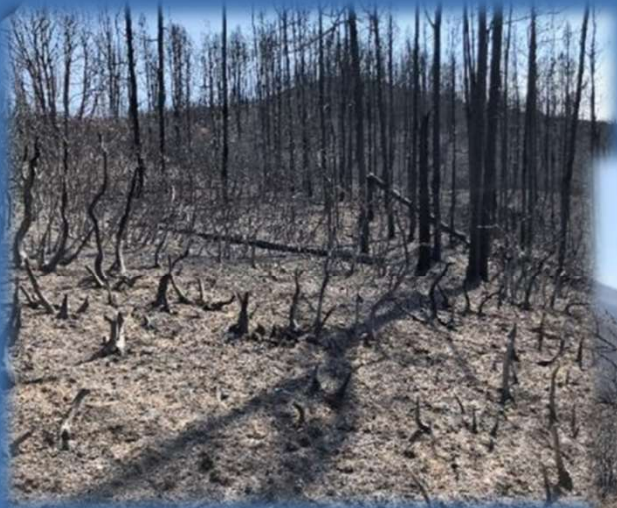
High

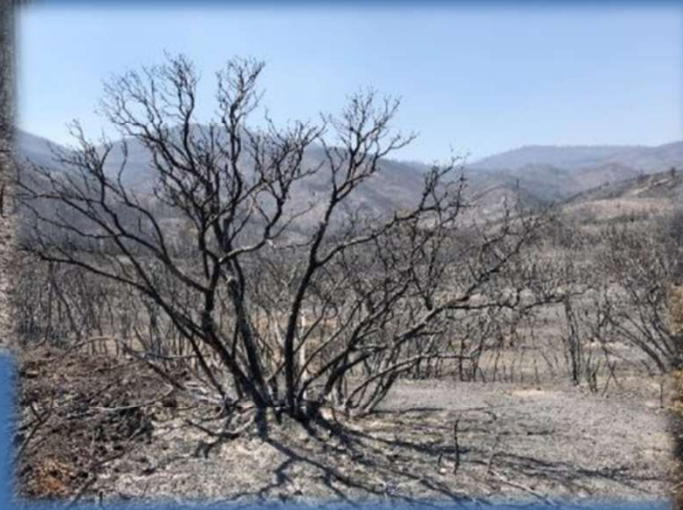
Moderate

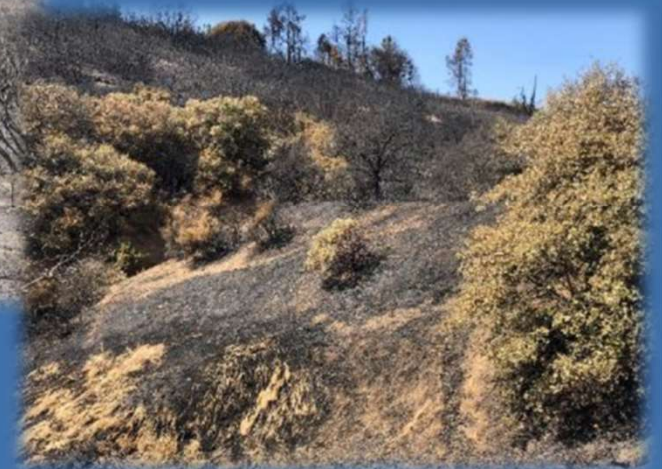
Low

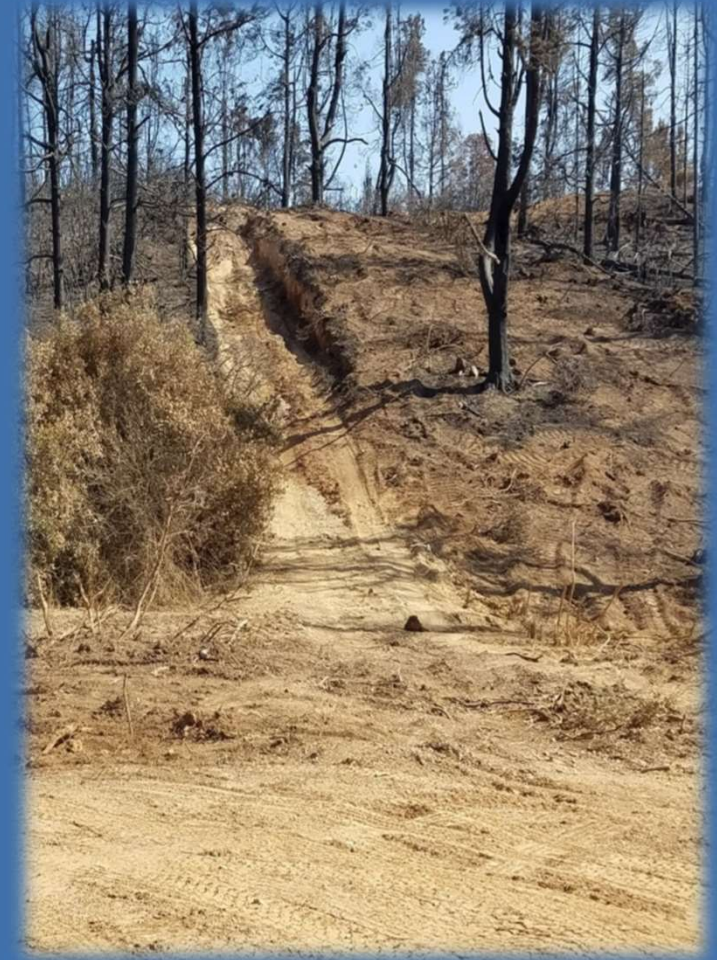
1. 82% Moderate-High Soil Burn Severity
2. Watershed Response (AGWA model)
3. Highly Erodible Soils

1. Scotts Watershed - Clear Lake Total Maximum Daily Load
2. 8-Mile Meadow Restoration
3. (Morrison Watershed – Habitat Endangered Species Act-listed Fish)
4. Roads, Trails and Cultural Sites

- Focused on implementing actions that contribute to Clear Lake water quality, sediment reduction goals and complement 8-mile meadow restoration project.
- 73 miles of trails, 66 miles affected by moderate and high soil burn severity (SBS).
- Clean existing trail drainage structures, construct additional waterbars and rolling grade dips, rebuild fire-damaged retaining walls, and place straw wattles to slow water flow.

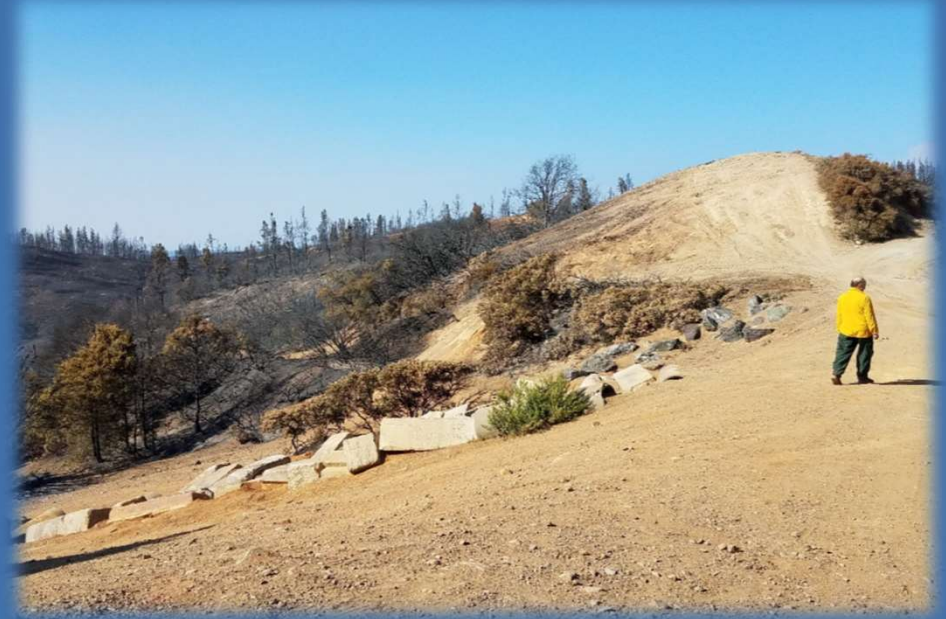
Road Drainage Improvements

- Focused on implementing actions contributing to Clear Lake water quality, sediment reduction goals and complement 8-mile meadow restoration project.
- 53 miles of roads, 38 miles in moderate and high soil burn severity.
- Construct rolling drainage dips, strategically place drain runouts, culvert inlet cleaning, ditch cleaning, and template shaping to reduce concentration of overland flow and increase ability of road to handle increased runoff, sediment and debris from fire.

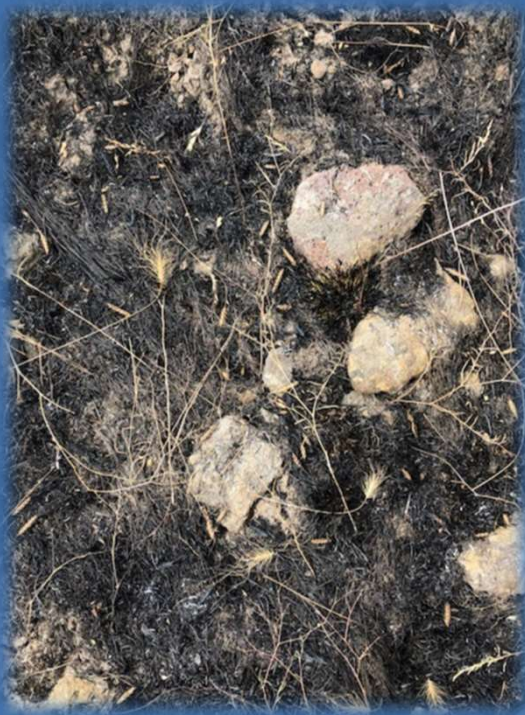
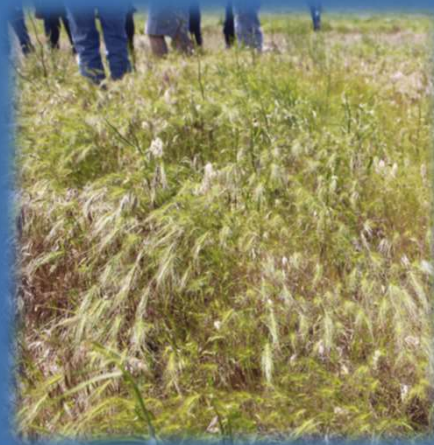
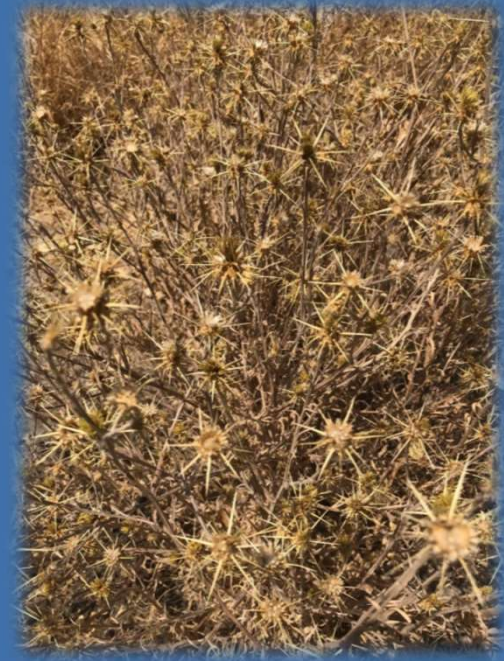
Vegetation Issues

- Impacts from noxious weeds

- Inventory Invasive and Noxious weeds
- Treatment

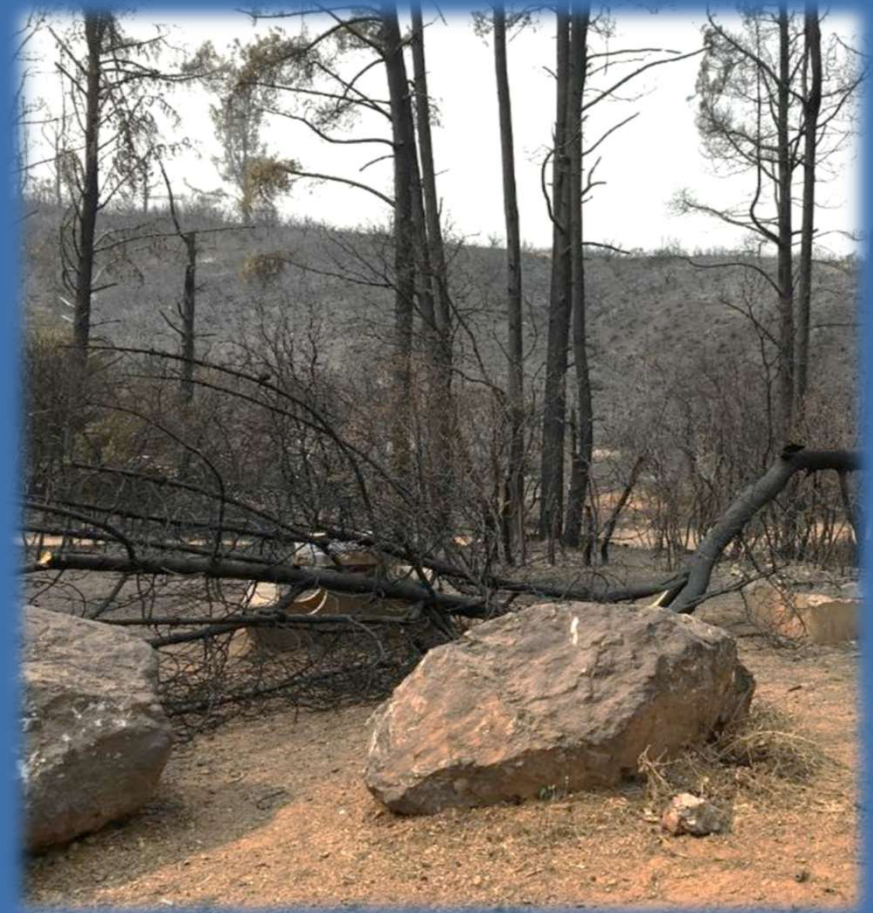
Recreational Site Hazards

- Emergency Stabilization (ES) - Recreational Site Hazard Mitigation
 - Reduces or eliminates threats to human life and safety caused by hazard trees.
 - Prevents further destruction of BLM facility investments.

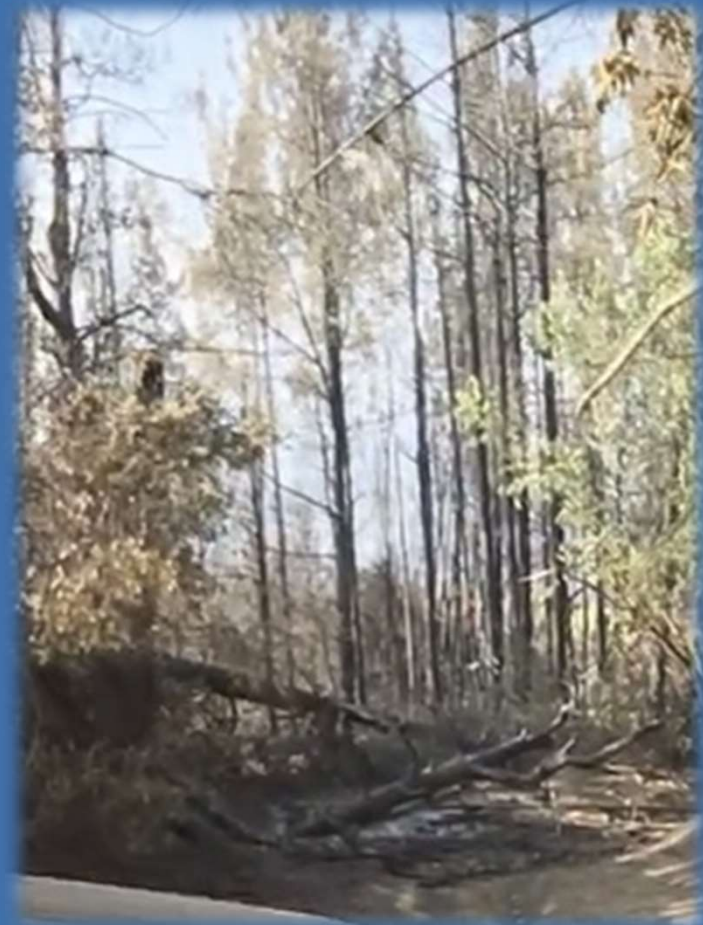
Trail Hazards

- ES - Trail Hazard Mitigation
 - Reduces or eliminates threats to human life and safety caused by hazard trees, falling rocks, and burned roots along BLM developed trails.
 - Facilitates soil site stability.

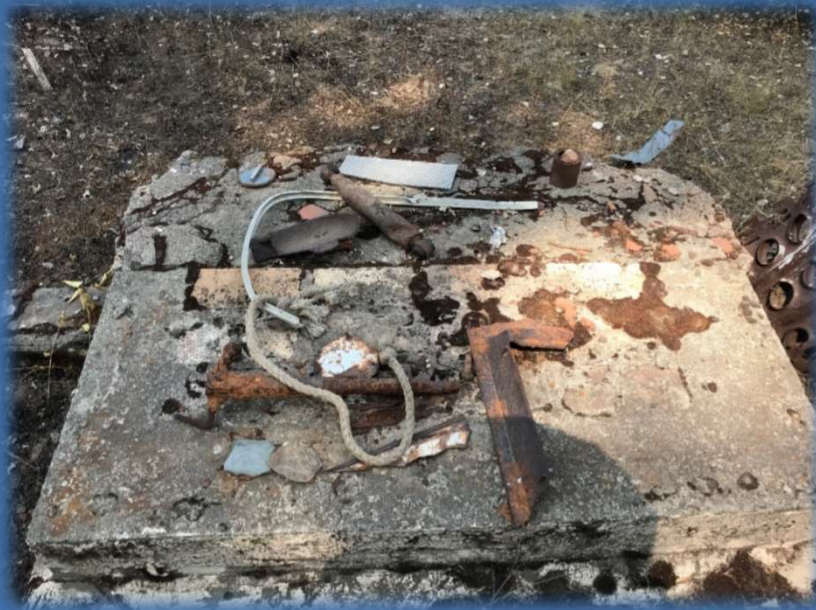
Post-fire Exposure to Cultural Sites

- Norris Homestead
- New visibility increases temptation to loot
- Post-fire vulnerability increases potential loss of this history

- Monitoring
 - Erosion from increased sediment run-off
 - Looting by individuals looking for relics
 - Vandalism (trespass)
- Barricading sites from potential trespass
- Placement of rip-rap
 - Lessen erosive force
