Sulphur Bank Mercury Mine Superfund Site

June 5, 2019

Presentation Overview

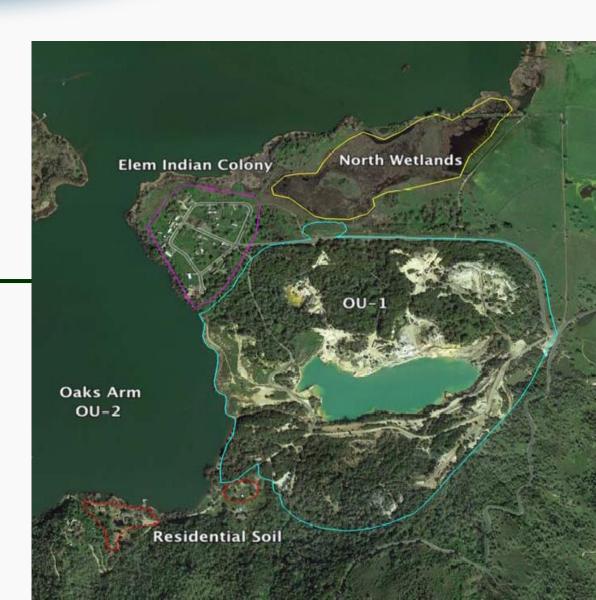
Site Overview

Terrestrial Mine Site and Residential Soils
Operable Unit 1

Lake Sediments and North Wetlands
Operable Unit 2

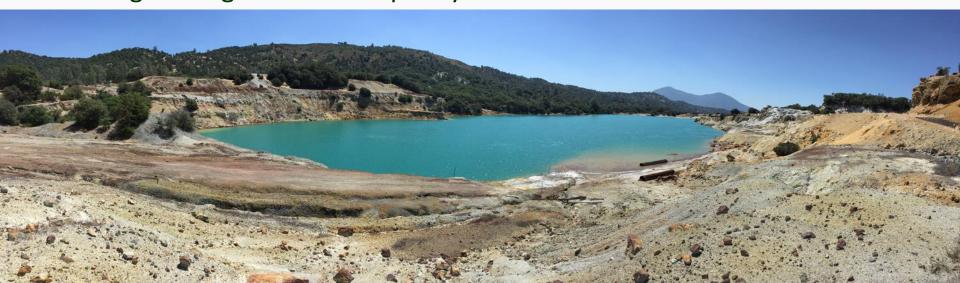
Revised Site Understanding

Changes in Herman Impoundment water quality

- Stormwater divisions and drought led to improved water quality in Herman Impoundment – pH from around 3 to nearly 5
- Capping the exposed mine waste at the site would further:
 - Reduce acid rock drainage
 - Reduce hydraulic head pushing water through WRD
 - Reduce contaminant loading into Clear Lake
- Once waste is capped, HI water chemistry modeled to move toward background groundwater quality
