2019 SWP Construction Project Updates

California Water Commission Briefing, November 20, 2019

CALIFORNIA DEPARTMENT OF
WATER RESOURCES

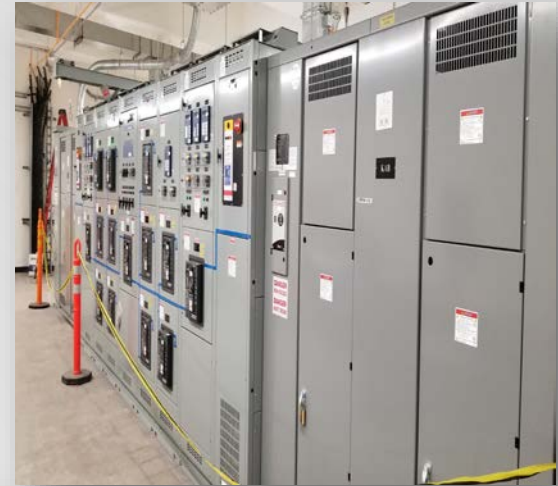
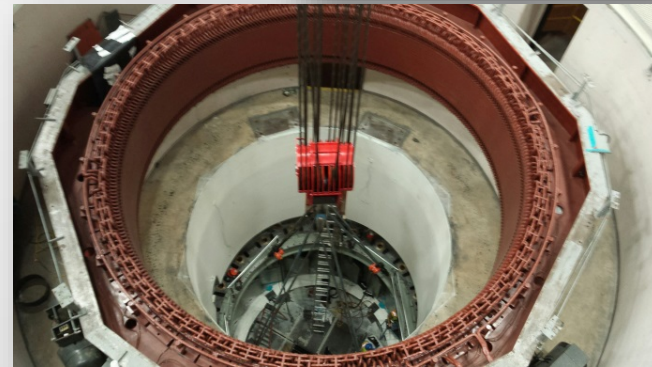
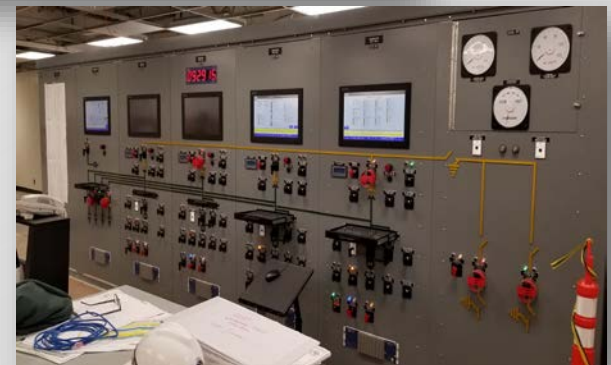
THERMALITO RESTORATION PROJECT

Thermalito Pumping-Generating Plant is a 115 MW hydro plant located in Oroville, CA. On Thanksgiving Day 2012, a fire occurred in the plant rendering it inoperable. Clean-up occurred during the span of 2013-2014, with Restoration beginning in 2015.

- Replace Plant Electrical Systems
- Mechanical Refurbishment – All units
- Power Transformer Refurbishment
- Roof Replacement
- Fire and Life Safety Modernization

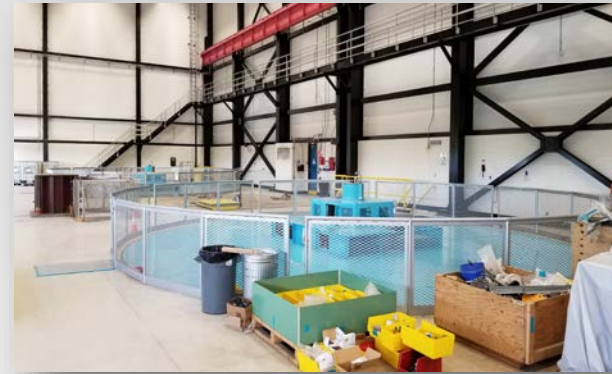
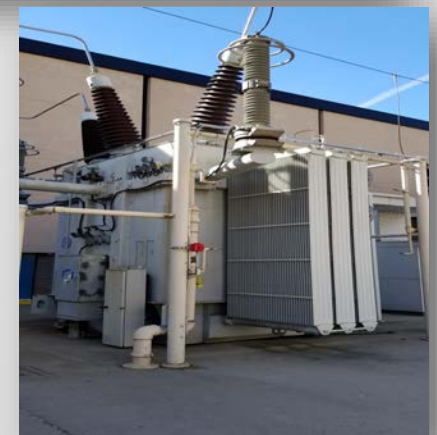
THERMALITO RESTORATION PROJECT

- Roof Replacement – Complete
- Power Transformer Refurbishment – Complete
- Unit Mechanical Refurbishment – Complete
- Project is in Startup and Commissioning Phase

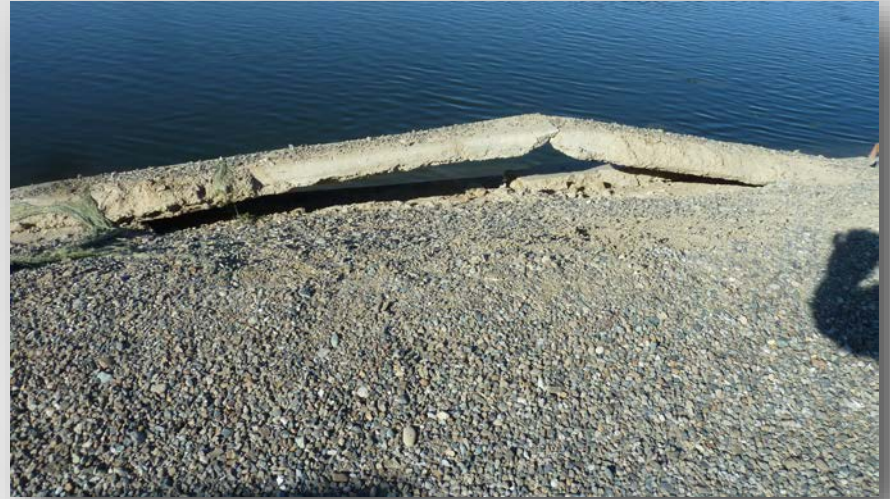
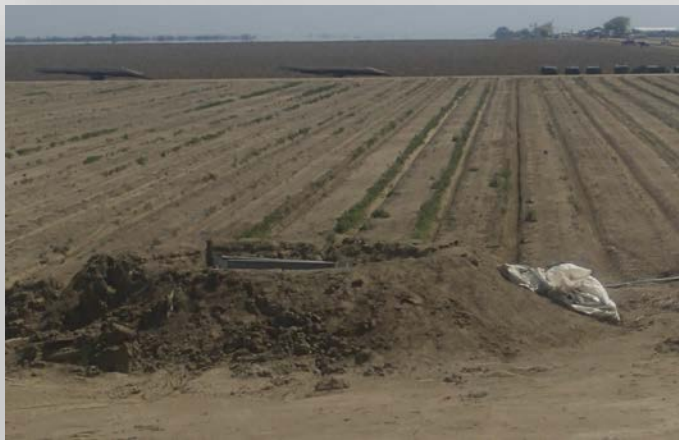
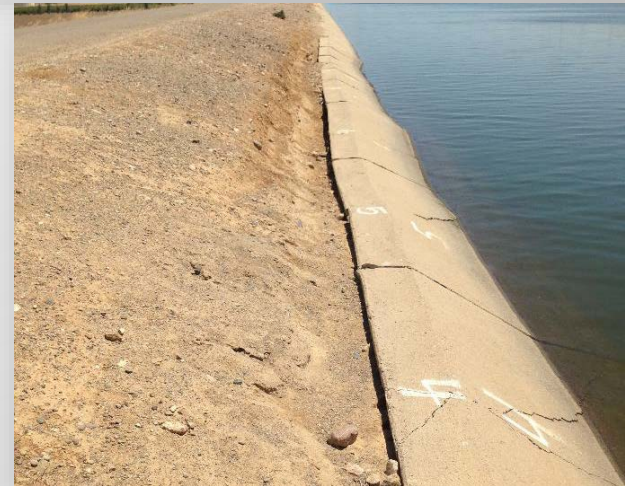
California Aqueduct Canal Liner and Embankment Repairs

Repair sites were identified through
O&M's Condition Assessment
Program

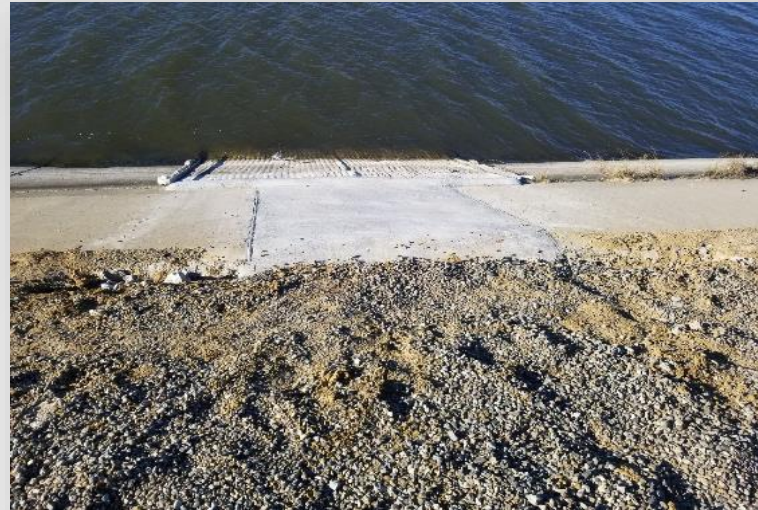
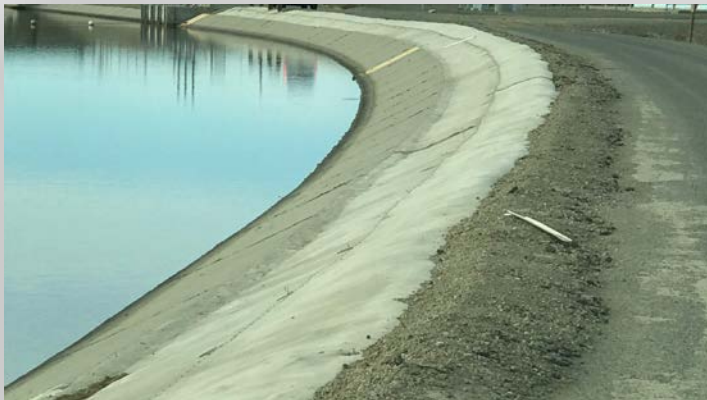
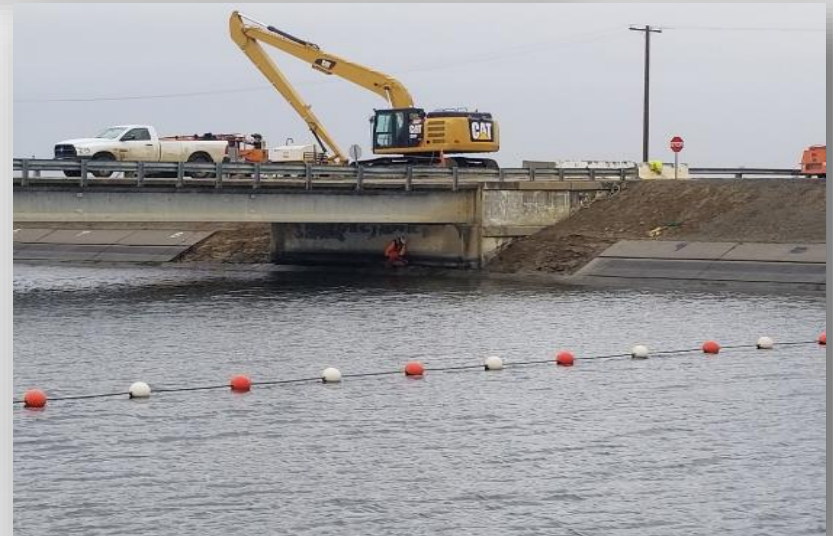
California Aqueduct Canal Liner and Embankment Repairs

- 30 Sites between 2016 and 2019
- Multiple panel replacement and repair methodologies
- Repairs scheduled based on operational constraints
- Project completed in March 2019

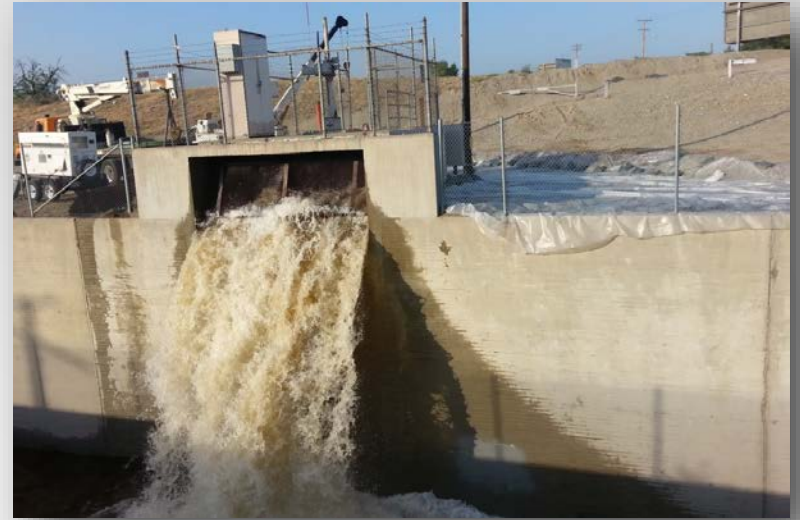
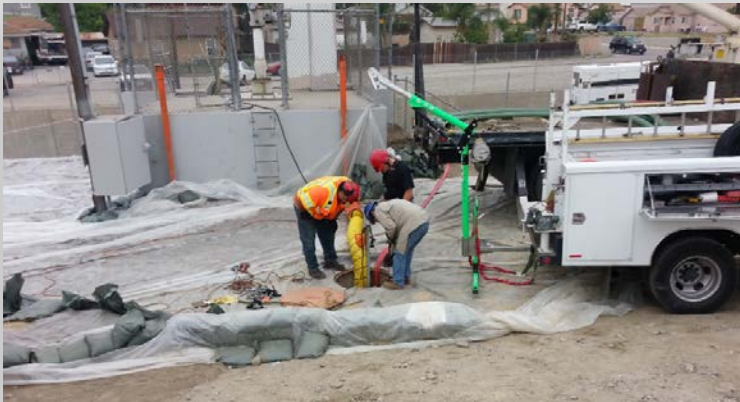
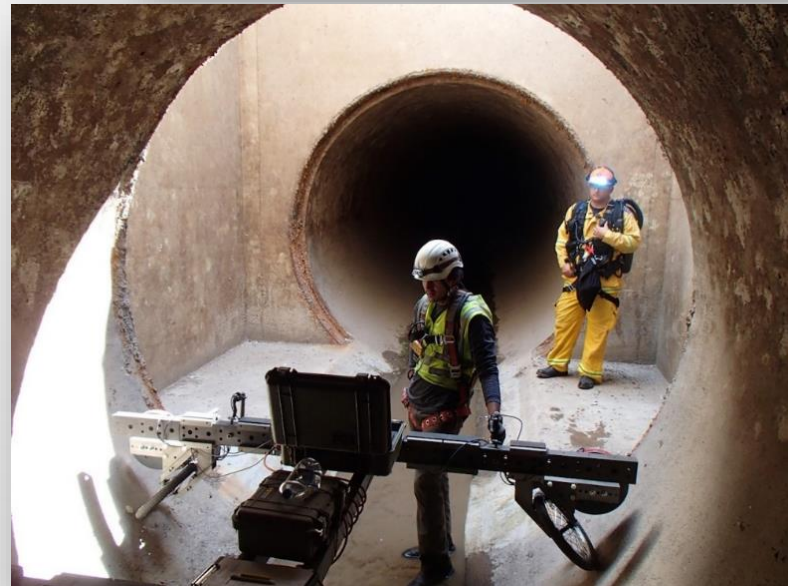
SWP Pipeline Condition Assessment

O&M investing in new technologies for performing Pipeline Condition Assessments that do not require dewatering

- SmartBall Technologies for Leak Detection
- PipeDiver Technologies for detecting broken prestressed wires in a Prestressed Concrete Cylinder Pipe

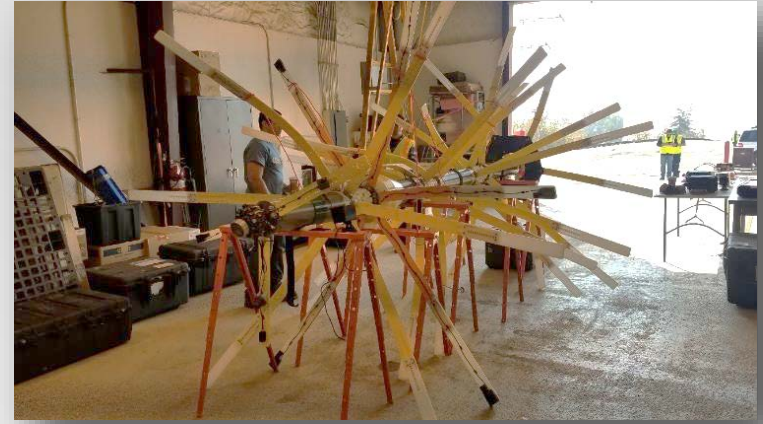
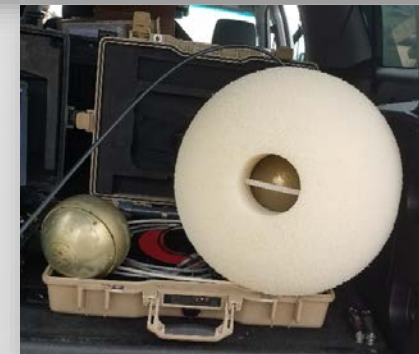
SWP Pipeline Condition Assessment

- South Bay Aqueduct Pipeline System
- North Bay Aqueduct Pipeline System
- Santa Ana Pipeline
- All leaks were validated and repaired or planned

- Santa Ana Pipeline
 - Increase in wire breaks next steps to perform Structural Analysis on entire system

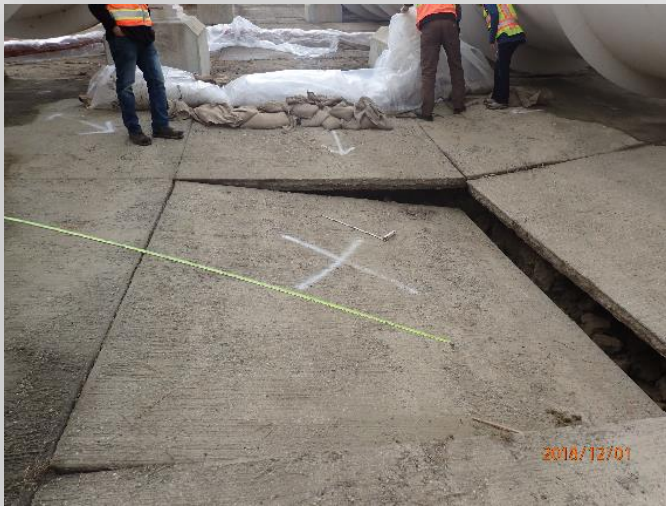
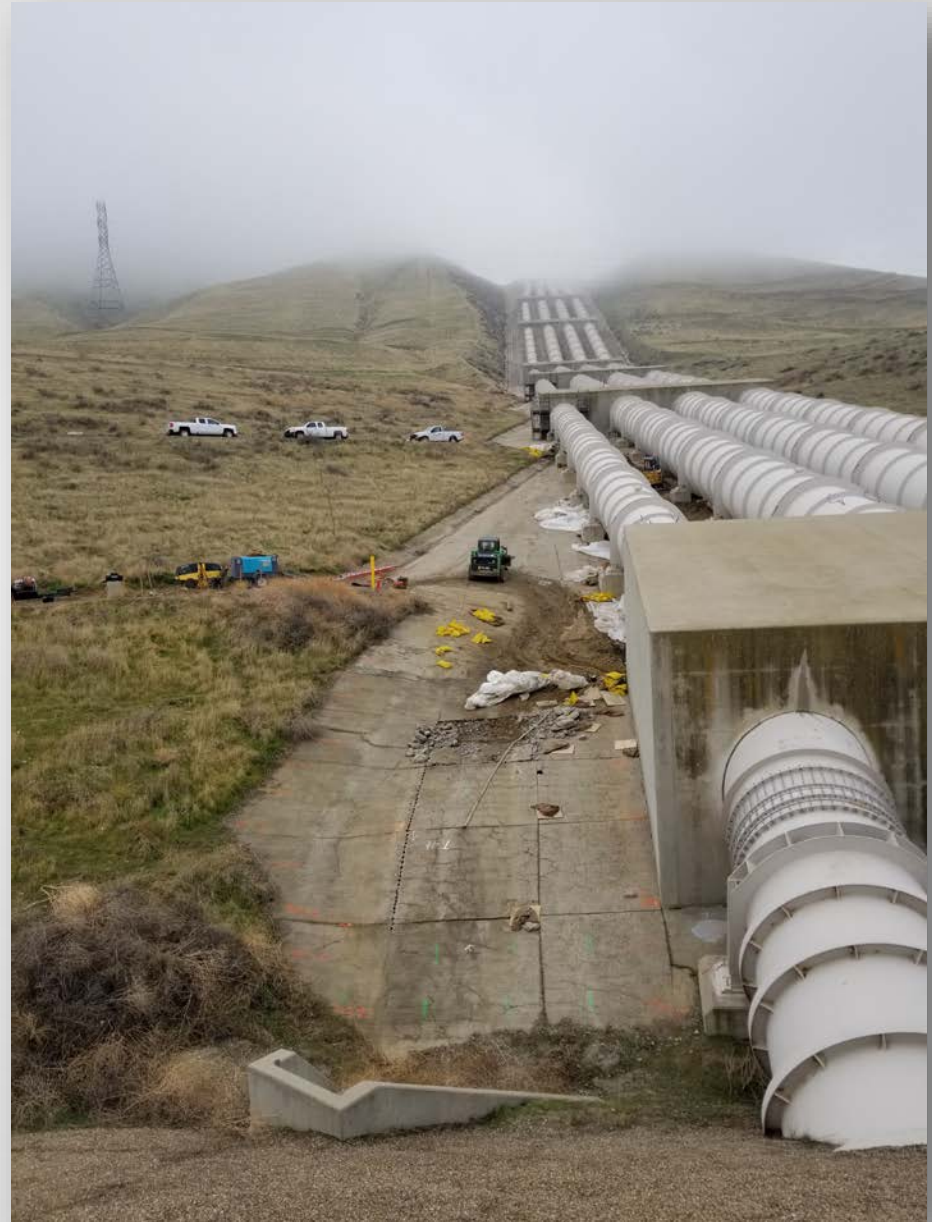
Chrisman Pumping Plant Apron Repair

The Ira J Chrisman Wind Gap Pumping Plant is located at the base of the Tehachapi mountains and pumps water, through four large diameter and above ground discharge lines, over a hill before the aqueduct returns to a gravity canal.

In November 2018, damage to the concrete apron under the discharge lines was observed.

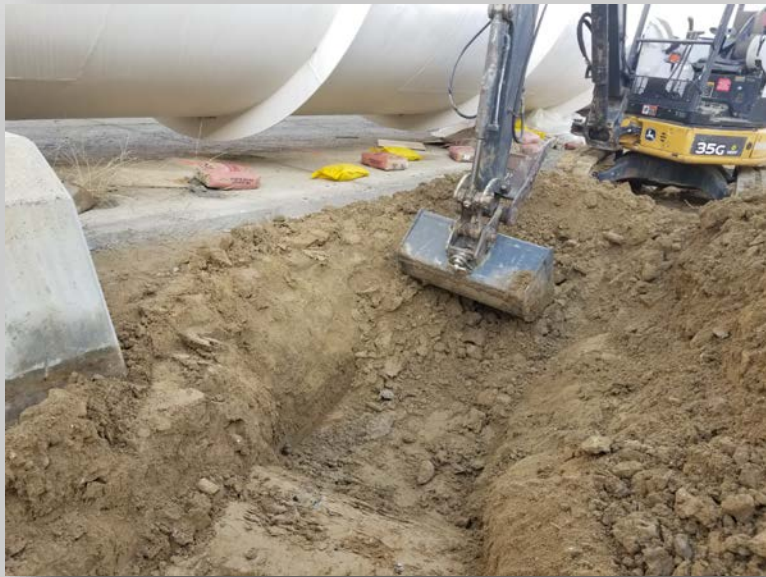
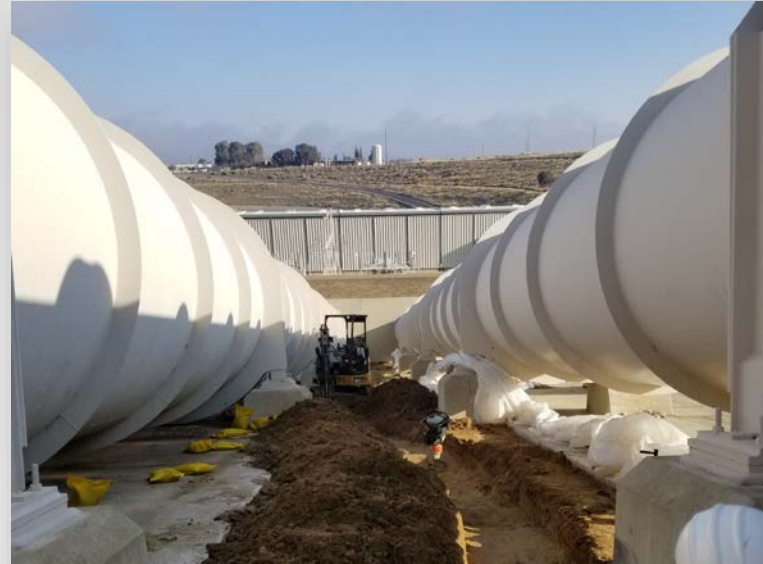
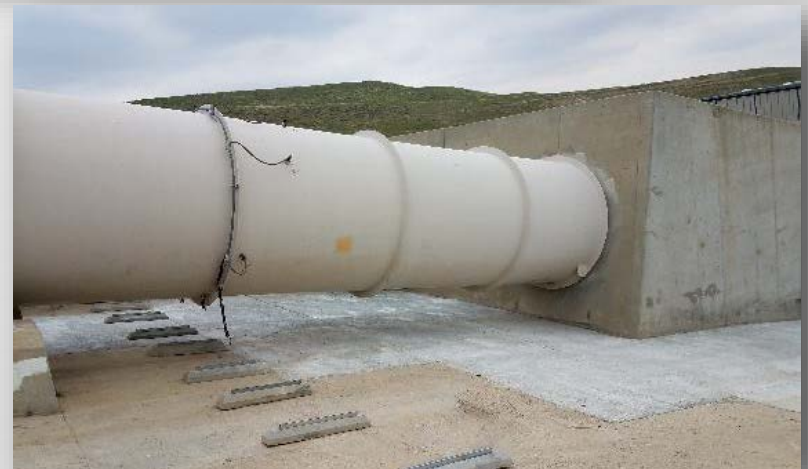
Chrisman Pumping Plant Apron Repair

- Remove and replace existing broken concrete panels
- Place reinforcing steel and backfill

Work Completed March 2019

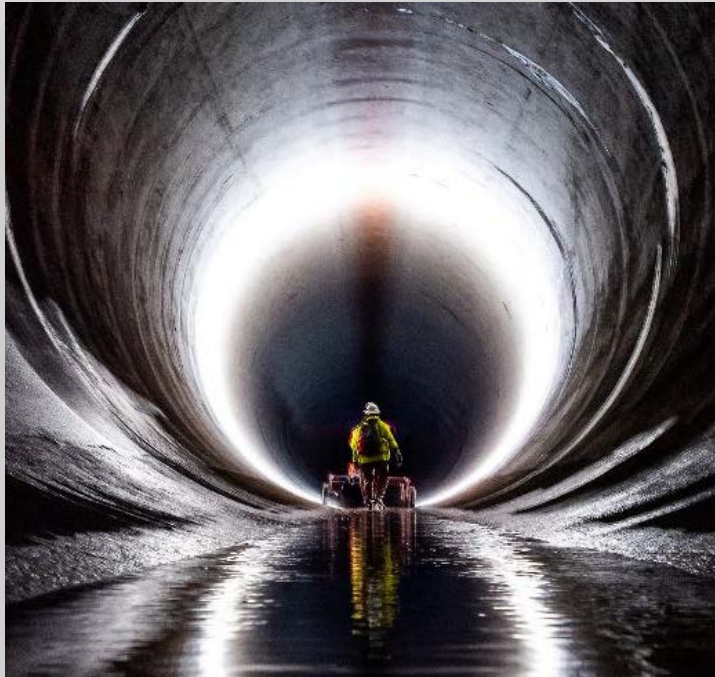
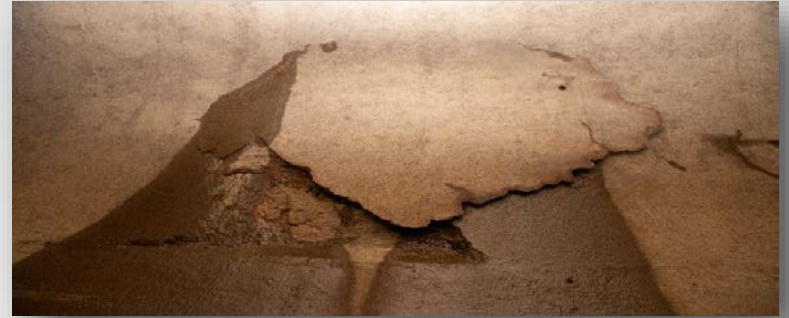
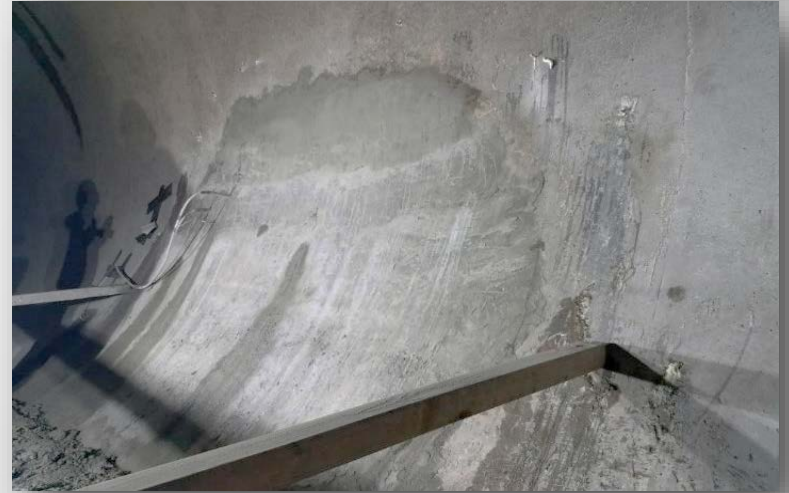
Tehachapi Crossing Inspection and Repair

- Surveyed and 3D Scanned Tunnels
- Visual Structural Inspection and Non-Destructive Testing
- Emergency concrete repair triggered by damage observed in Carley V Porter Tunnel

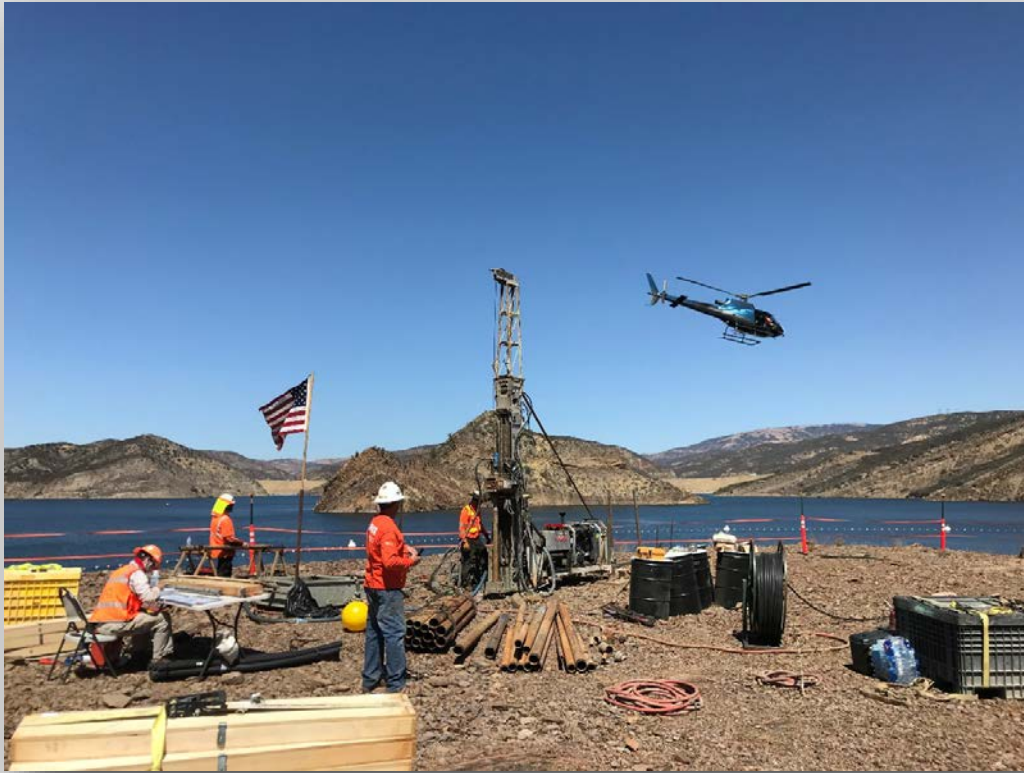
Emergency Spillway Project Scope:

- Subsurface geophysics (depth of weathering) – data collection
 - Completed in July 2019
- Rock coring – 33% complete
- Geologic mapping – 90% complete
- Laboratory testing of rock core samples for geotechnical properties
 - Start November 2019

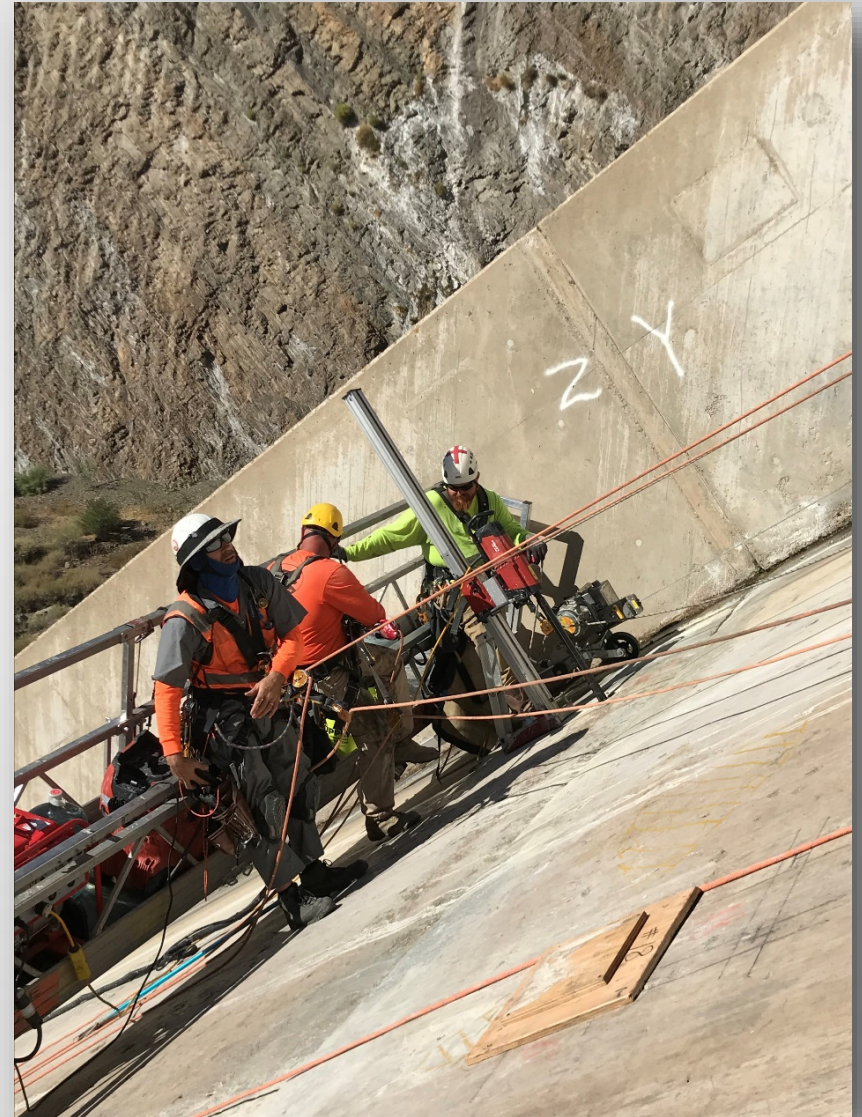
Pyramid Dam

- Concrete coring – 92% complete
 - Slab thickness - 25 to 76 inches (> design thickness of 18 inches)
 - Foundation-slab interface generally good
- Connectivity testing and instrument installation – Started October 2019
- Outfall drain cleaning and re-inspection – Started October 2019

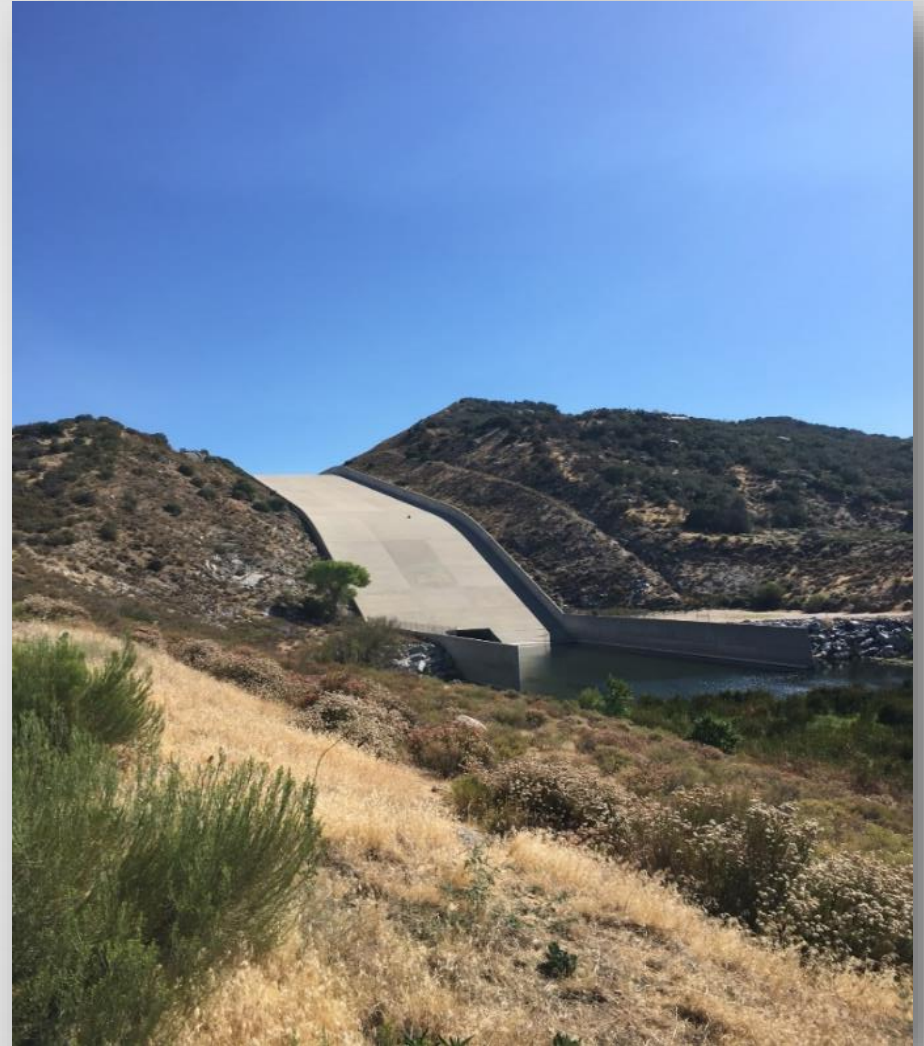
Cedar Springs Dam Spillway Under Drain Repairs and Access Road Improvements

- Excavation of original Backfill and replace Longitudinal Drain
- Inspection and Cleaning of Underdrains
- New Construction of access roads and access to the spillway for long term monitoring and accessibility
