TISDALE WEIR REHABILITATION AND FISH PASSAGE PROJECT

Flood Hydrologic and Hydraulic System Analysis
Technical Memorandum

Prepared for
California Department of Water Resources

September 2019 (Rev. August 2020)

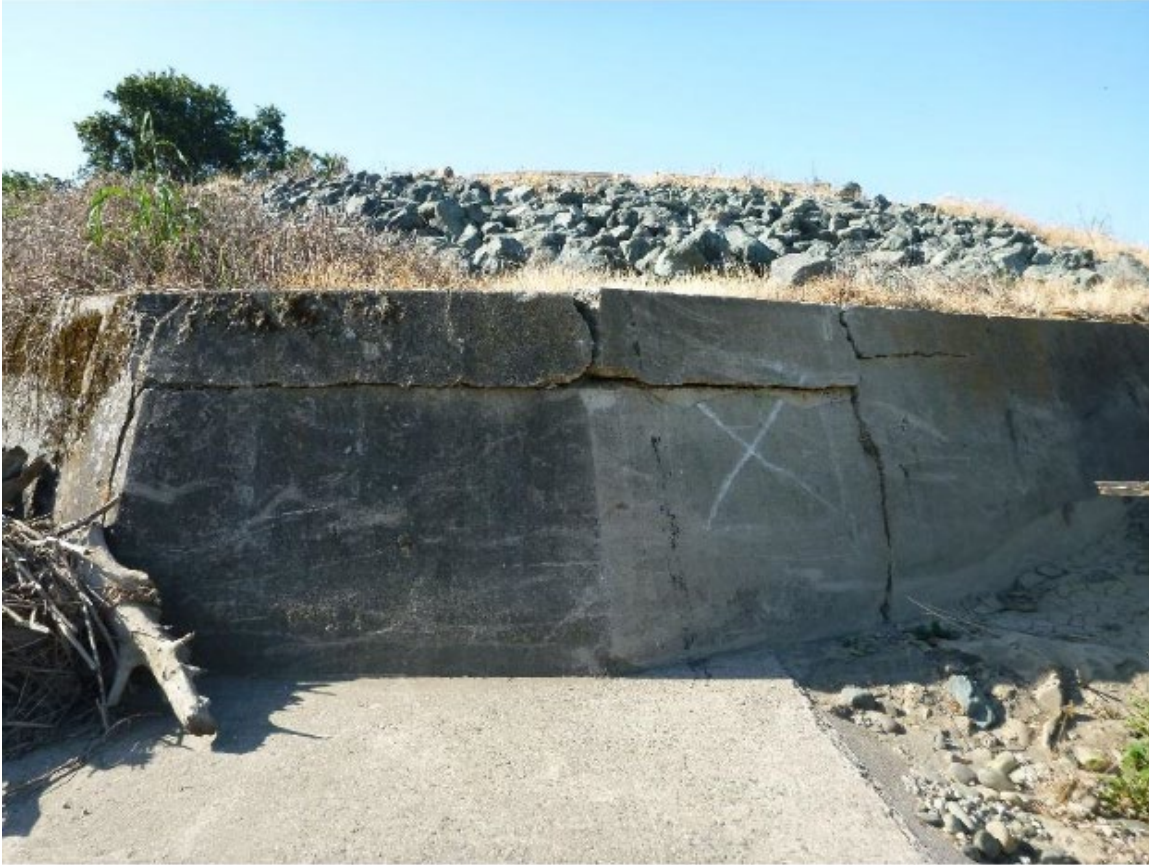
Figure 2
Vertical and Horizontal Cracking of the South Abutment Wall

3. Weir abutments – A 9-foot-long west segment of the south abutment wall is displaced out of plane and extensive horizontal and vertical cracks are visible (**Figure 2**). The wall of the north abutment has about a foot of missing concrete across the entire face with exposed rebar, and the concrete wing walls are falling apart. There is vertical and horizontal cracking throughout the walls. At the south end of the energy dissipation basin (basin) near the south abutment wall, there are large boulders and rocks covering the basin.

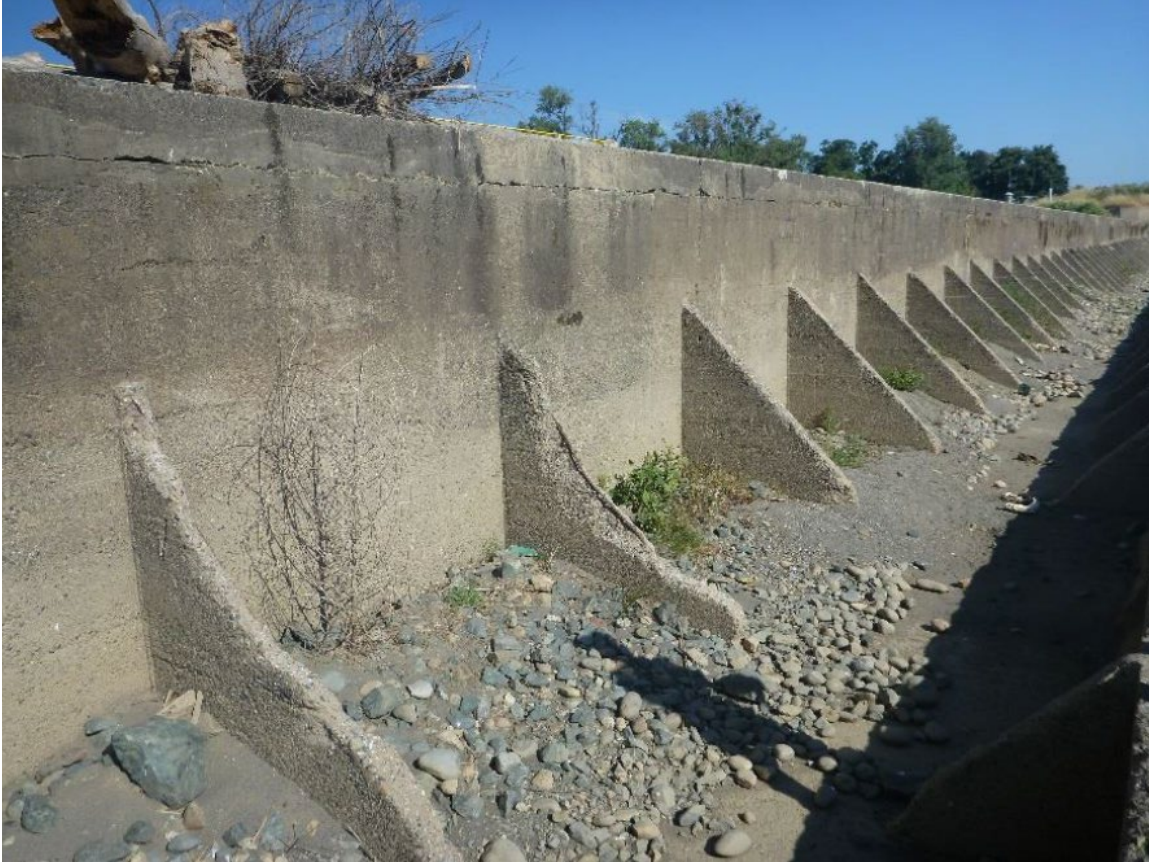
Figure 3
Deterioration of Energy Dissipation Basin and Buttress Walls

5. Energy dissipation basin (basin) – Numerous buttress walls in the basin (40 short and 4 tall) are missing or badly damaged, and the basin concrete is showing signs of light erosion (**Figure 3**). Sediment, including large rocks, and vegetation routinely collect in the basin and are removed during annual maintenance. This recurring collection and removal of sediment contributes to the collective damage of the basin.
6. Revetment – The stone revetment adjacent to (and upstream of) the top of the concrete weir sill is shown to be inconsistent throughout the length of the weir. The original stone revetment appears to be depleted throughout. The revetment appears to be eroded away from the weir sill and transported and dispersed all around the area, including inside the basin.

4. Weir sill – The weir sill concrete has eroded and exhibits exposed aggregate, spalls, cracks, and many patches; some locations show signs of exposed rebar. The cold joint above the energy dissipation basin (basin) wall appears to have some cracking and spalling along the entire length of the joint. The basin along the east side of the weir is badly damaged on the north end with concrete deterioration and exposed rebar and a buttress wall is missing.

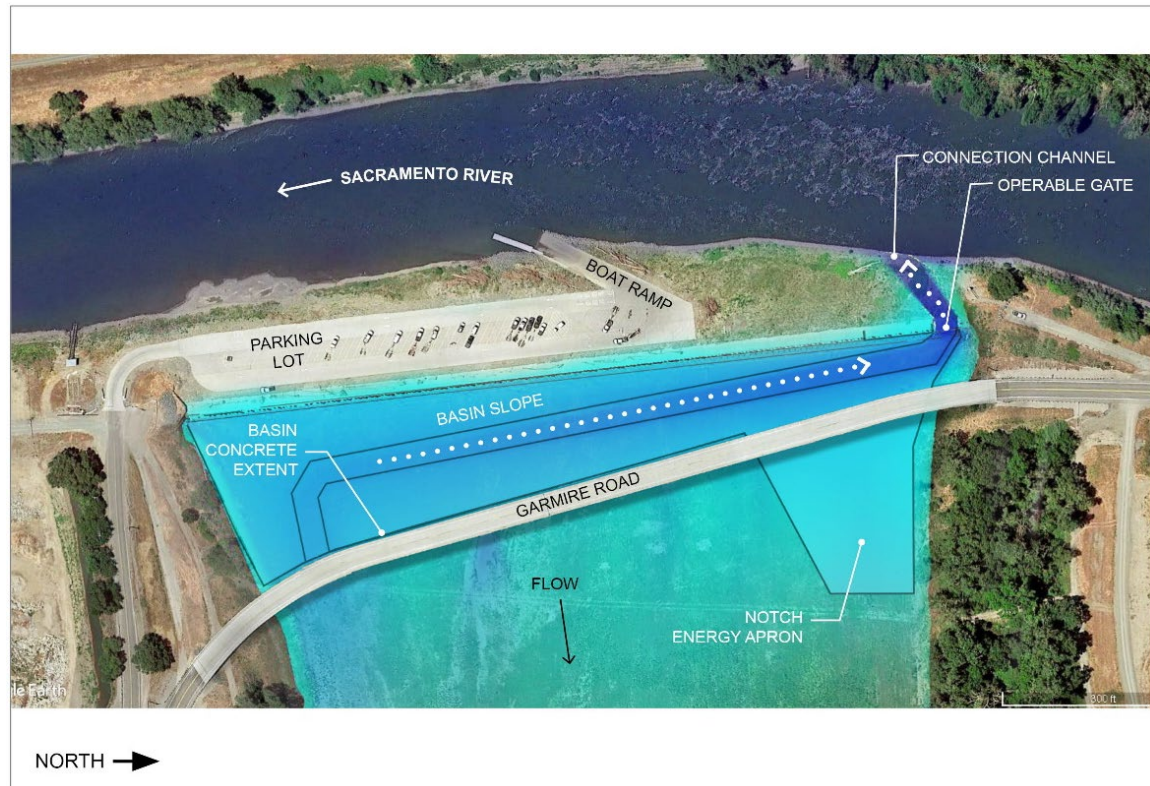
Figure 4
Tisdale Weir with Proposed Notch Alterations

Proposed alterations to the Tisdale Weir to improve fish passage include a 33-foot-wide by 11-foot-deep notch in the northern end of the existing weir (**Figure 4**). The notch would provide flow from the river to the bypass at depths and velocities in the range of suitability to allow for upstream passage of sturgeon and salmon. Flow through the notch opening would be regulated by a bottom-hinged gate actuated by an inflatable air bladder. The notch would be connected to the Sacramento River via a concrete lined trapezoidal channel, and would facilitate fish passage from the Tisdale Bypass to the Sacramento River when the gate is in the open position. A single bottom hinged gate would be formed by two gate assemblies bolted together, with gaskets on each side and in between to improve water sealing. Individual air bladders would actuate under the two gate sections but would always be operated in unison as a single gate. The existing energy dissipation basin will be replaced with a new, wider energy dissipation and fish collection basin sloped from south to north to facilitate drainage towards notch opening, encouraging any remaining fish behind the Tisdale Weir to swim towards the notch opening as elevations in the Sacramento River begin to recede.

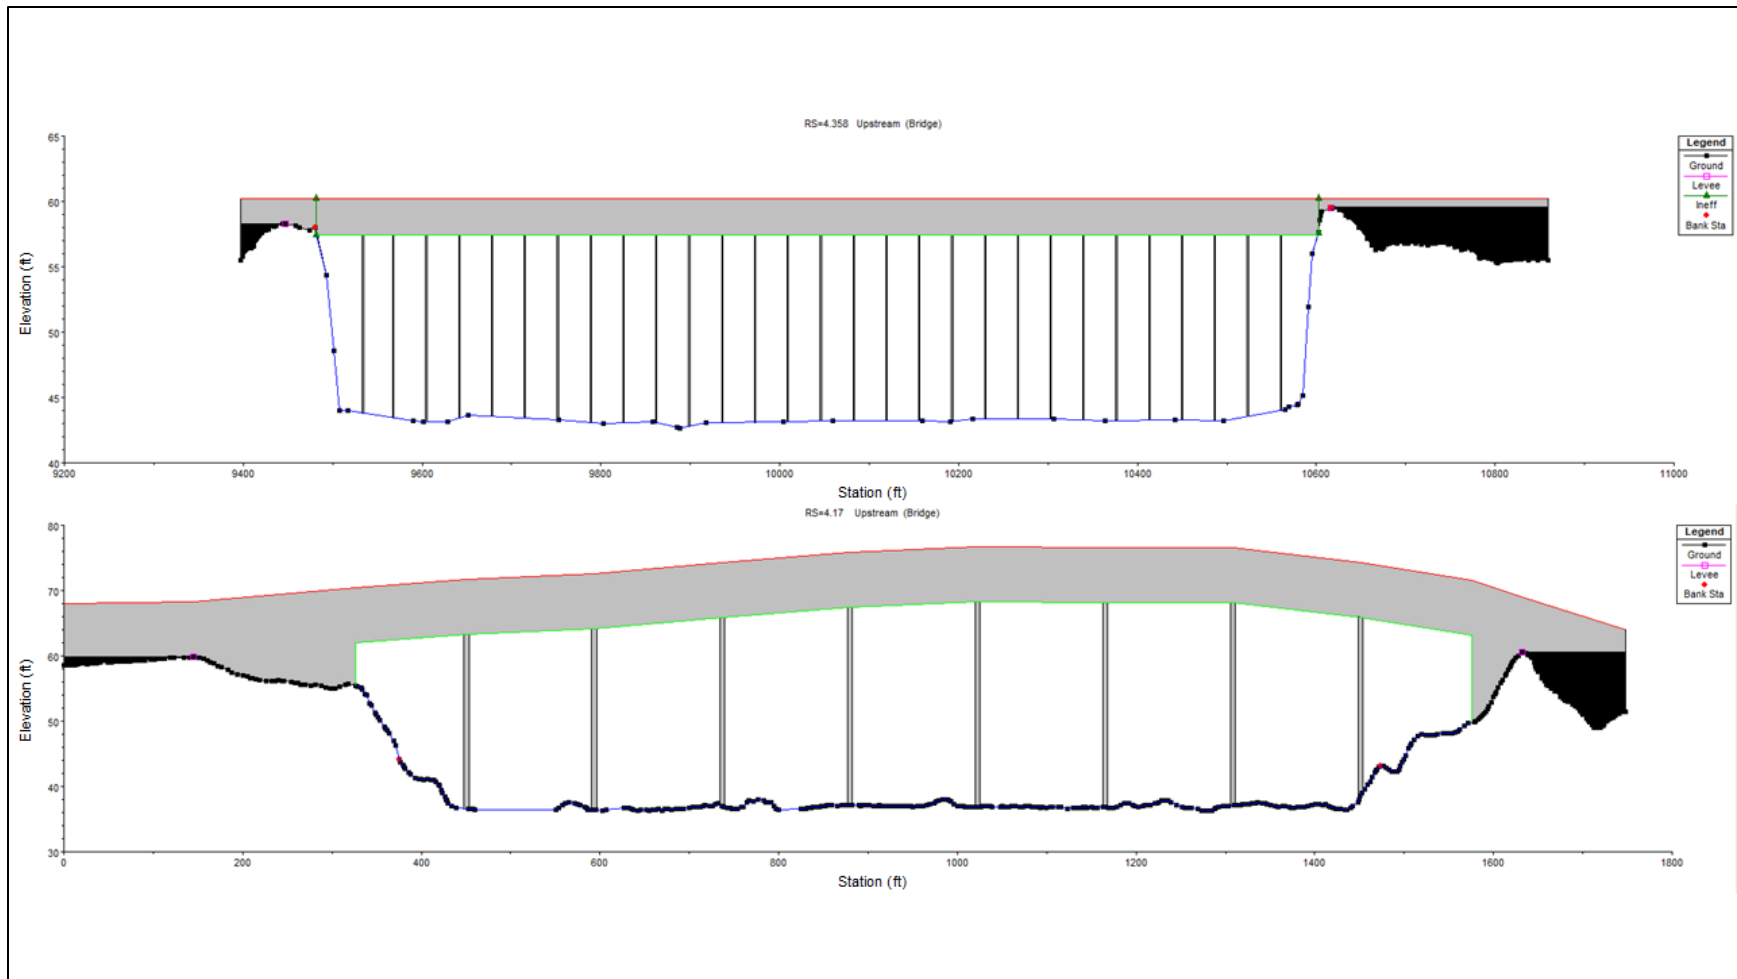
Figure 6
Garmire Road at Tisdale Weir HEC-RAS Bridge Geometry

Note: Top graphic shows the old bridge geometry. The bottom graphic has updated pier geometry to more accurately capture the existing bridge conditions.

Tisdale Weir, it was necessary to update the model geometry files to reflect the present day Garmire Road bridge geometry. The Garmire Road bridge geometry was obtained from an existing HEC-RAS model of the Tisdale Bypass developed for DWR's CVFED Program (Wood Rodgers, 2015). **Figure 6** shows the previous model's bridge geometry and the updated geometry used for the without-Project condition baseline.

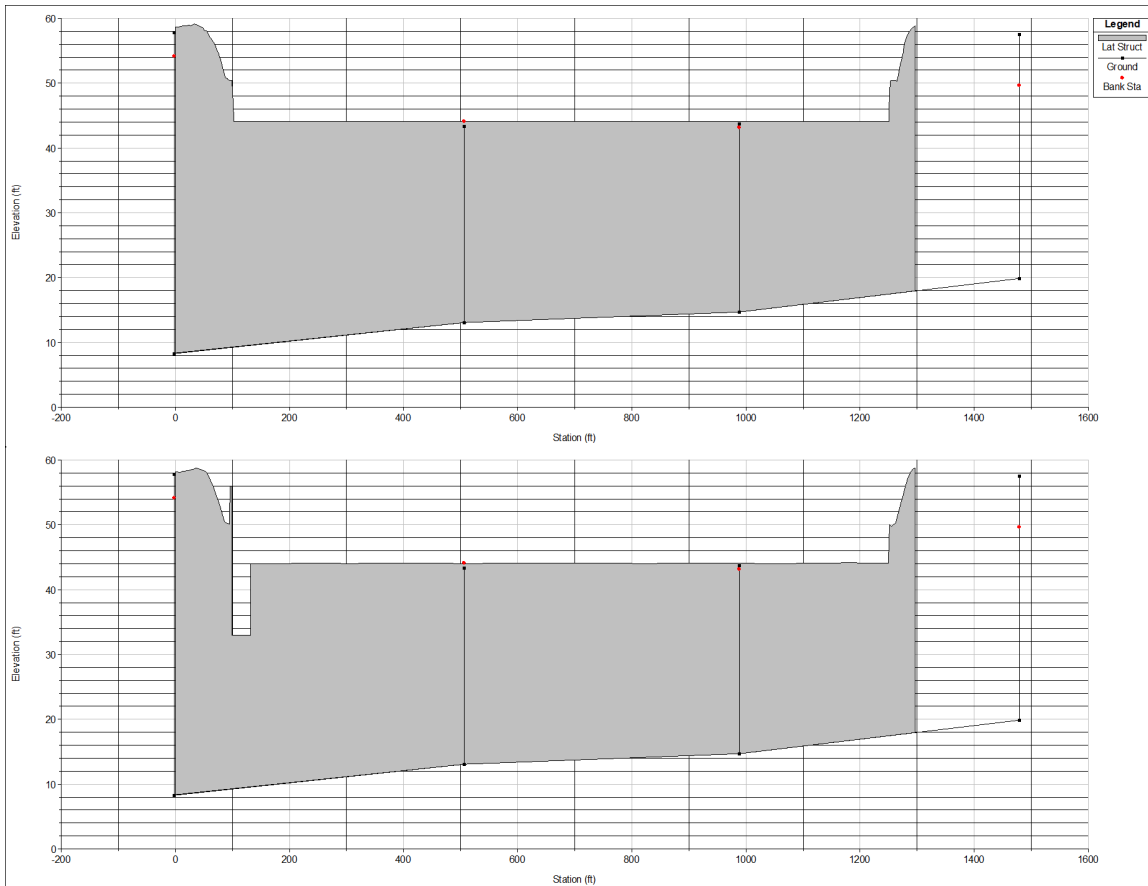
Figure 7
Tisdale Weir HEC-RAS Geometries

Note: The top graphic shows the without-project conditions, and the bottom graphic shows the with-project conditions with the notch included.

For the with-Project conditions, ESA developed an updated HEC-RAS geometry file to reflect the proposed geometry of the Tisdale Weir notch. The Project proposes to make a notch in the weir approximately 33 feet wide, 11 feet tall, located at the northern abutment of the weir. **Figure 7** shows the without- and with-Project HEC-RAS weir geometries.

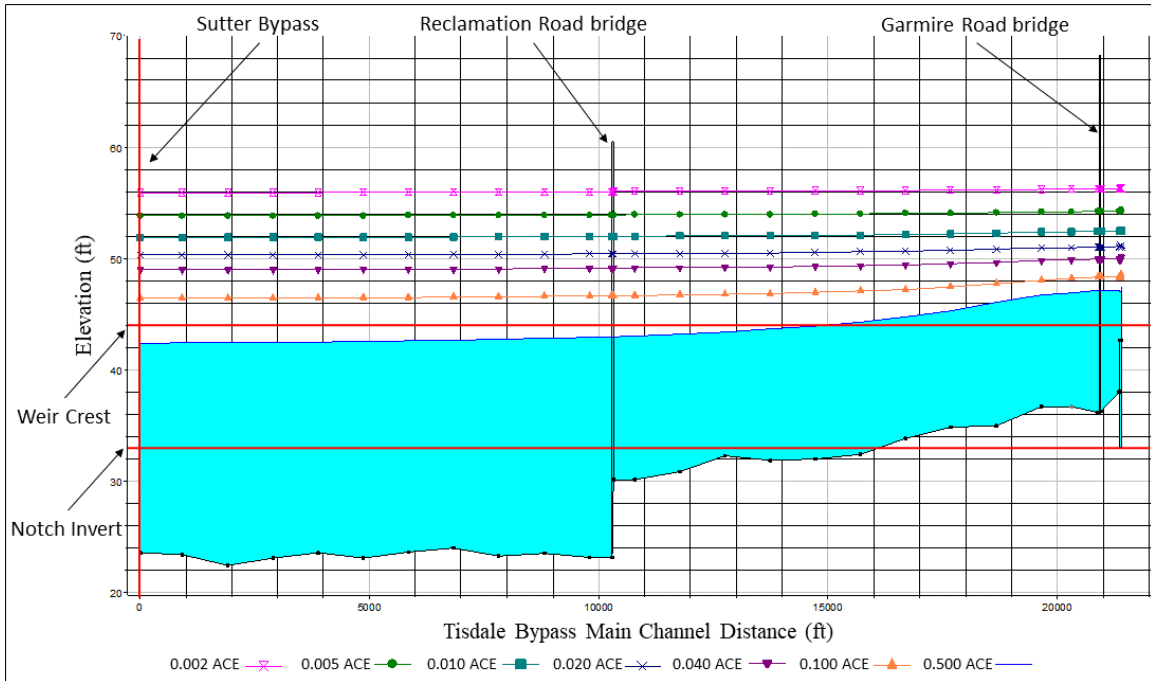
Figure 8
With-Project Water Surface Profiles at Tisdale Bypass

downstream of the Project in the Tisdale Bypass and Sutter Bypass. These increases in stage do not exceed 0.01 feet. Additionally, there are minor stage reductions at several locations on the Sacramento River. These reductions in stage do not exceed 0.03 feet. These changes in system performance would only occur if the gate experienced a mechanical failure and are not deemed significant enough to warrant detailed system performance calculations using HEC-FDA. The deterministic analysis conducted for the Project is considered sufficient for describing the overall system performance for the without- and with-Project conditions and verifies that the reduction in assurance is negligible.

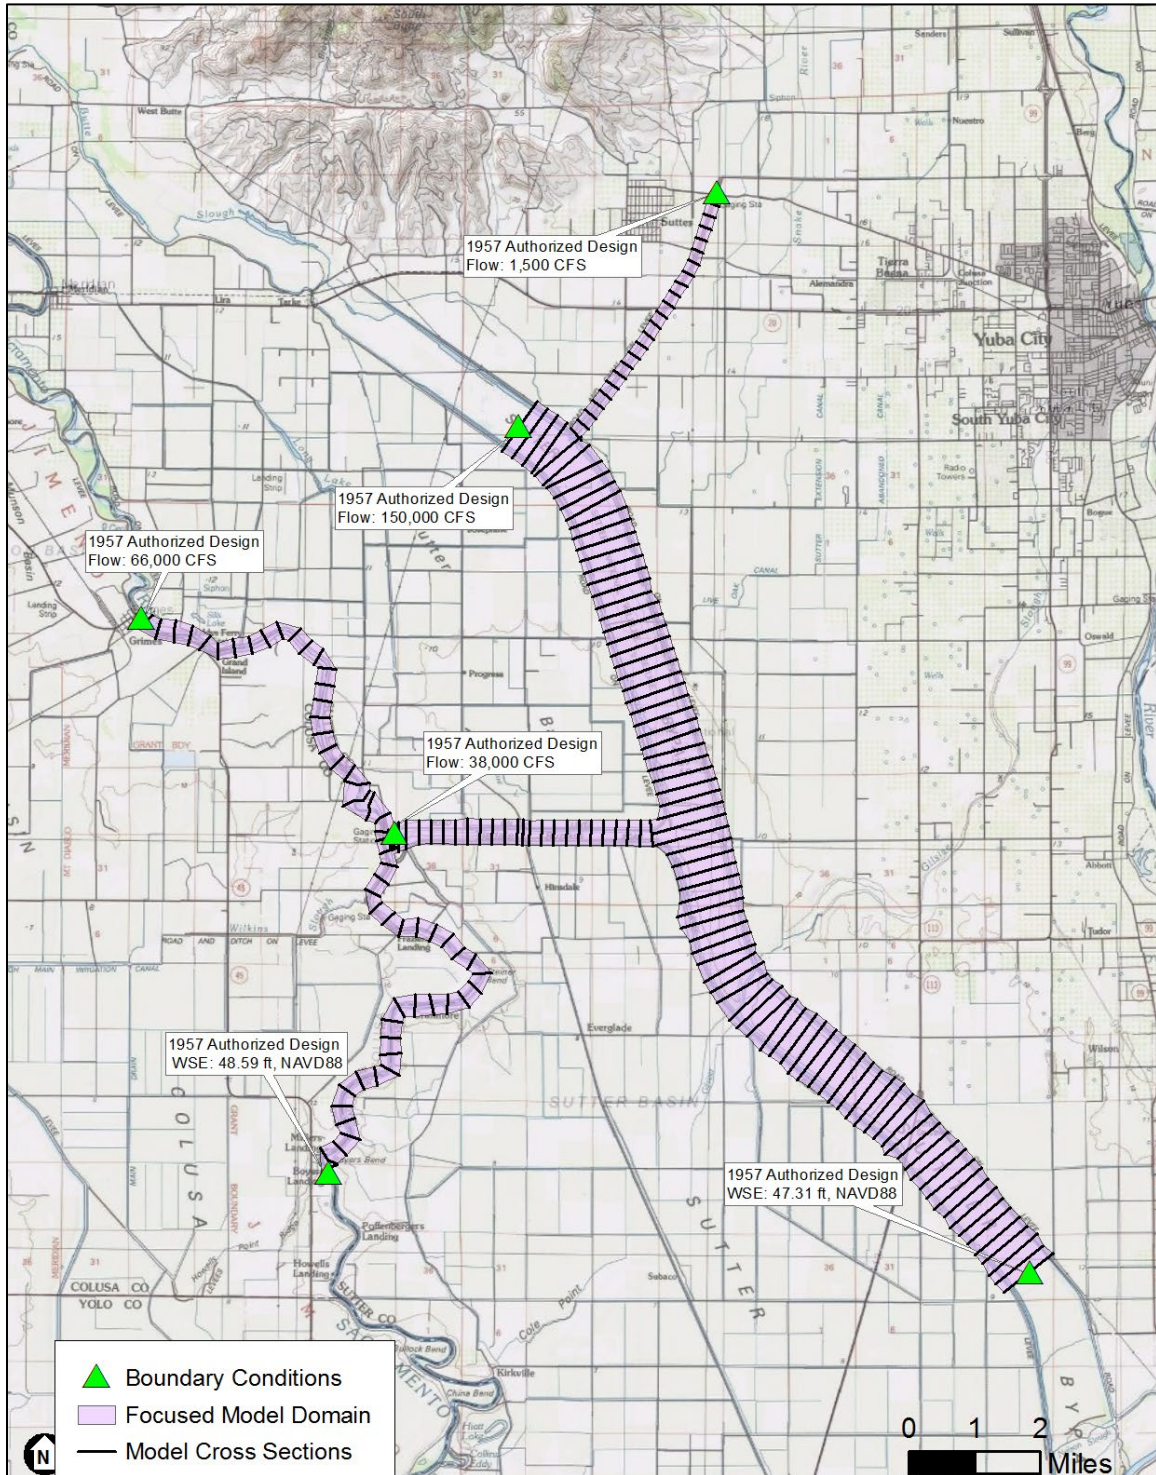
Figure 9
 Focused Model Domain for the Phase 2 Hydraulic Analysis and the
 Associated Boundary Conditions

The Phase 2 analysis was used to assess the performance of the system under the system's authorized design flow. The Common Features model geometry extents were reduced to focus the analysis on the areas surrounding the proposed project (**Figure 9**). The reduced model was then analyzed in steady state using the authorized design flows and water surface elevations documented in the 1957 Levee and Channel Profiles (USACE, 1957). The design flow for each reach was used as upstream boundary conditions for the Phase 2 analysis (**Table 5**). The design water surface elevations for the approximate downstream boundaries for the analysis (**Table 6**) were obtained from Levee and Channel Profiles (USACE, 1957 and Atkins, 2013). All of the authorized design water surface elevations were converted from the U.S. Corps of Engineers Datum (USED) to NAVD 88 heights using the survey datum conversions provided by DWR's Geodetic Branch (L. Grade, personal communication, November 5, 2018 & J. West personal communication, June 27, 2019). The Sacramento River downstream boundary water surface elevation was obtained using the following equation, applicable in the vicinity of the Tisdale Weir (L. Grade, personal communication, November 5, 2018):

Analysis of the authorized design flow of the system for the without- and with-Project conditions was performed. The water levels for index points 4 and 7 were fixed at the authorized design water surface elevation as the downstream boundary conditions. The model analysis resulted in zero change in water surface elevations for the remaining index points for the 1957 design authorized flow (**Table 7**).
