State of California
California Natural Resources Agency
DEPARTMENT OF WATER RESOURCES
Division of Engineering

CALIFORNIA AQUEDUCT SUBSIDENCE STUDY
San Luis Field Division
San Joaquin Field Division

June 2017

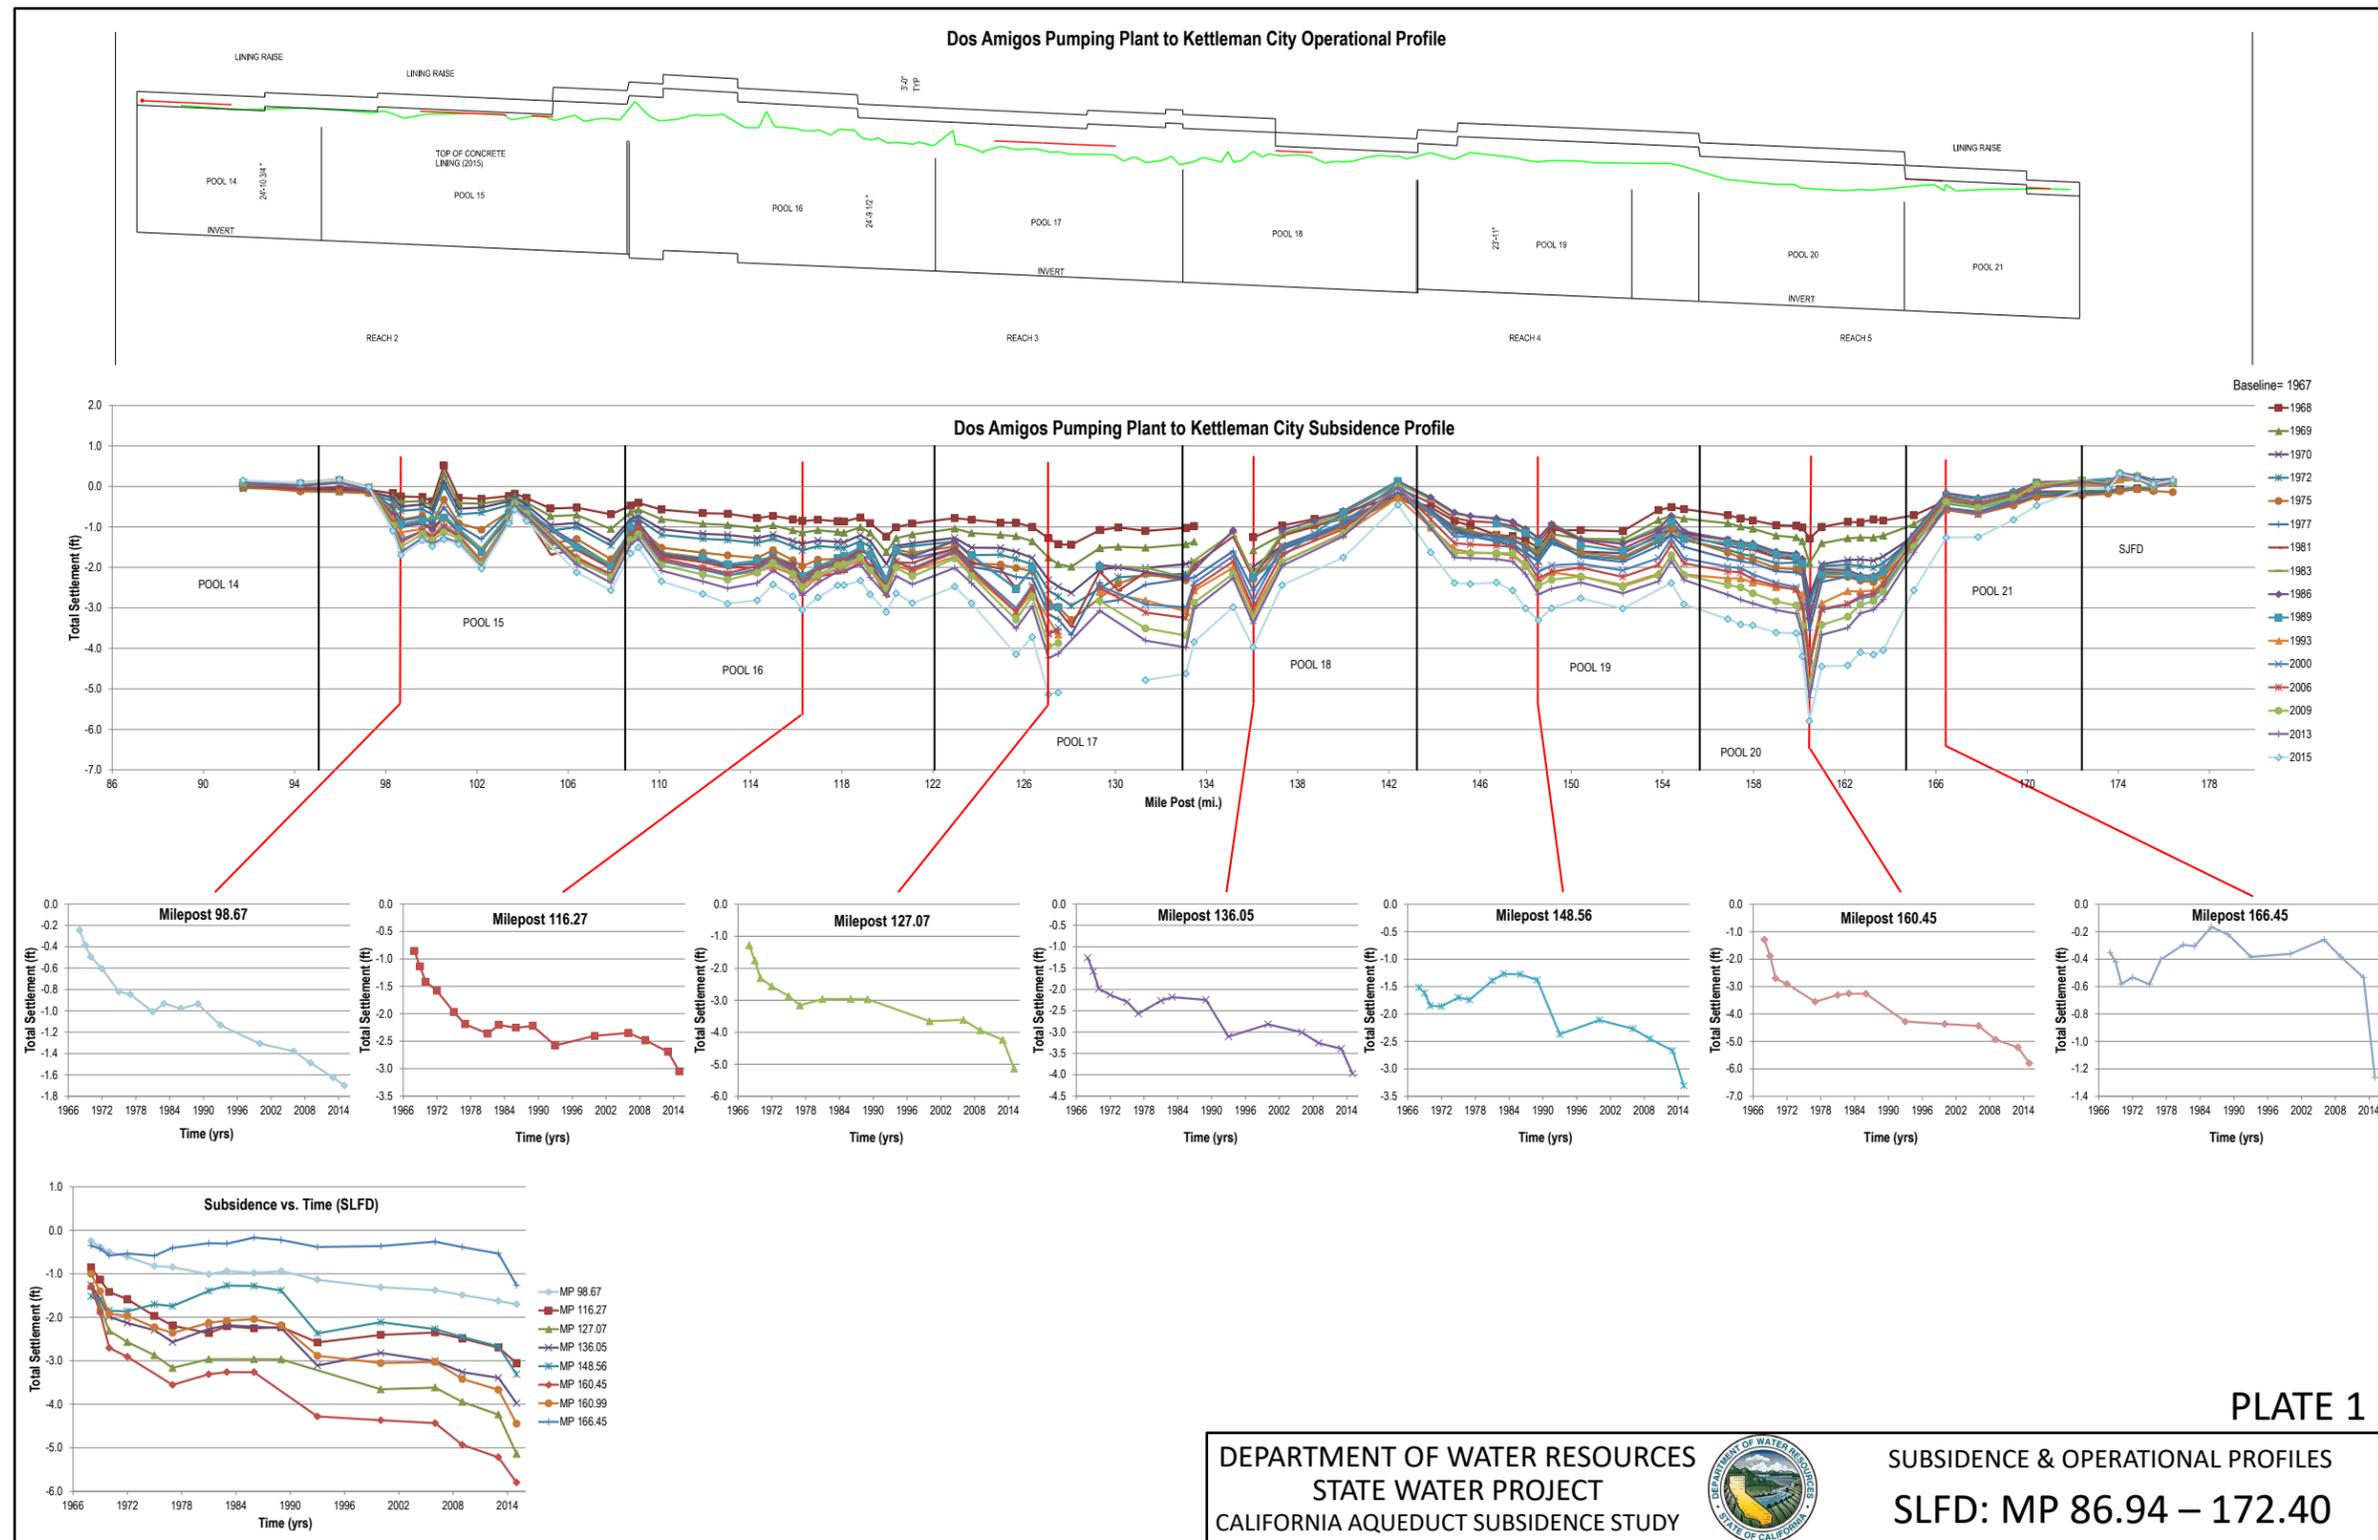
Figure 6-1 Subsidence and Operational Profiles - San Luis Field Division - Plate 1

1. A data set of 90 benchmarks, located on structures and top of the lining, was selected based on historic regional data benchmarks that were used in past subsidence studies. The yearly data of these benchmarks, identified by their milepost location, were plotted, milepost versus total subsidence in a given year, to show the progression of subsidence from 1967 to 2015. That change was calculated by subtracting a recorded elevation for a particular benchmark, at each year, from the baseline value recorded in 1967. The process was repeated for all of the benchmarks and the difference in elevation was plotted out on the y-axis, for a given milepost (x-axis). The leveling data from these benchmarks are summarized in Section 6.3 and are profiled in the subsidence profile graphs on Plates 1 through 9. Plate 1 is a plot of the SLFD. Plates 2 through 9 are plots of Aqueduct Pools 14 through 21.

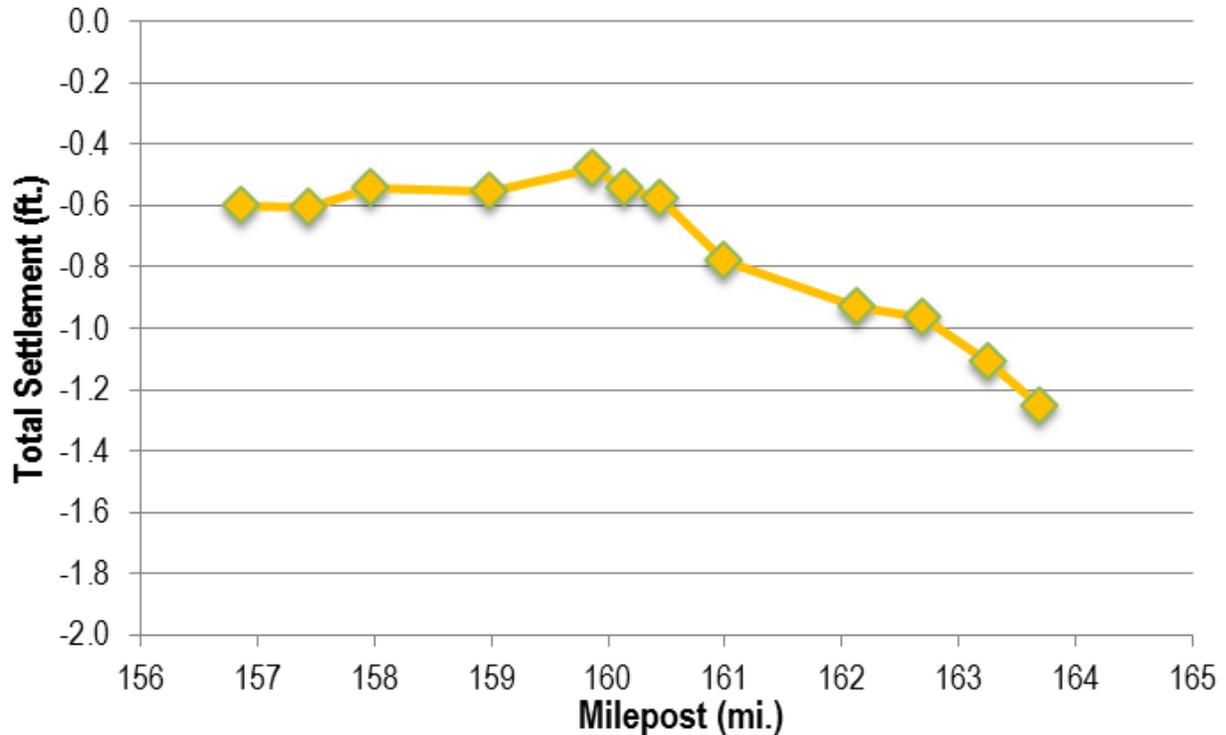
Figure 6-5 Pool 20 Subsidence from 2013 to March 2015

Subsidence along the San Luis Canal has varied from year to year. Generally, subsidence has not been consistent. Such is the case from 2013 to March 2015 when some areas of the Aqueduct subsided more than in all previous years combined. Plate 29 shows a profile of subsidence along the San Luis Canal (Los Banos to the Kettleman City area) from Milepost 91.75 to 176.39, from 2013 to March 2015. This profile was created using leveling data taken from 22 benchmarks located on hard structures and from 60 benchmarks located on the top of the liner.

Milepost	Subsidence 2013-March 2015 (feet)	Subsidence March 2015-August 2015 (feet)
156.87	-0.60	-0.74
157.44	-0.61	-0.73
157.97	-0.54	-0.66
158.99	-0.56	-0.63
159.87	-0.48	-0.65
160.14	-0.54	-0.61
160.45	-0.58	-0.62
160.99	-0.78	-0.39
162.13	-0.93	-0.45
162.69	-0.97	-0.38
163.26	-1.11	-0.51
163.69	-1.26	-0.56

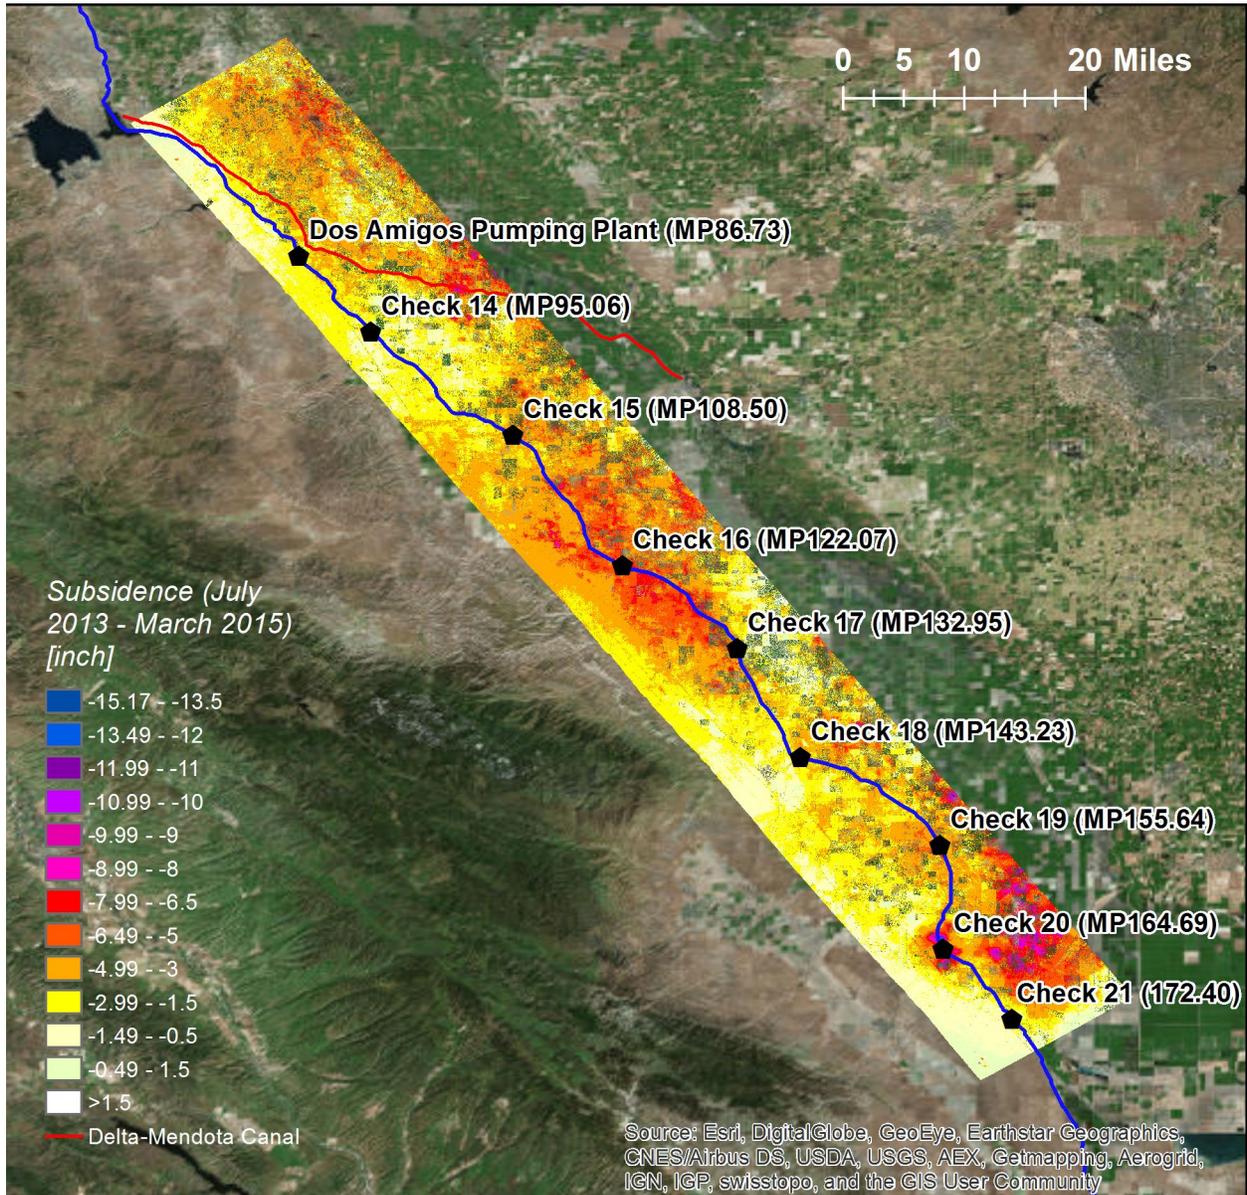
Figure 6-7 Subsidence in San Luis Field Division between July 2013 and March 2015, from UAVSAR (NASA 2015)

There were 11 flights along the SLFD flight line from July 2013 to March 2015 which produced 10 sets of interferograms showing the progression of subsidence. Figure 6-7 shows the estimated subsidence between July 2013 and March 2015, from O'Neill Forebay to Kettleman City, in yellows (-1.5 inches to -3.0 inches), oranges (-3.0 inches to -5.0 inches) and reds (-5.0 inches to -8.0 inches). There were seven flights along the SJFD flight line between April 2014 and January 2015, which produced six sets of interferograms. The SJFD flight line covers the area approximately between Mileposts 215 and 292. Figure 6-8 shows the estimated subsidence between April 2014 and January 2015, which show areas of green (-3 inches to -4 inches) and light blue (-4 inches to -5 inches); but, those areas are in the Buena Vista Lakebed area. All 16 interferograms produced for the NASA study have been transferred to DWR in raster format for use in this study and future studies.

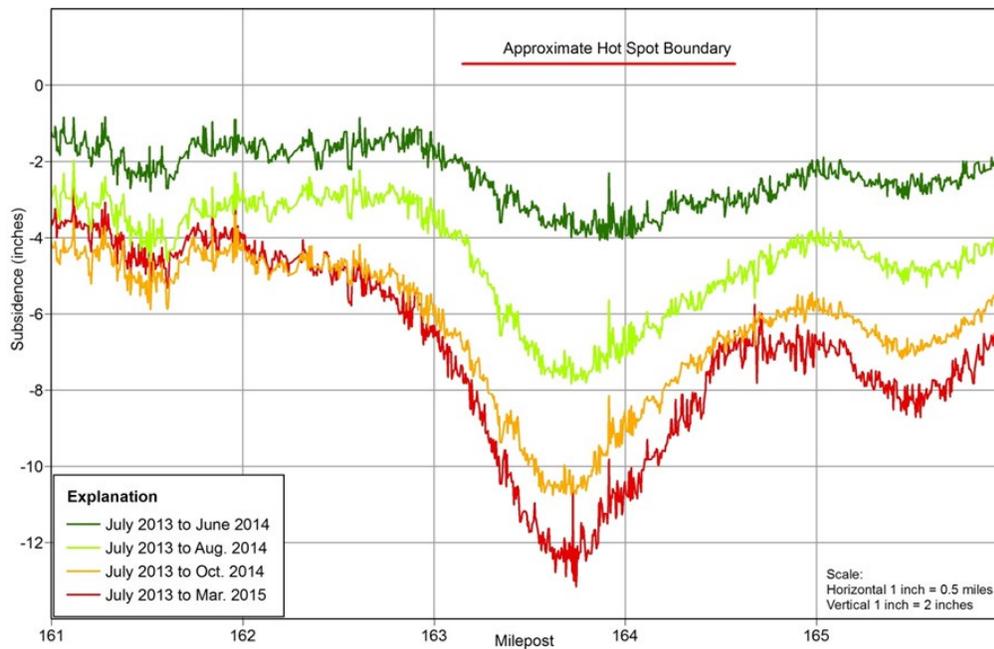
Figure 6-10 Aqueduct Subsidence Profile at Avenal Cutoff Hotspot

After the creation of the first few sets of UAVSAR interferograms in the SLFD, an area was noticed near Avenal Cutoff Road, Milepost 163.69, which had significantly more subsidence than the surrounding area. It was a distinct “hotspot” bowl of subsidence centered approximately 1,500 feet east of the Aqueduct.

To illustrate the increase in subsidence over time, a profile was created along the eastern side of the Aqueduct for each interferogram. They were combined in Figure 6-10 to show the progression of the cumulative subsidence. When the times between datasets are taken into account, the most subsidence occurred from June 2014 to August 2014 (the space between the dark green line and the light green line).

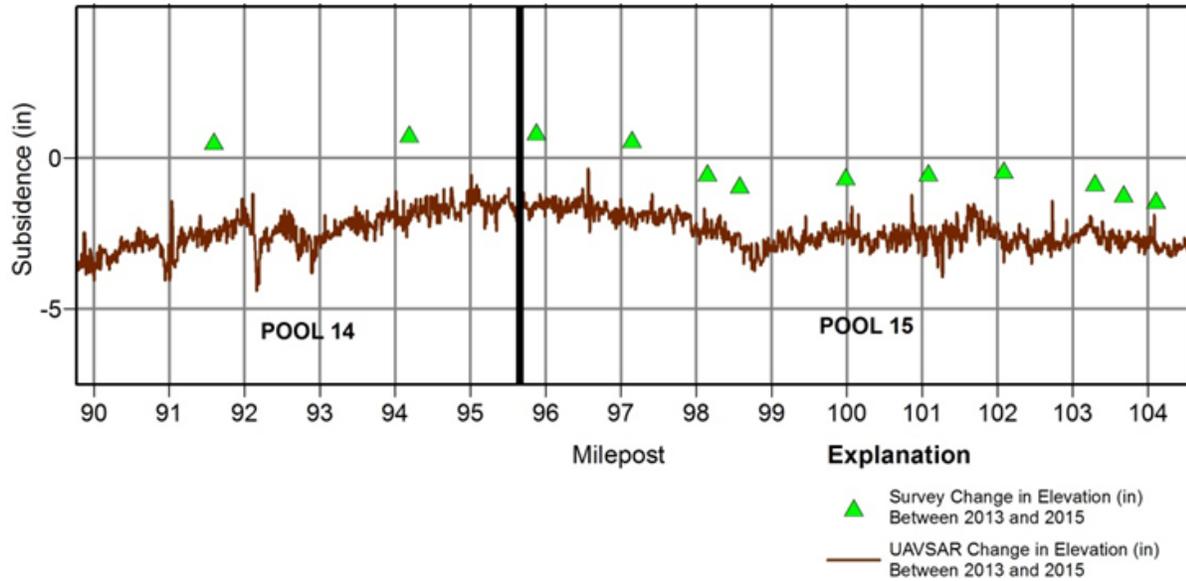
Figure 6-11 Comparison of UAVSAR and Survey Data Subsidence in Pools 14 and 15 (from Plate 30)

The comparison of the survey data to the UAVSAR data shows a general correspondence between the two data sets. A closer comparison of the survey point data to the UAVSAR data plotted for each survey point for the San Luis Canal allowed the data to be broken into three sections. The first section was between Pools 14 and 16, and indicates the survey data show generally less subsidence than the UAVSAR data by +0.23 inches to +3.0 inches. Figure 6-11 shows the UAVSAR and survey data comparison in Pools 14 and 15, from Plate 30.

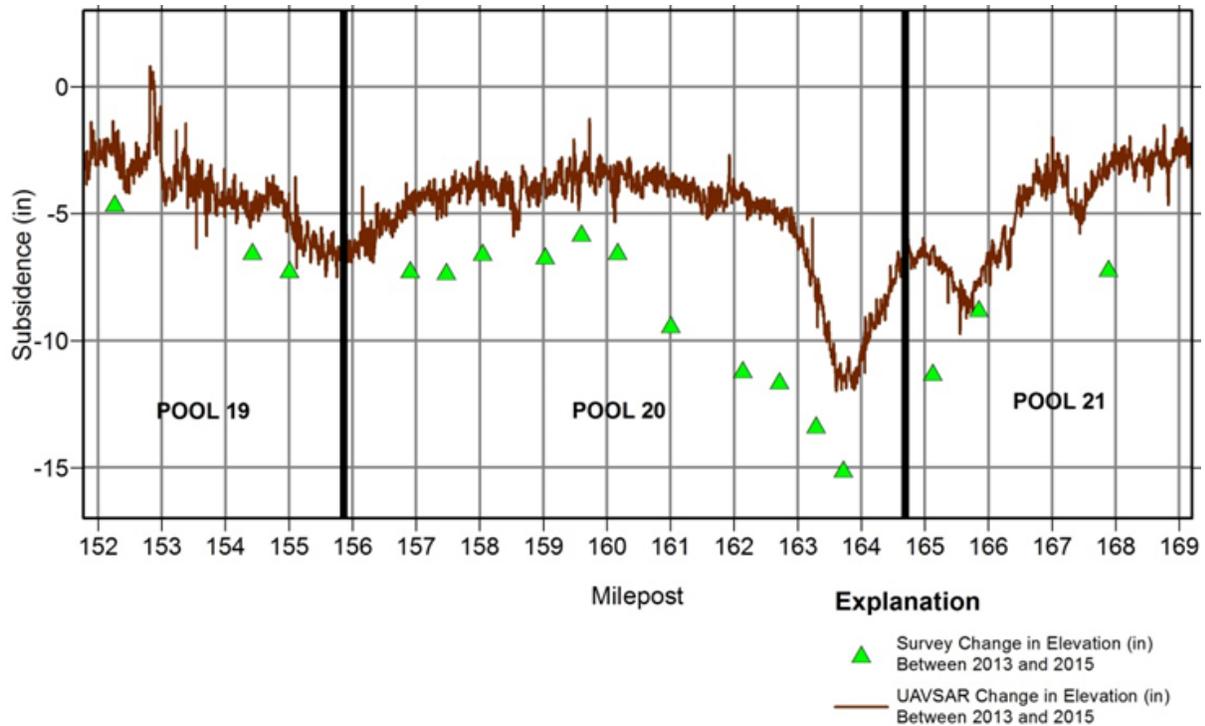
Figure 6-12 Comparison of UAVSAR and Survey Data Subsidence in Pools 19 through 21 (from Plate 30)

The second section is between Pools 17 and 21. It indicates the survey data show more subsidence than the UAVSAR data by about -0.35 inch to -9.5 inches. Figure 6-12 shows the UAVSAR and survey data comparison in Pool 19 through Pool 21, from Plate 30.

The reasons for the differences between the survey data and UAVSAR data may be because of numerous factors:

- The cell size of the UAVSAR data averages all the elevation points in the cell. In that case the Aqueduct embankment, field, and water-elevation data may be averaged.
- The lack of UAVSAR data at some points because of data gaps or no change in the elevation because water surface elevations remained relatively constant.
- The uncertainty of the UAVSAR data ranges between 0.13 inch and 0.80 inch, which is a factor of processing and conditions during acquisition.

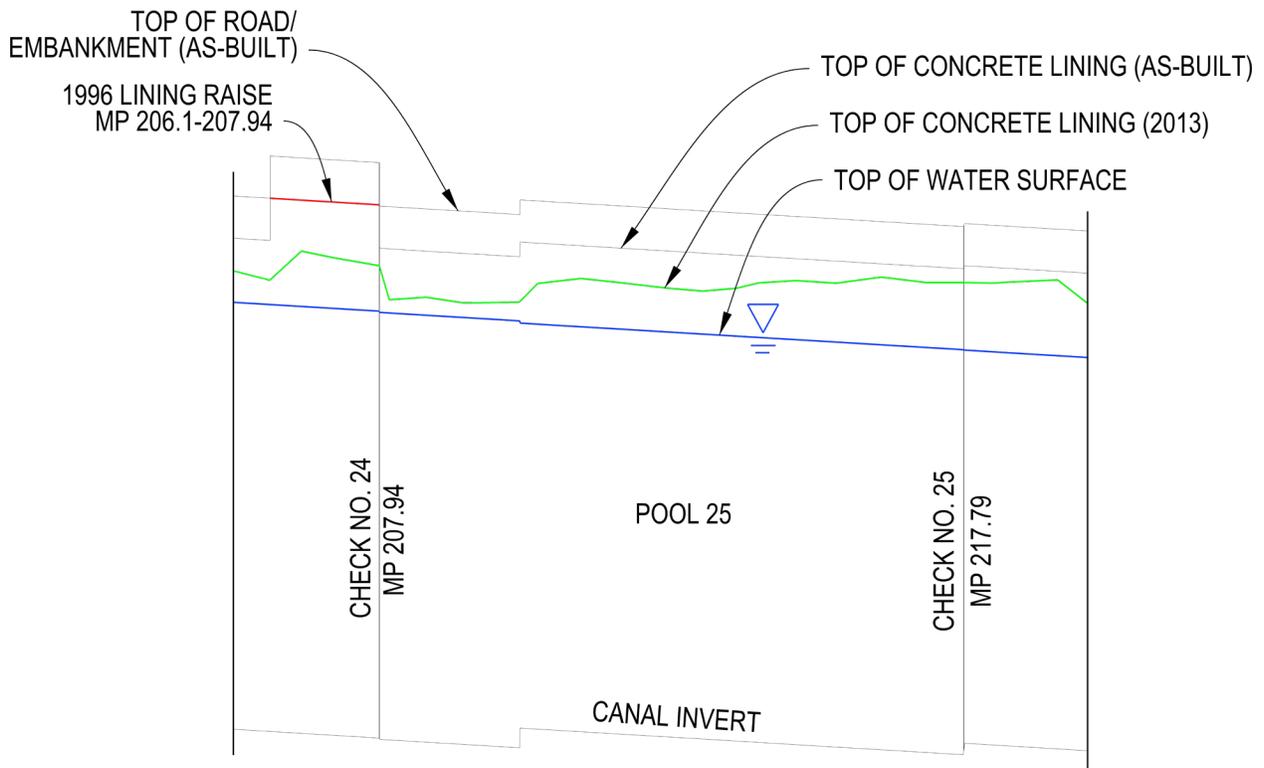
Figure 7-1 Pool 25 Operational Profile

Along the Aqueduct, subsidence has caused a reduction of the design freeboard, but the amount of subsidence is not uniform. As shown on Plates 1 and 10 in Chapter 6, the subsidence varies along the Aqueduct alignment. In Pools 18 and 25, the upstream ends of the pools have subsided significantly more than the downstream ends. Past canal raises in the SLFD have left Pool 18 with adequate freeboard to be able to accommodate the variation in subsidence. But on the upstream end of Pool 25, there are approximately 9 inches to 12 inches of lined freeboard above the design WSE, for approximately 2 miles, as shown in Figure 7-1.

The magnitude of the subsidence shown in Figure 7-2 in Pool 25 compares well with the difference between the top of concrete lining (as built), and the top of concrete lining (2013) as shown in Figure 7-1. The subsidence (or difference) is greater on the upstream end of Pool 25, and decreases as it goes downstream to the end of the pool.

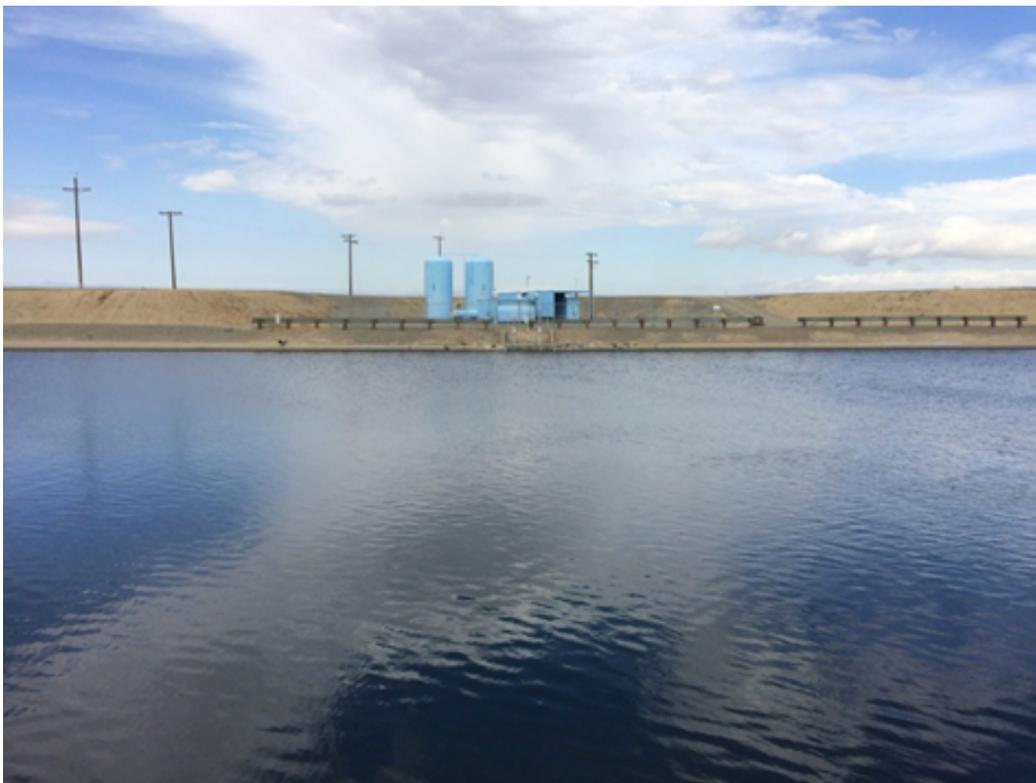
Figure 7-7 Turnout at Milepost 160.45

While driving from Check 20 toward Milepost 160, it became apparent that the distance between the WSE and the top of the liner was getting smaller. Normally (at design flows), the WSE and the top of the liner should be equidistant. At 1,000 cfs (flow during site visit), the distance between the WSE and the top of the liner should get larger, not smaller. This observation was consistent with the Precise Survey unit's data that showed a large drop (about 6 feet of subsidence) at Milepost 160.45. Figure 7-7 provides a view of Milepost 160.45 (right side). It shows the height of the WSE while flowing 1,000 cfs (maximum design flow in this pool is 8,350 cfs). Very little freeboard is visible between the WSE and the top of liner.

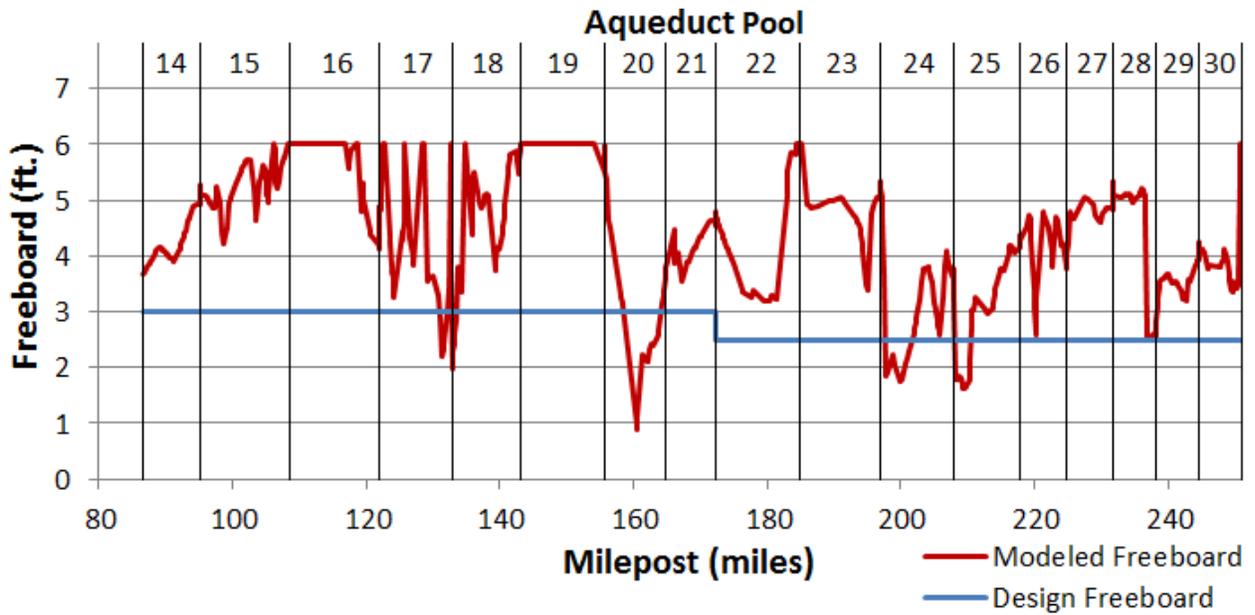
Figure 8-1 Lined Freeboard with Original n-value (0.0160) and Design Flow Capacity

Figure 8-1 shows the modeled freeboard along the Aqueduct alignment under the assumption that the channel roughness, n, equals the original design value of 0.016, and each pool is carrying the design flow. The geometry used in the model corresponds to the subsided geometry of the Aqueduct. It is seen that at multiple pools, the lined freeboard (red line) is lower than the designed minimum freeboard (blue line). Table 8-2 shows the design freeboard of the Aqueduct has been reduced for a length of about 12.7 miles. The lowest freeboard is 0.9 foot in Pool 20, and near Milepost 160.45, extending about 750 feet in length.

Given the decades of canal operation with accumulation of sediments and debris in the canal bed, along with movement of panels and accumulation of algae, the channel roughness, or the Manning’s coefficient, has likely increased. An increase in the channel roughness decreases the canal conveyance capacity. The results, as shown in Figure 8-1, represent the upper limit of the conveyance capacity.

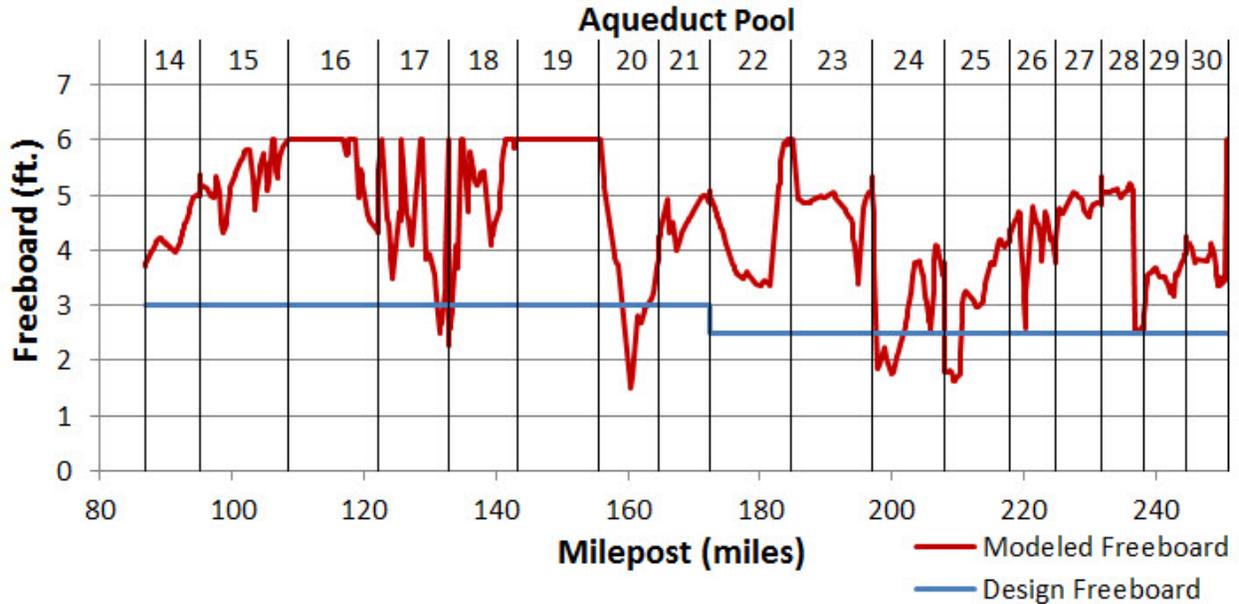
Figure 8-2 Lined Freeboard with Original n-value (0.016) and Reduced Flow Capacity

In the second run, and in order to assess the impacts of subsidence on freeboard, the HEC-RAS model was rerun with a revised freeboard requirement. The HEC-RAS model was run multiple times by changing the inflow into a pool so that the freeboard at any point within a pool is at least 1.5 feet. For all trial runs, and in order to maximize the flow, the check structures gates were kept open. The modeled freeboards along the Aqueduct profile are shown in Figure 8-2. Pools 17, 18, 20, 24, and 25 are some of the pools with reduced freeboard. The original and modeled capacities of the pools are shown in Figure 8-3. In order to maintain a minimum freeboard of 1.5 feet, the maximum flow at Pool 20 had to be limited to approximately 7,600 cfs. This relates to about a 9 percent reduction from the original capacity of 8,350 cfs. As shown in Table 5-1, the original design capacities of Pools 21 and 22 were 8,350 cfs and 8,100 cfs, respectively. The reduction in the Pool 20 flow capacity also reduces the capacities of Pools 21 and 22. As a result, Pool 20 acts like a choke point for pools downstream.

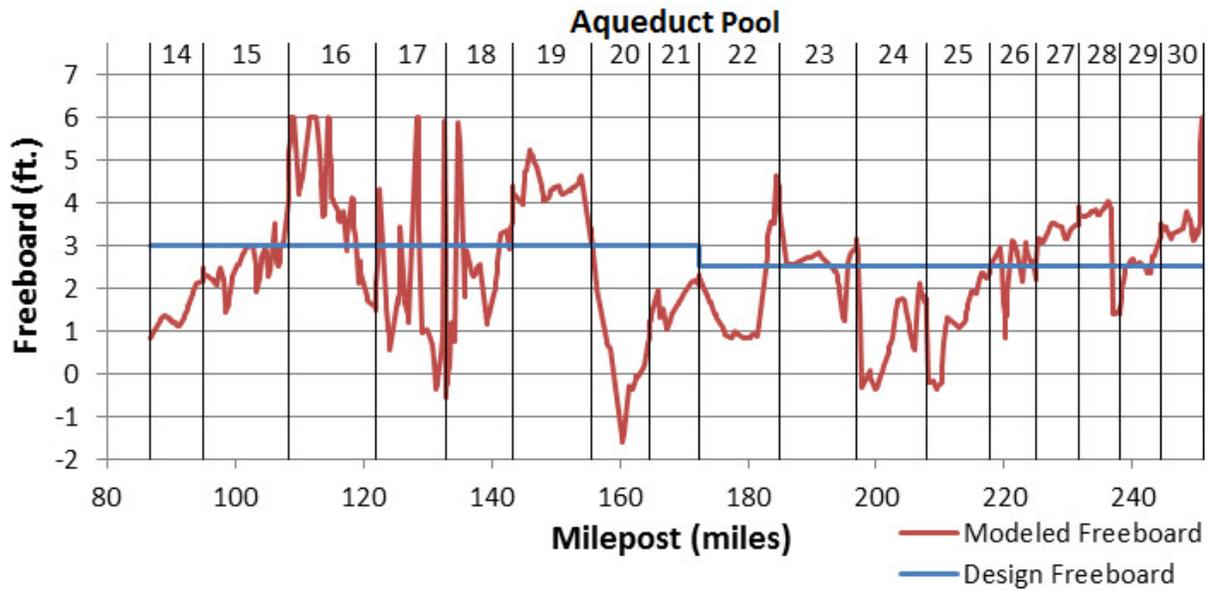
Figure 8-4 Lined Freeboard with Current n-value (0.020) and Design Flow Capacity

To model the current conditions, the HEC-RAS model was modified by setting the Manning’s n-value to 0.020. The upstream boundary condition corresponds to the design flow capacity and the downstream boundary condition is the minimum WSE at BVPP forebay pool. The lined freeboard along the Aqueduct profile is shown in Figure 8-4. Model results show that, with the increased bed roughness, the liner is overtopped at multiple locations. As shown in Table 8-2, out of the 164.2 mile long Aqueduct section that was considered in the model, the freeboard has been reduced below designed minimum of 3feet for about 96 miles. In total, the liner is overtopped for about a 9.5 mile stretch of Aqueduct. At Pool 20 and near Milepost 160.45, which experienced the greatest subsidence, the liner is over topped by 1.6 feet. The liner is also overtopped at Pools 17, 18, 20, 24, and 25. Table 8-2 shows the length of Aqueduct that has less than the design freeboard height, for both ideal conditions (n=0.016) and the estimated current conditions (n=0.020).

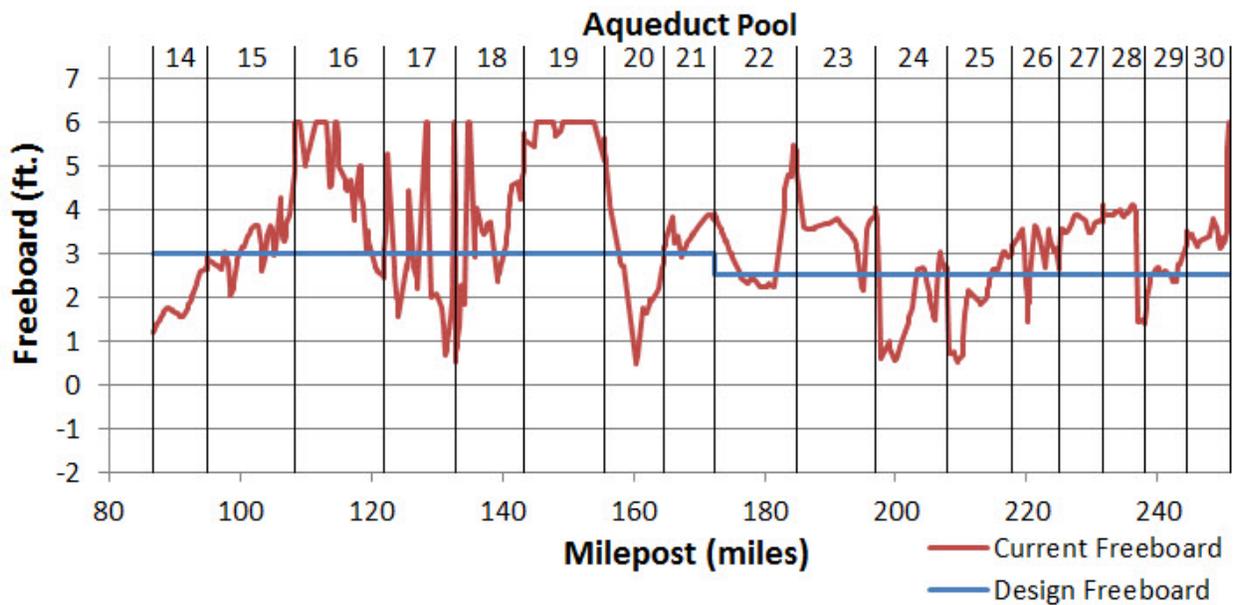
Figure 8-5 Lined Freeboard with Current n-value (0.020) and Reduced Flow Capacity

model was run multiple times, using trial error, by changing the inflow into a pool so that the freeboard at any point within a pool is about 0.5 foot. In the run, the flow rate within a pool was kept constant. Figure 8-5 shows the freeboard along the aqueduct section. The minimum freeboard is seen near Mile Post 160.42 (Pool 20), which has experienced the greatest subsidence. At multiple locations in Pools 17, 18, 24, and 25, the freeboard is less than 1 foot. Figure 8-6 shows the design flow rate and the maximum flow rate that result in 0.5 foot freeboard. The figure allows a comparison to see the reduction flow rate caused by subsidence in each pool. As shown in Figure 8-7, the flow capacity has been reduced at multiple pools. For Pool 20, which has the most subsidence, the maximum capacity is 6,650 cfs, a reduction of 1,700 cfs, or about 20 percent from the original capacity.

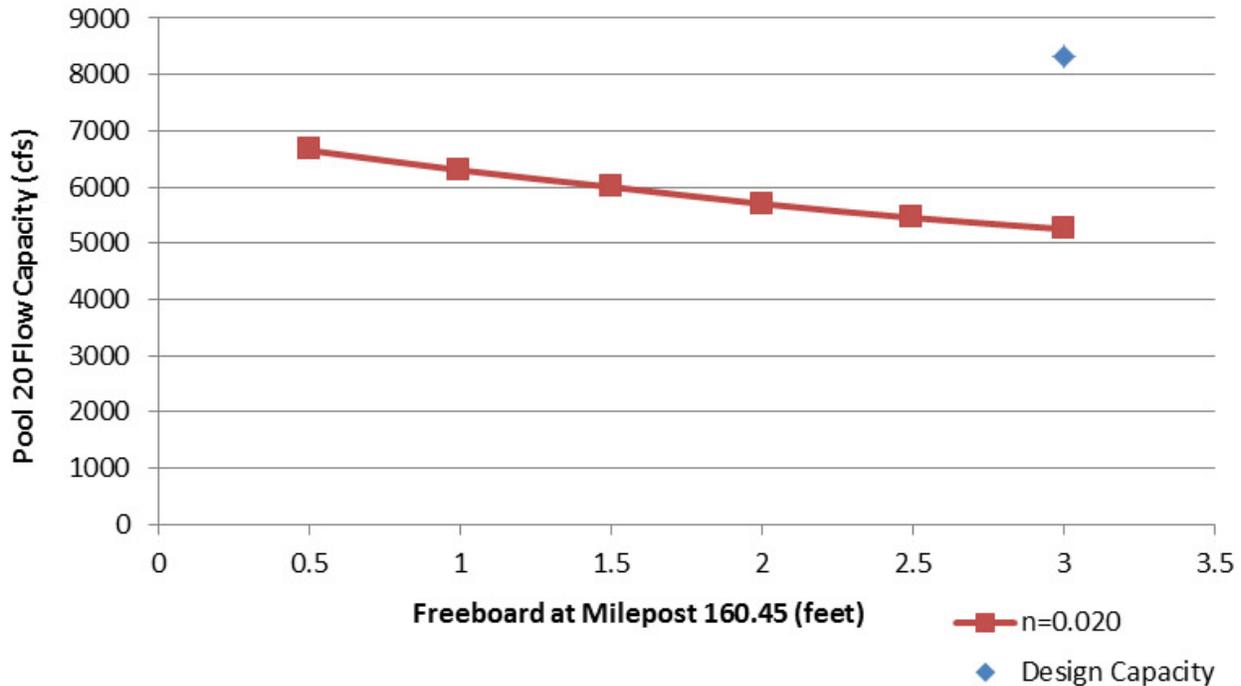
Figure 8-8 Reductions in Pool 20 Flow Capacity with Increase in Freeboard for n=0.020

For a desired freeboard of 0.5 foot, the capacity of Pool 20 has been reduced by about 1,700 cfs. It is anticipated that the subsidence will continue in the future, impacting the Aqueduct conveyance capacity. In order to assess impact of additional subsidence on the Aqueduct capacity, the HEC-RAS model was re-run for increased freeboard. The model was run separately to estimate the maximum flow for a freeboard of 1 foot, 1.5 feet, 2 feet, 2.5 feet, and 3.0 feet for Pool 20 near Milepost 160.42. The minimum operating elevation for Pool 20 is 313.4 feet, and based on the 2015 GPS survey, the lining’s top elevation at Milepost 160.45 is 316.31 feet. Because the additional freeboard based upon the standard operating order is 2.9 feet, the sensitivity analysis was stopped at 3 feet.

The maximum flow passing through Pool 20 as a function of freeboard is shown in Figure 8-8. The modeling results show that for a freeboard of 0.5 foot the flow capacity is 6,650 cfs, and for a freeboard of 3.0 feet the flow capacity is 5,250 cfs. The figure also shows flow capacity of Pool 20 decreases linearly with subsidence. This suggests additional subsidence will further reduce the capacity of Pool 20.

Note: At 2.6 feet of freeboard, Pool 20 would be lower than minimum elevation; turnouts may be inoperable.
