Mendocino complex / Ranch Fire 2018

Blue Ribbon Commission Meeting
December 20, 2018
Upper Lake, CA

Frank A. Aebly, Ph.D.
District Ranger, Covelo and Upper
Lake Ranger Districts
Mendocino National Forest

Ranch Fire Overview

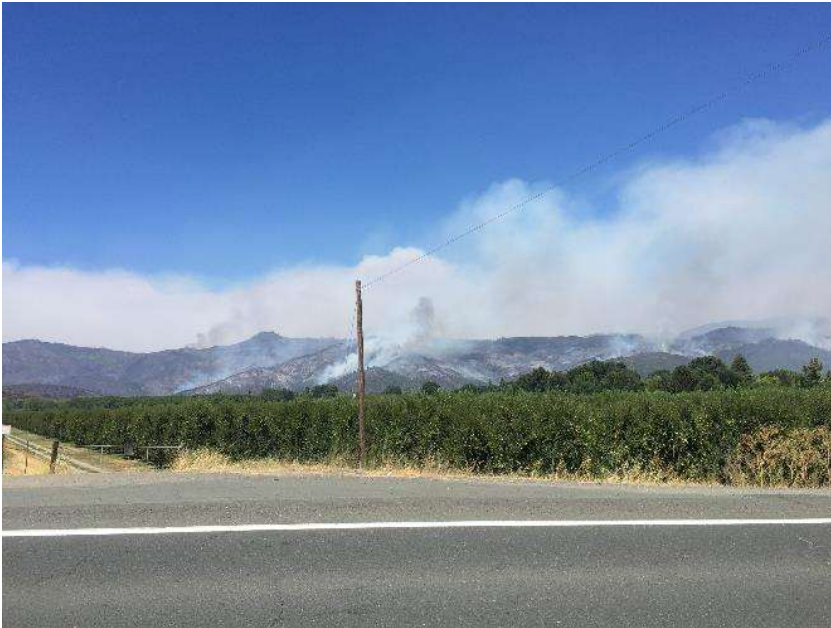
Approximately 98,000 acres of the Clear Lake basin within the fire perimeters (~40%)

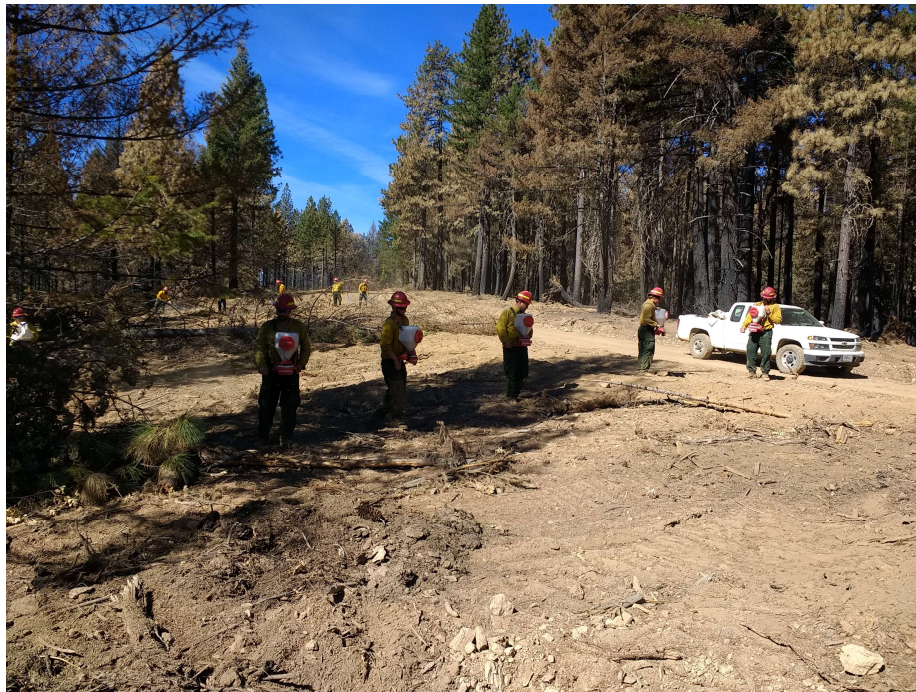
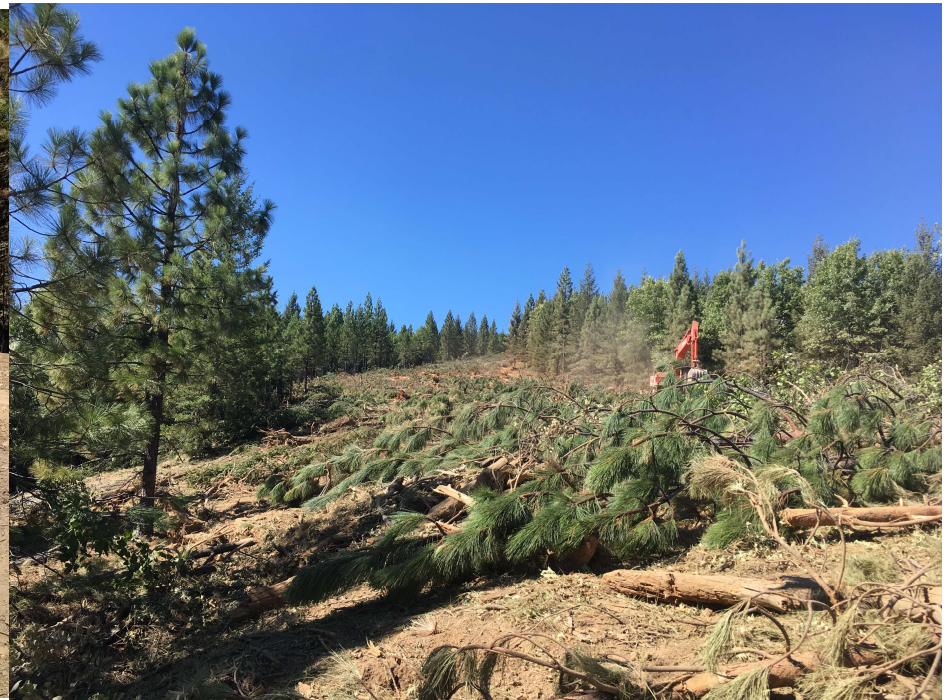
Post Fire Practices and Policies – Suppression Repair

- Dozer line and hand line repair (300 miles)
- Road grading
- Draft site repair
- Seeding
- Garbage removal

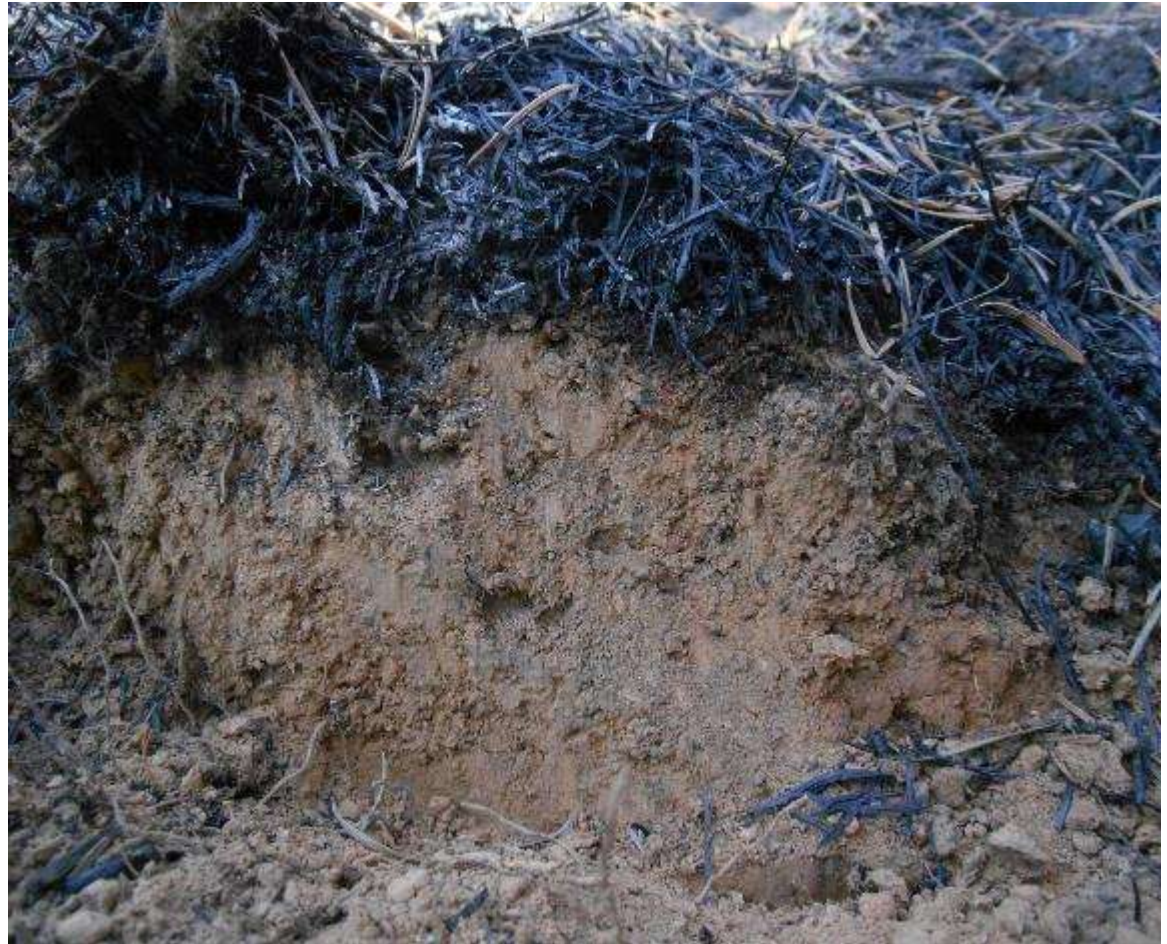
Low SBS

Shallow surface char
(<1 cm)

OM unaffected

Structure ok

Porosity ok

Fine roots abundant

Seed bank ok

Natural/slight water
repellency

Natural recovery rapid

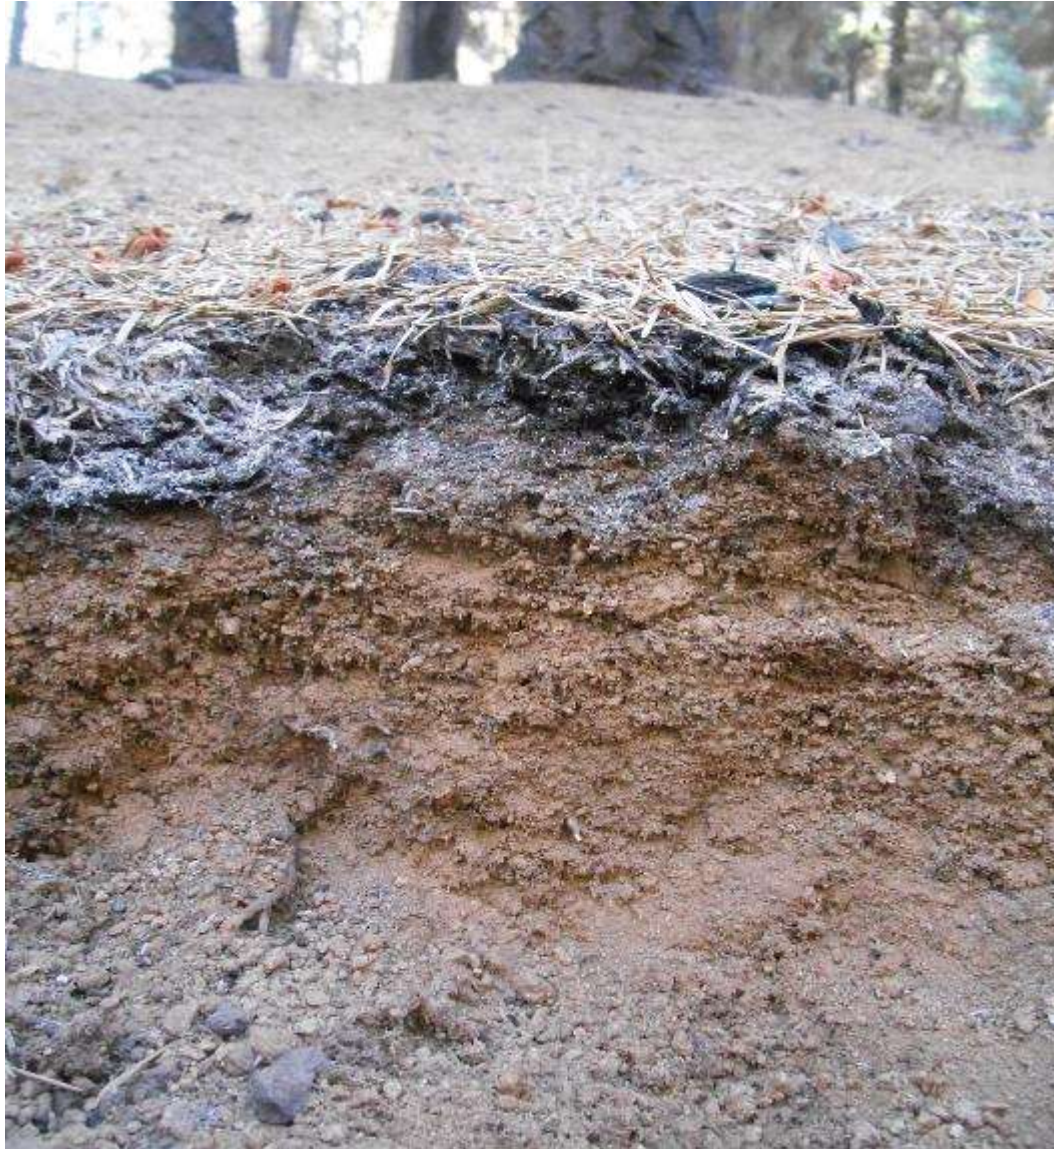
Moderate SBS

$\frac{1}{2}$ inch +/- surface
char

OM unaffected

Structure mostly intact

Porosity mostly intact

Fine roots
charred/present

Seed bank ok

Moderate H₂O repellency

Natural recovery normal

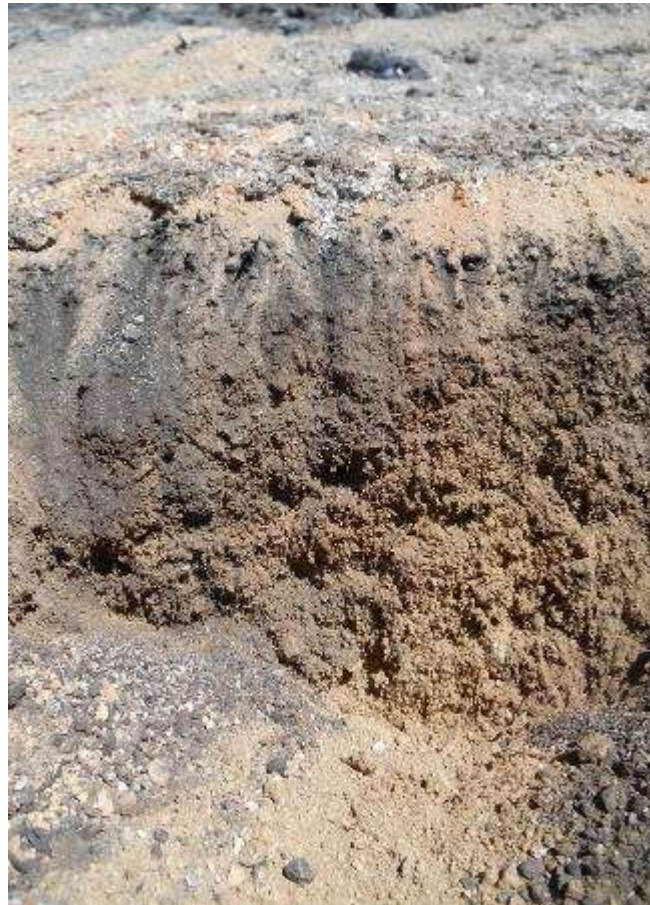
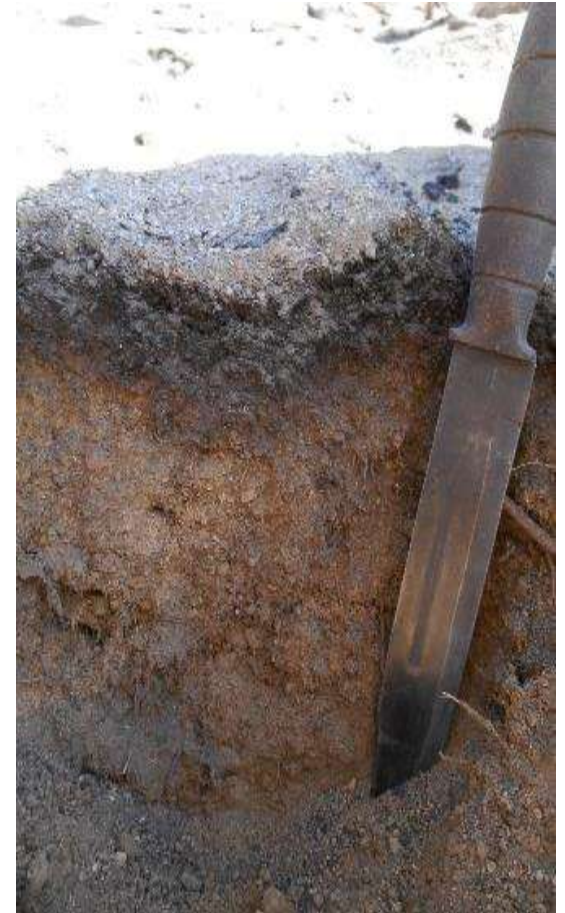
High SBS

Surface oxidation

Deep char- 1.5+ inches

Structure very degraded

Porosity very degraded

Fine roots consumed

OM volatilized

May have severe water repellency

Natural recovery slow

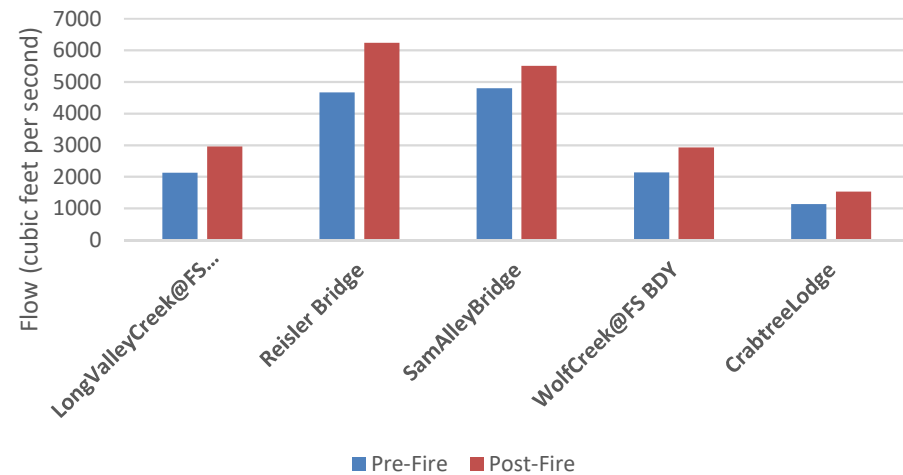
Pre- and Post- fire flows for PourPoints of interest

Post-Fire Hydrologic Response

2-year 24 hr. storm (3.6 inches)

- **Given a typical winter storm, we do not anticipate extremely large increases in flow due to the burned area.**
- **FS roads and trails should be treated or monitored to protect infrastructure and water quality**
- **Water from Lake Pillsbury and Clear Lake may be temporarily impacted by turbidity and/or debris during large storm events**

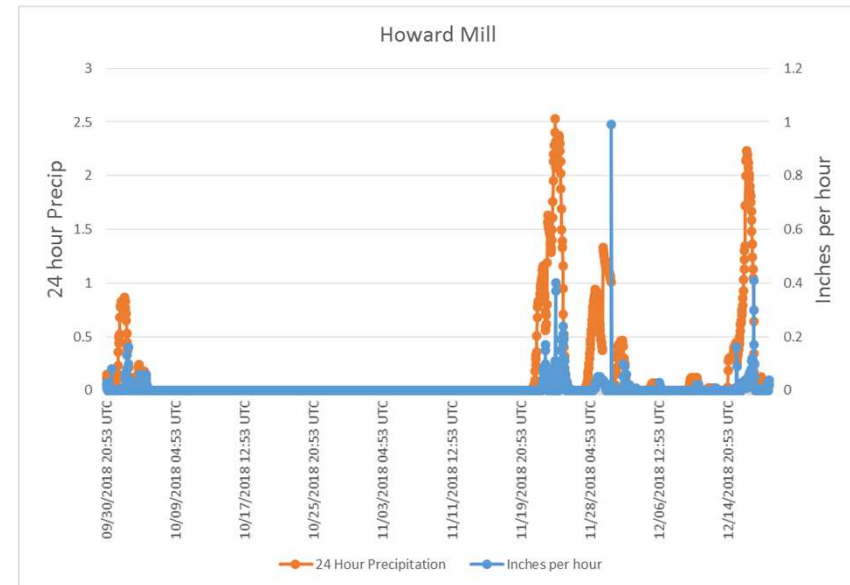
Howard Mill RAWS

- 2.5 inches in 24 hrs.
- 1 inch/hour

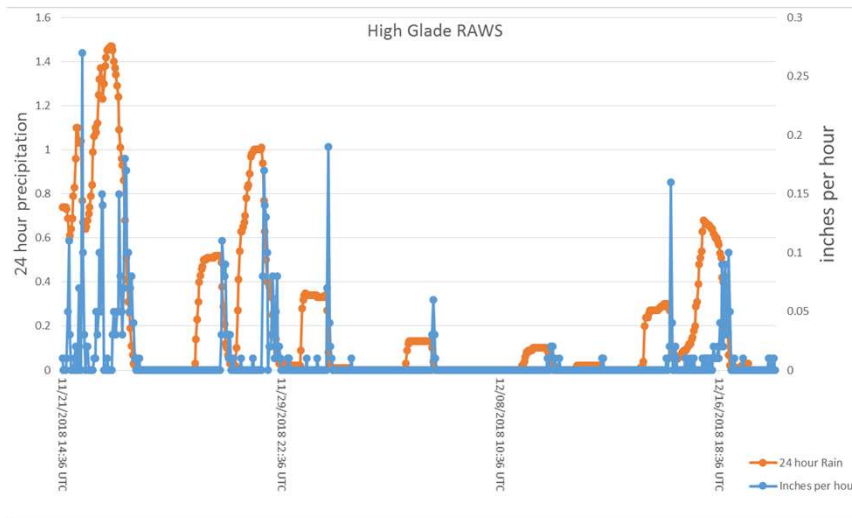
High Glade RAWS

- ~1.4 inches in 24 hrs.
- ~0.25 inch/hour

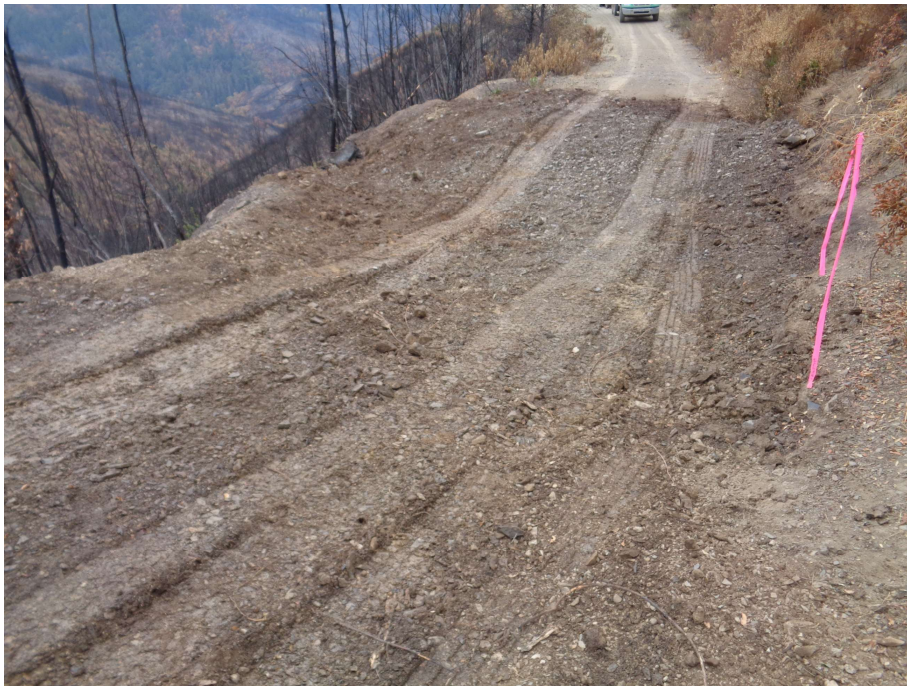
Armored rolling
dips

- Treatments were approved mainly for roads, trails, invasive weeds, and heritage resource protection
 - New and reinforced rolling dips
 - “Storm-proofing” Roads
 - Closures
 - No surface treatments (e.g mulching) approved

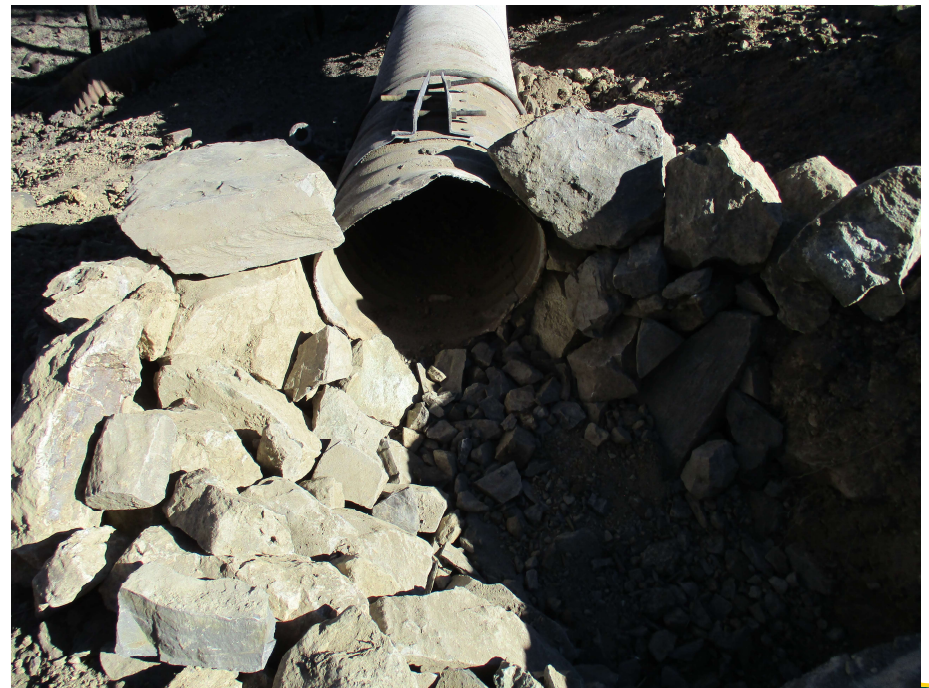
Culvert armoring

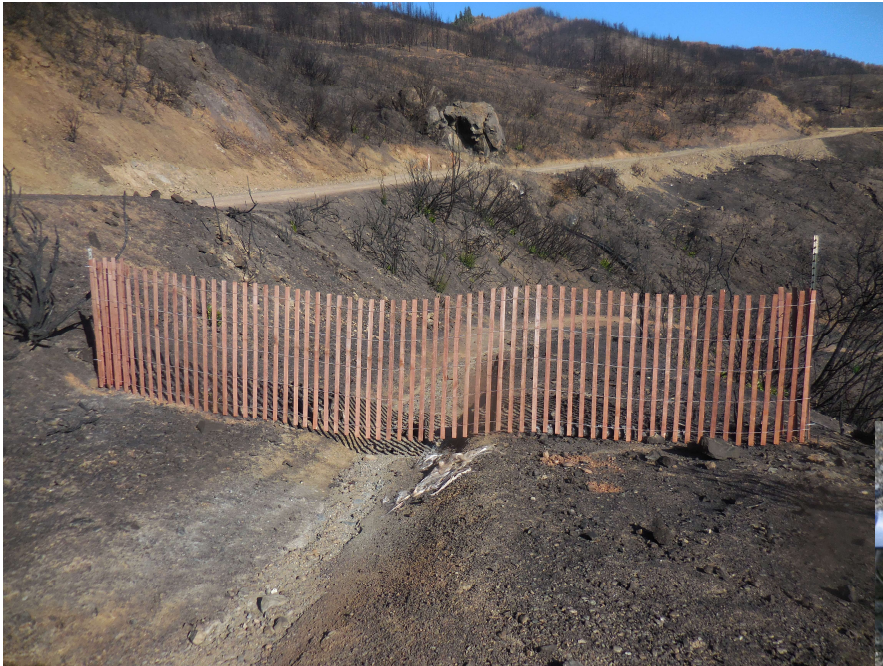
Blockades

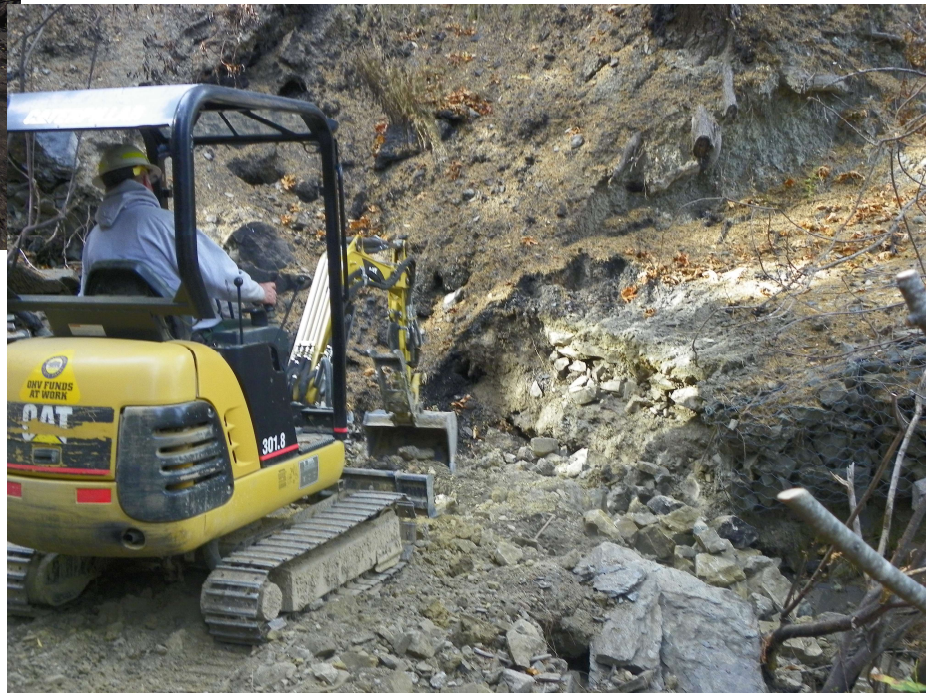
Culvert Removal
