# **OROVILLE DAM CITIZENS ADVISORY COMMISSION**

**Meeting 21  
October 24, 2025**

# OROVILLE DAM SAFETY PROGRAM UPDATE

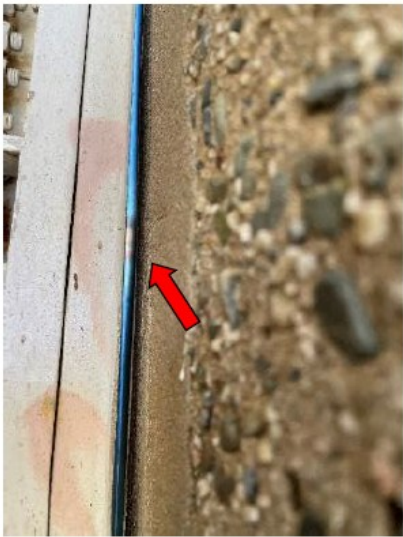
Photo 4-94: Gate 2 – Typical day-light gap observed at side seal.

- Gates subject to full-open exercises every year that includes measurements of electrical power draw to monitor for any binding/friction.
- 2017: Hoist Rope magnetic particle testing – no wire breaks
- 2022: 10-year Structural, Mechanical, and Electrical Inspection
  - Found suitable for continued operation
  - Recommendations focused on continued maintenance and monitoring
  - Wire ropes inspected and measured, with no evidence of advanced wear
  - Inflatable side seals are not receiving sufficient pressure from water line to counter reservoir pressure, which results in leakage when the reservoir is high.
  - Seal rehabilitation project initiates in 2026

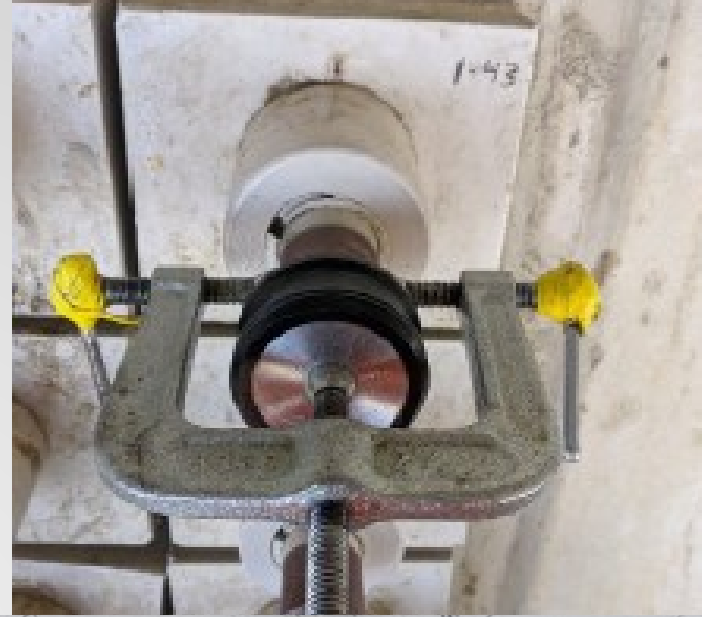
# Non-Destructive Examinations

- Radial gates are “tied” to the structure by high strength steel (tensioned) anchor rods embedded within the concrete piers.
- Rods are grouted, and would require invasive, destructive drilling for replacement. Curvature and density of rods makes replacement infeasible.
- Ultrasonic testing of anchor rods (382) performed on an annual basis to monitor for cracking/corrosion in vicinity to grip nut.
- Periodic testing by USACE performed (guided wave method) used to monitor for any breaks/major cracks at depth along the rod.
- No significant anomalies.
- Structural analyses indicate significant redundancy provided by number of rods, including for seismic loading.
- Alternatives for structural support or redundant gates being considered in upcoming Flood Control Outlet studies.

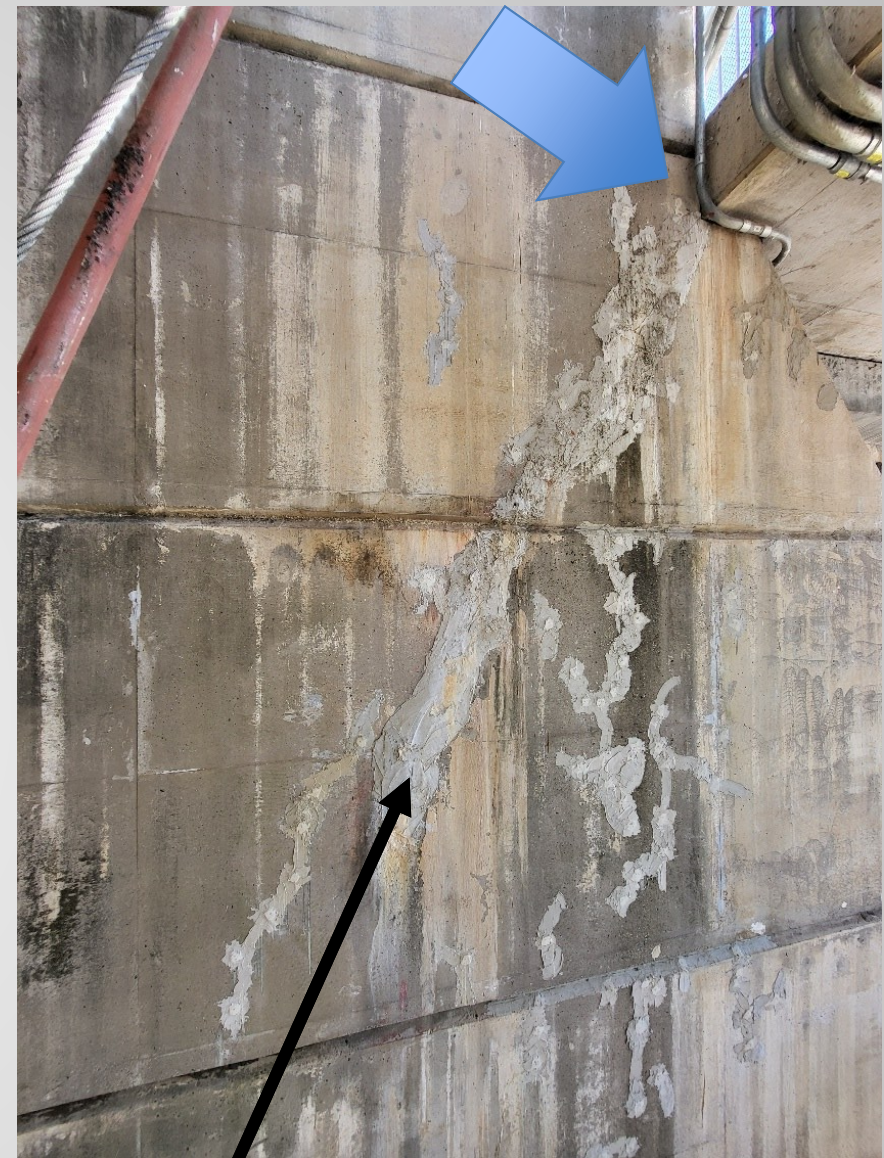
# Flood Control Outlet – Pier 10 Crack

Prior to 2017, the crack was monitored for changes and painted red to assist in visual monitoring for potential growth over time. Red paint (2-4 inches wide) was much wider than the crack itself (0.04 inches).

- Crack originates at a re-entrant corner of a notch in the pier wall for the roadway bridge deck.
- Extends down in upstream direction at about 45 degrees for about 12 feet.
- Measured as 0.04 inches wide (“fine” crack per USACE criteria)
- Non-structural in nature, caused by tensile stress concentrations at the re-entrant corner as a result of concrete shrinkage following construction.
- Minor seepage noted, fed by surface drainage adjacent/external to Pier 10 which concentrated water (corrected).
- All other cracks in FCO also considered non-structural and fine (0.04 inches wide or less).

2019 Crack Sealing: Epoxy injection and surface application

2019 Pier 10 Crack Sealing, light grey epoxy injection and surface application; much wider than actual crack which is 0.04 inches wide

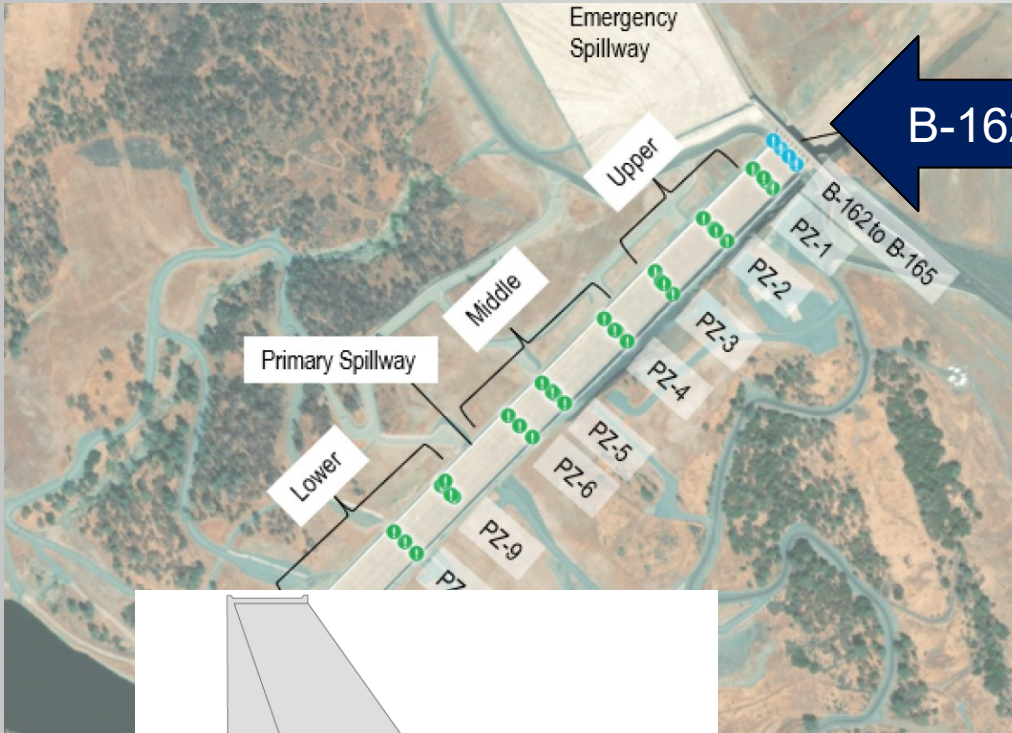
B-162 to -165

# Spillway Performance – Flood Control Outlet Piezometers

- Piezometers **have not** exhibited high ground water pressures with the spillway releases nor the high reservoir condition.
- B-162 (in grey), located in Pier 1 at the edge of the Monolith, continues to show a response to precipitation and sustained lake levels.
- Data continues to demonstrate high quality foundation and concrete-bedrock contact, and lack of uplift pressures
